**APPENDIX 3: Photographs of test setup**  
**Radiated Spurious Emission**

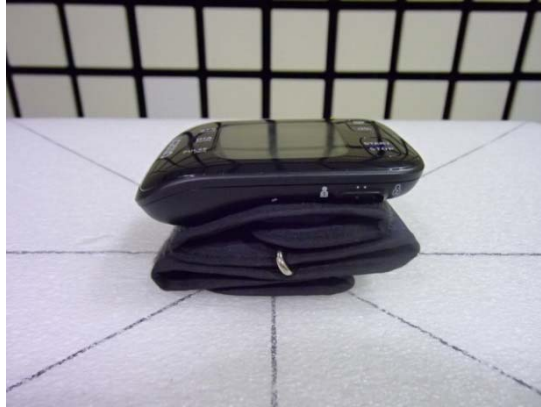
**X-axis**

**Worst Case Position**

**Below 1GHz (Horizontal: X-axis/ Vertical: X-axis)**

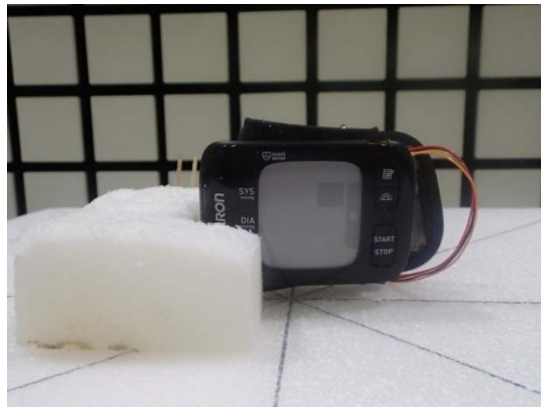
**Y-axis**

**Above 1GHz (Horizontal: Y-axis/ Vertical: Z-axis)**
