Exhibit: Test Setup Photos

FCC ID: QIQCSST1
IC: 10685A-CSST1

Report File #: 7169003115E-000

Product	StimRay	
Standard(s)	RSS 247 Issue 2:2017 FCC Part 15 Subpart 15.247:2015

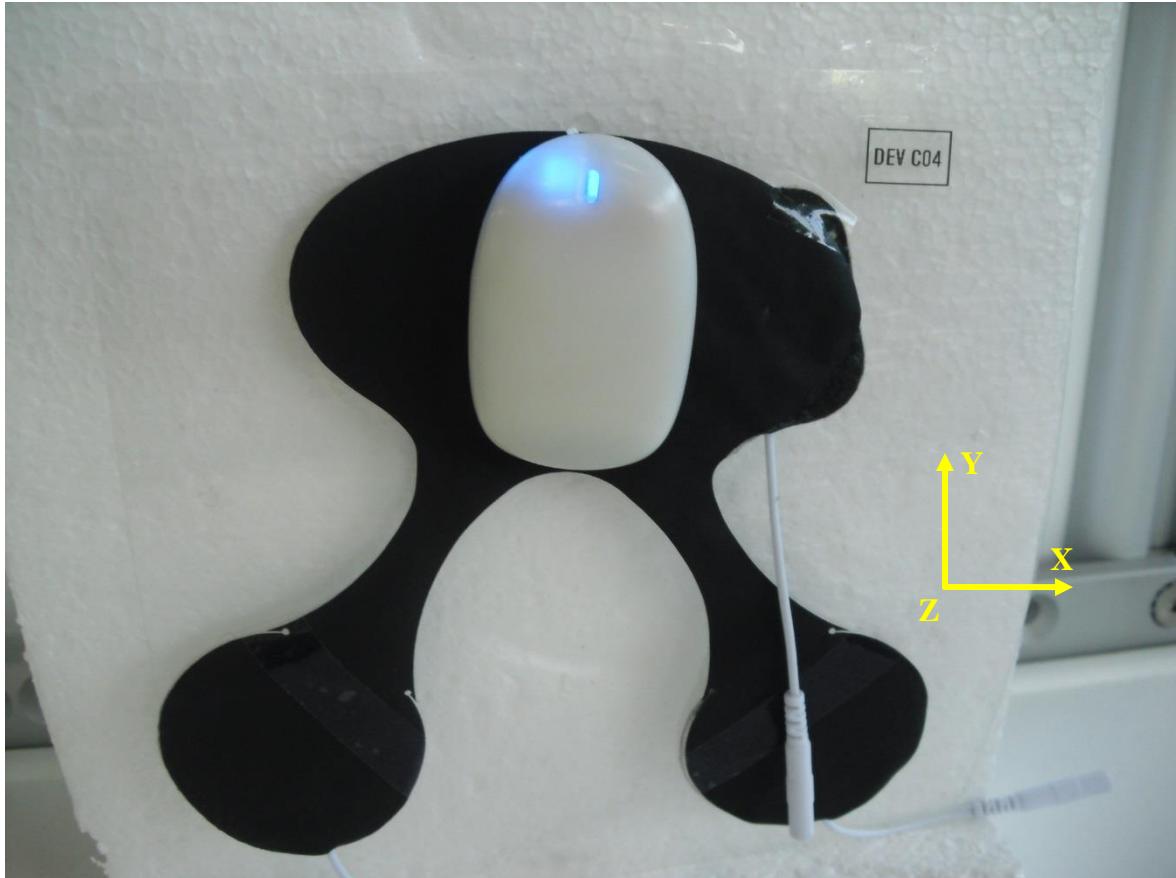
Figure 1 – EUT Close Up

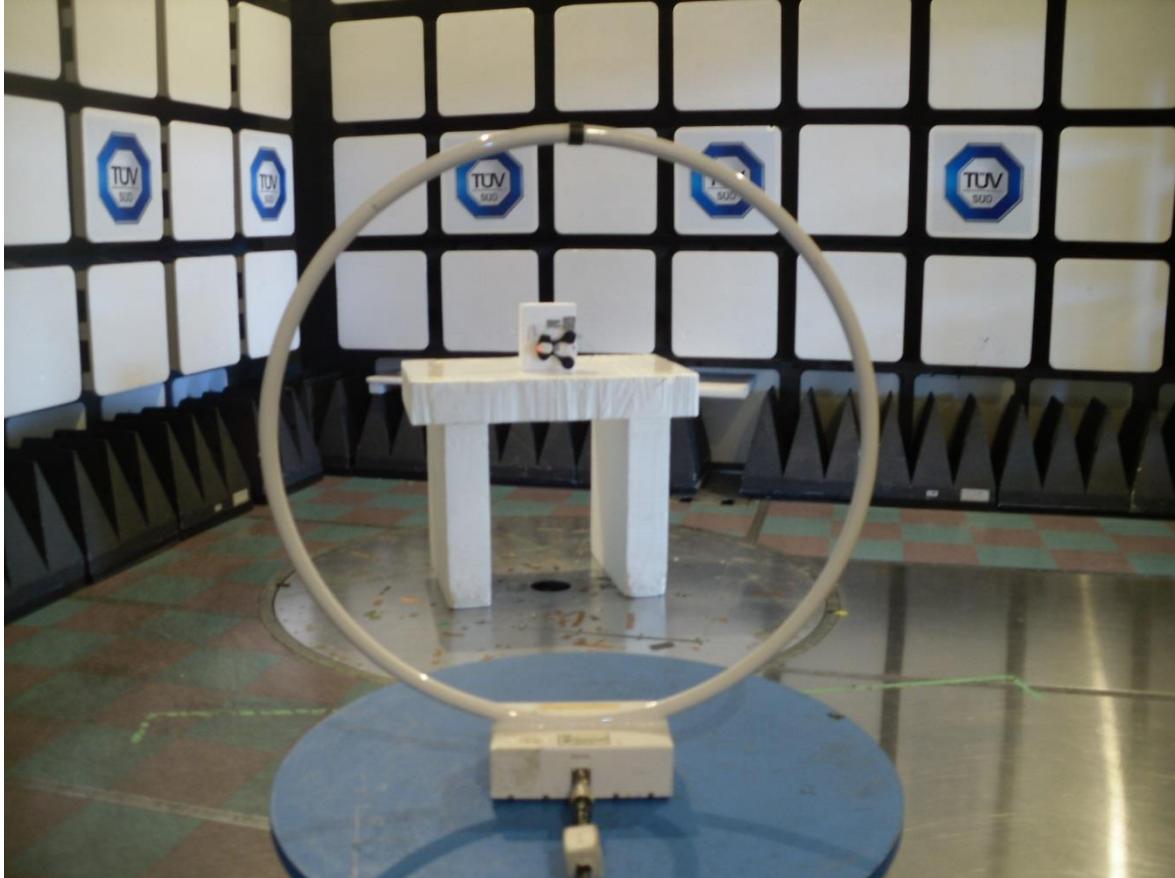
Figure 2 – Radiated Emissions Setup – Photo 1

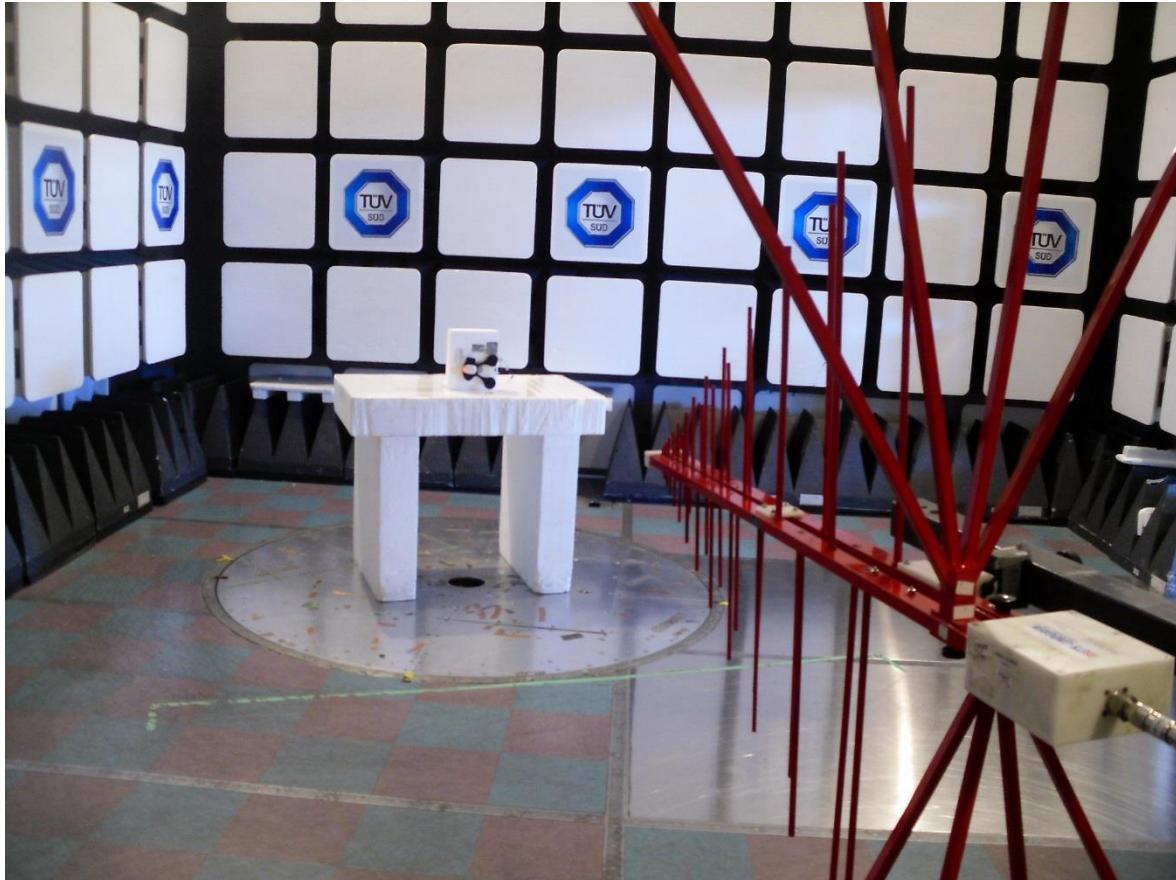
Figure 3 – Radiated Emissions Setup – Photo 2

Note: As per ANSI C63.10-2013 Clause 6.3.1, below 1GHz, the height of the EUT was set to 80cm. Above 1GHz, the height was raised to 1.5m.

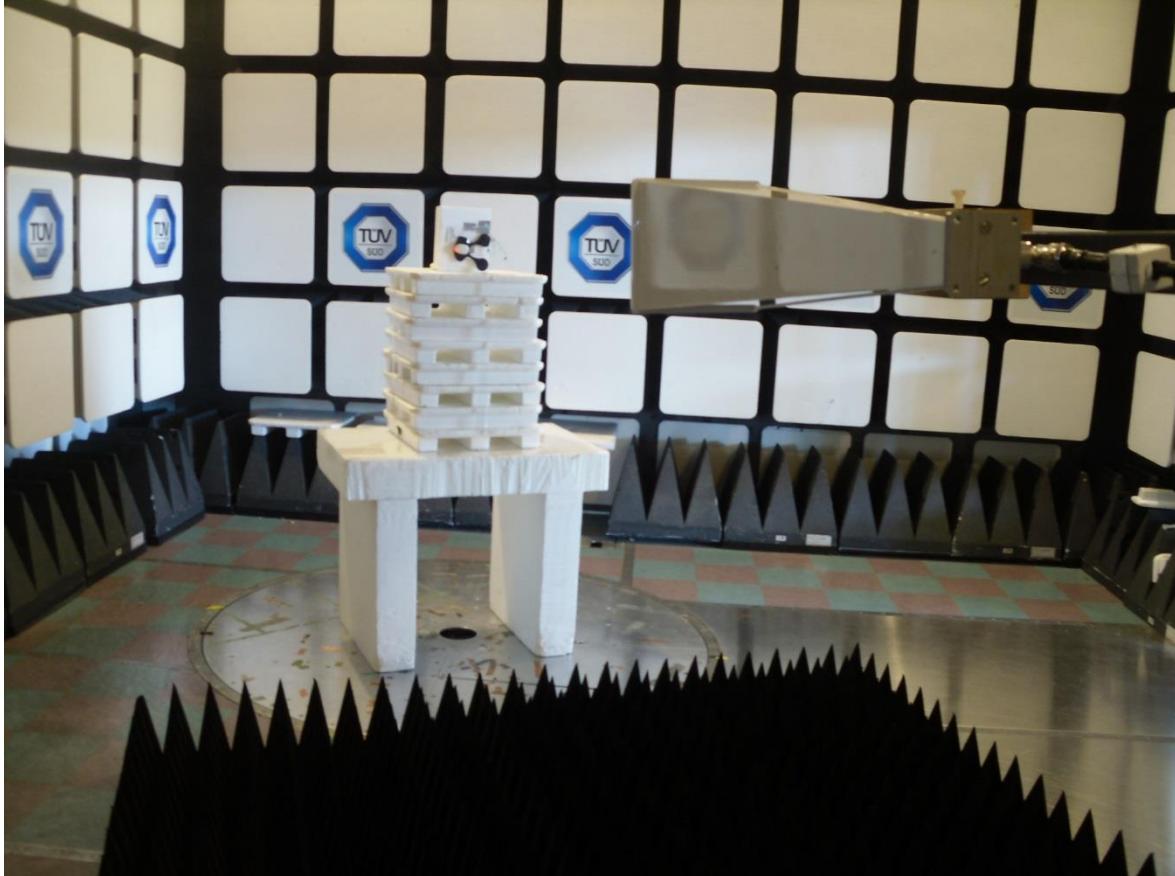
Figure 4 – Radiated Emissions Setup – Photo 3

Note: As per ANSI C63.10-2013 Clause 6.3.1, above 1GHz, the height of the EUT was set to 1.5m.

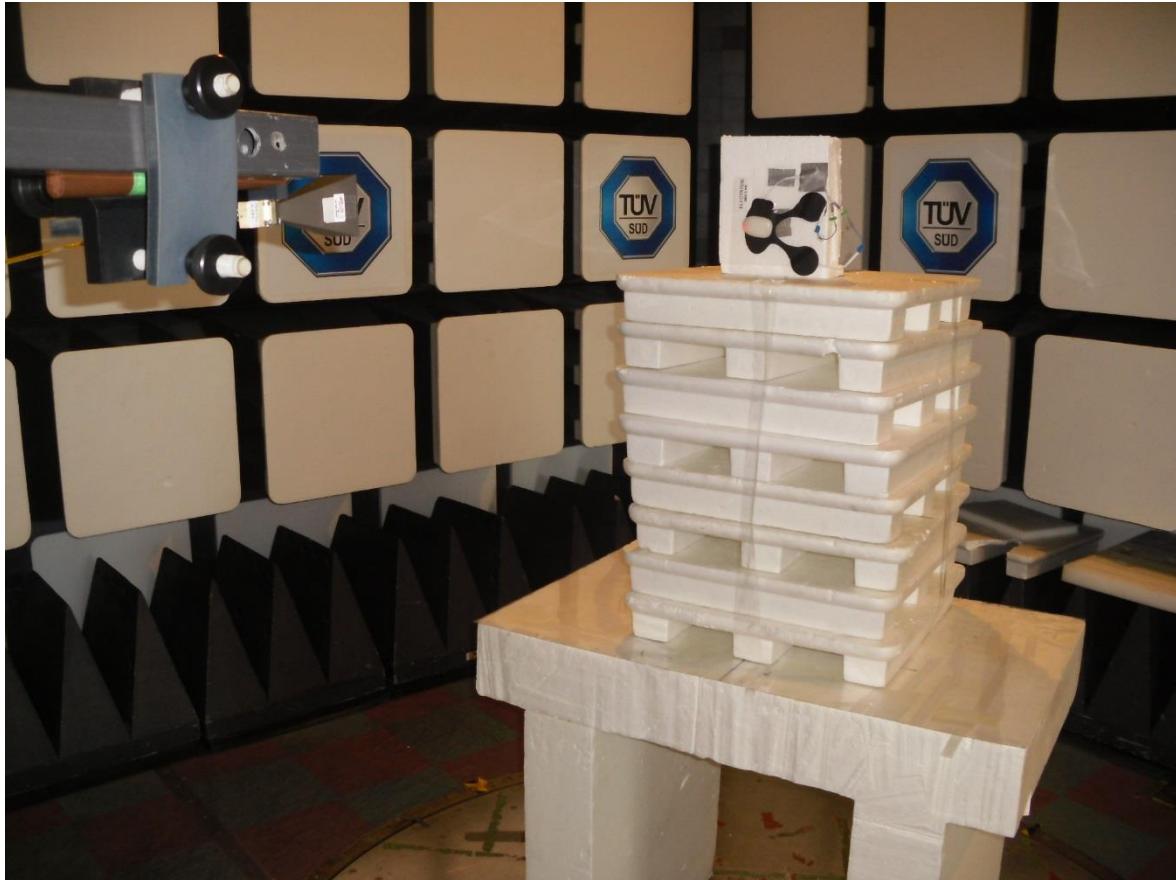
Figure 5 – Radiated Emissions Setup – Photo 3

Note: As per ANSI C63.10-2013 Clause 6.3.1, above 1GHz, the height of the EUT was set to 1.5m.

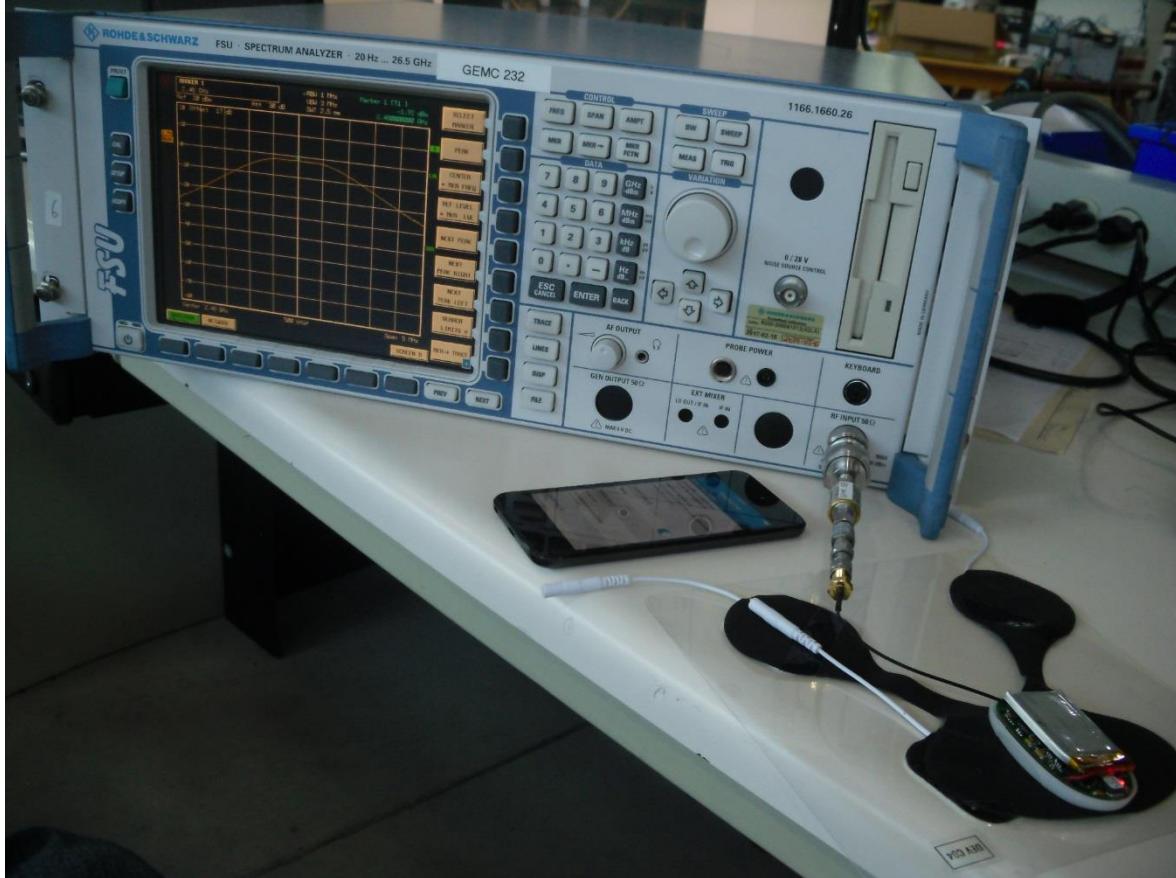
Figure 6 – Antenna Port Conducted Emissions Setup

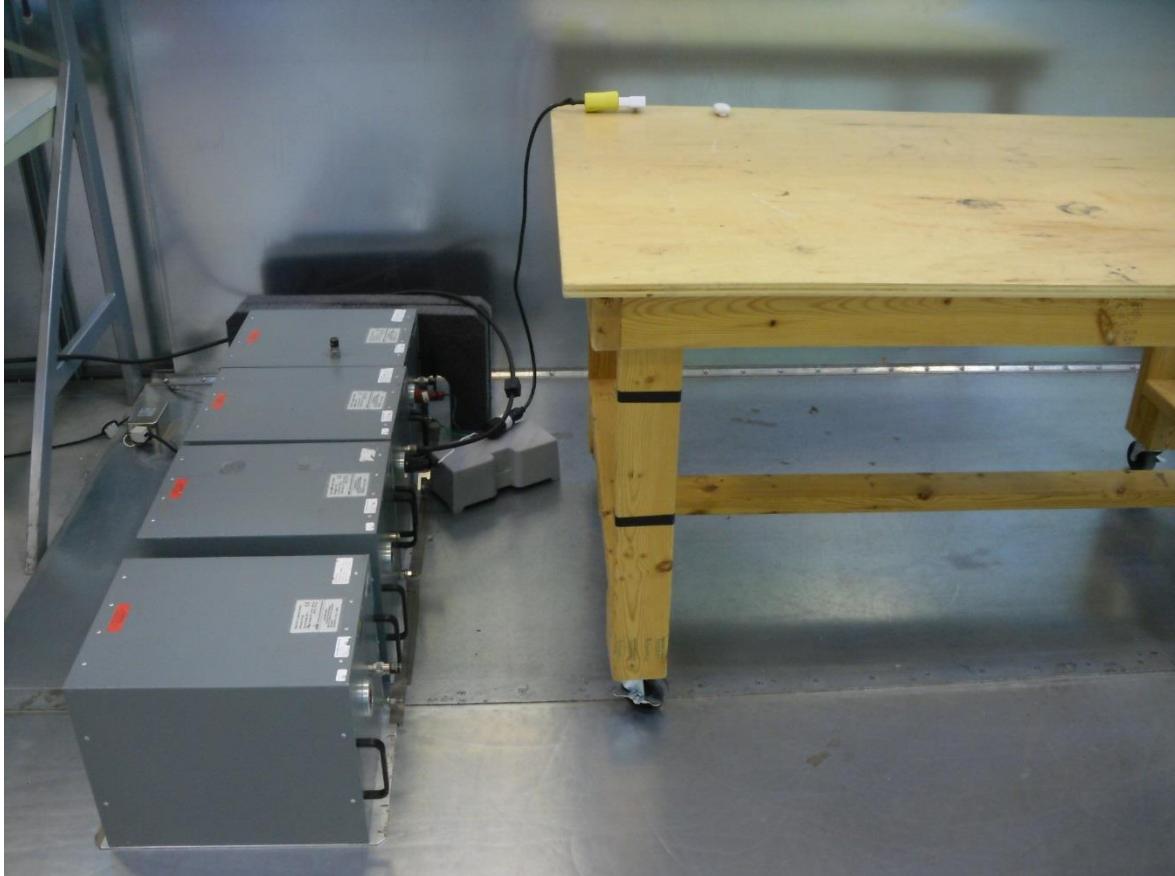
Figure 7 – Conducted Emissions Setup – Photo 1

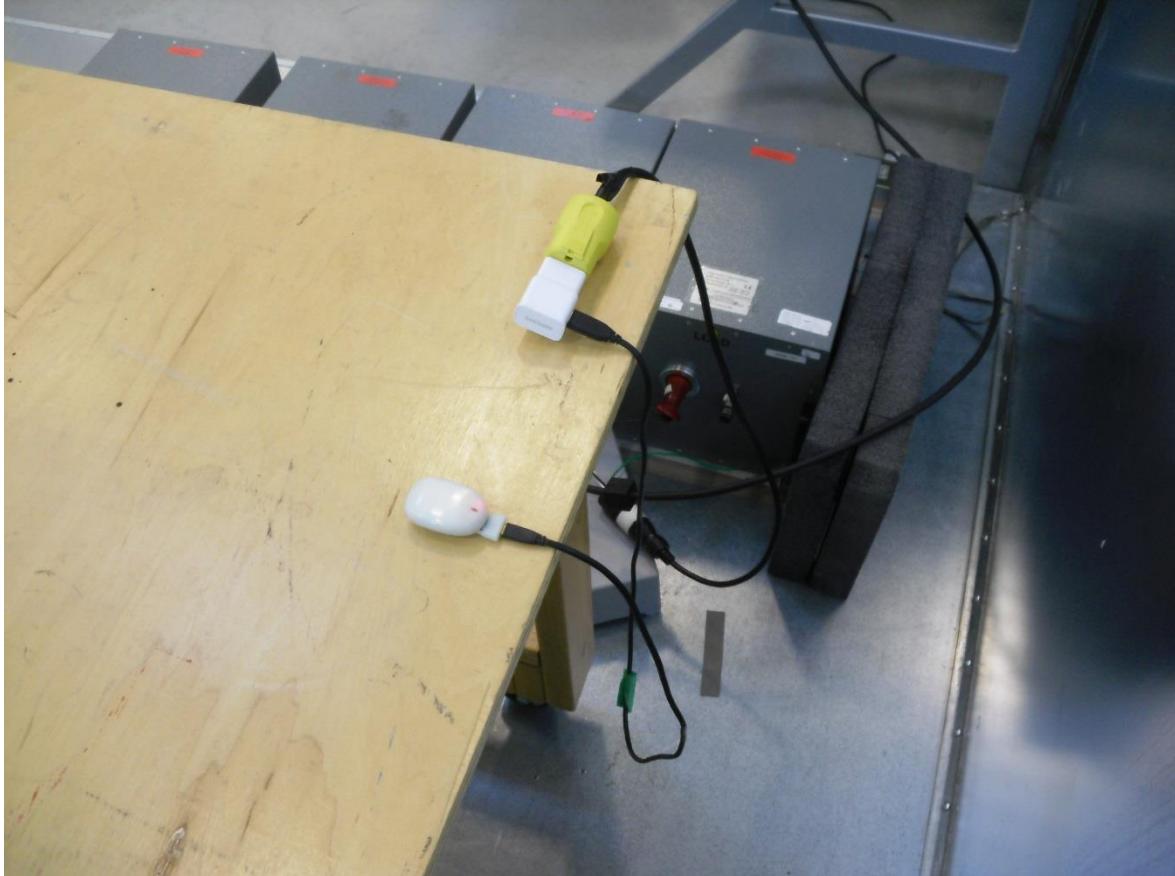
Figure 8 – Conducted Emissions Setup – Photo 2
