Test setup photos for HAC Test Report

Test report no.:	SD_HAC_0849_07	Date of report:	2008-12-12
Template version:	3.0	Number of pages:	4
Testing laboratory:	TCC Nokia San Diego Laboratory 12278 Scripps Summit Drive SAN DIEGO CA. 92131 USA Tel. +1 858 831 5000 Fax. +1 858 831 6500	Client:	Nokia Corporation 12278 Scripps Summit Drive SAN DIEGO CA. 92131 USA Tel. +1 858 831 5000 Fax. +1 858 831 6500
Responsible test engineer:	Julian Kim	Product contact person:	Bill Griffin
Measurements made by:	Julian Kim		
Tested devices:	RM-455 (Hearing aid mode active)		
FCC ID:	QMNRM-455	IC:	661X-RM455
Supplement reports:	SD_HAC_0849_06, SD_HAC_0849_08		
Testing has been carried out in accordance with:	ANSI C63.19-2007 American National Standard for Methods of Measurement of Compatibility between Wireless Communications Devices and Hearing Aids		
Documentation:	The documentation of the testing performed on the tested devices is archived for 15 years at TCC Nokia.

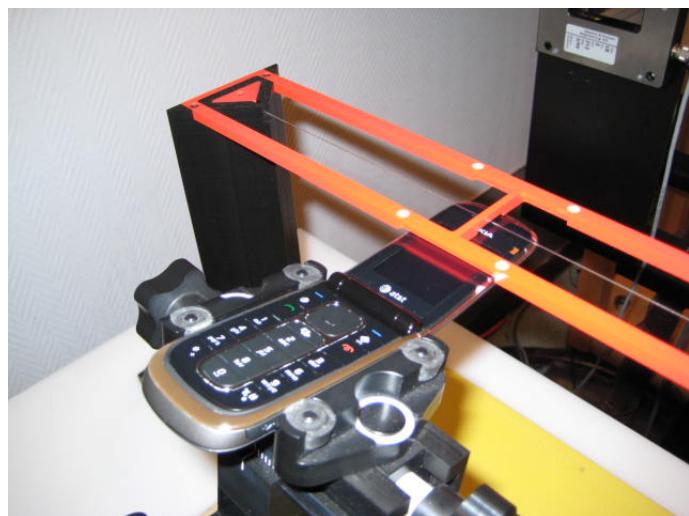
The device was positioned such that Device Reference plane was touching the bottom of the Test Arch. The scan is centered at the acoustic output by aligning the acoustic output with the intersection of the Test Arch's middle bar and dielectric wire.

Photo of the device positioned under Test Arch
