Annex D: Photographs of the test setup

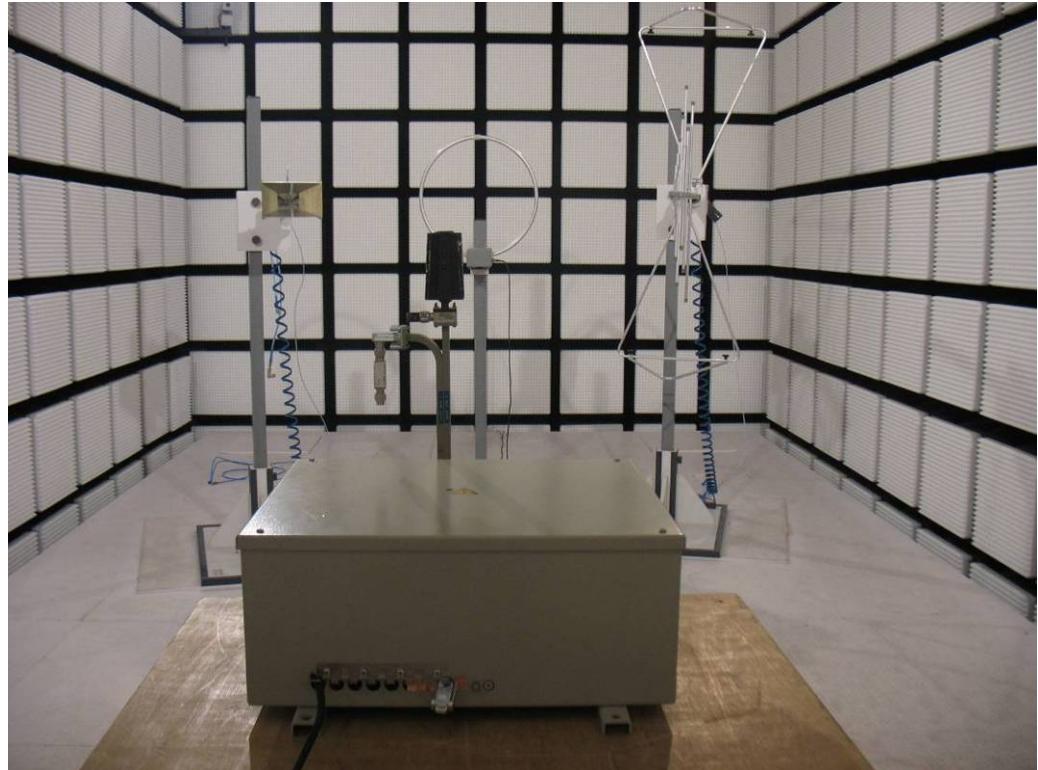
Photo No. 1: radiated spurious emissions up to 12 GHz

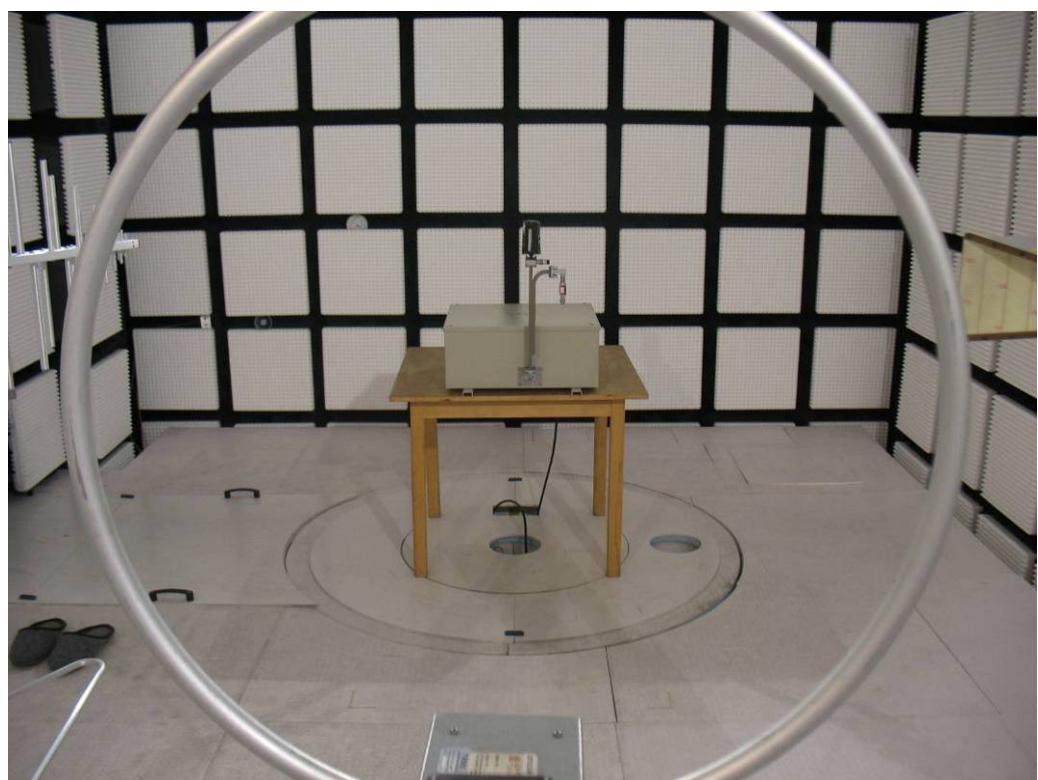
Photo No. 2: radiated spurious emissions up to 12 GHz

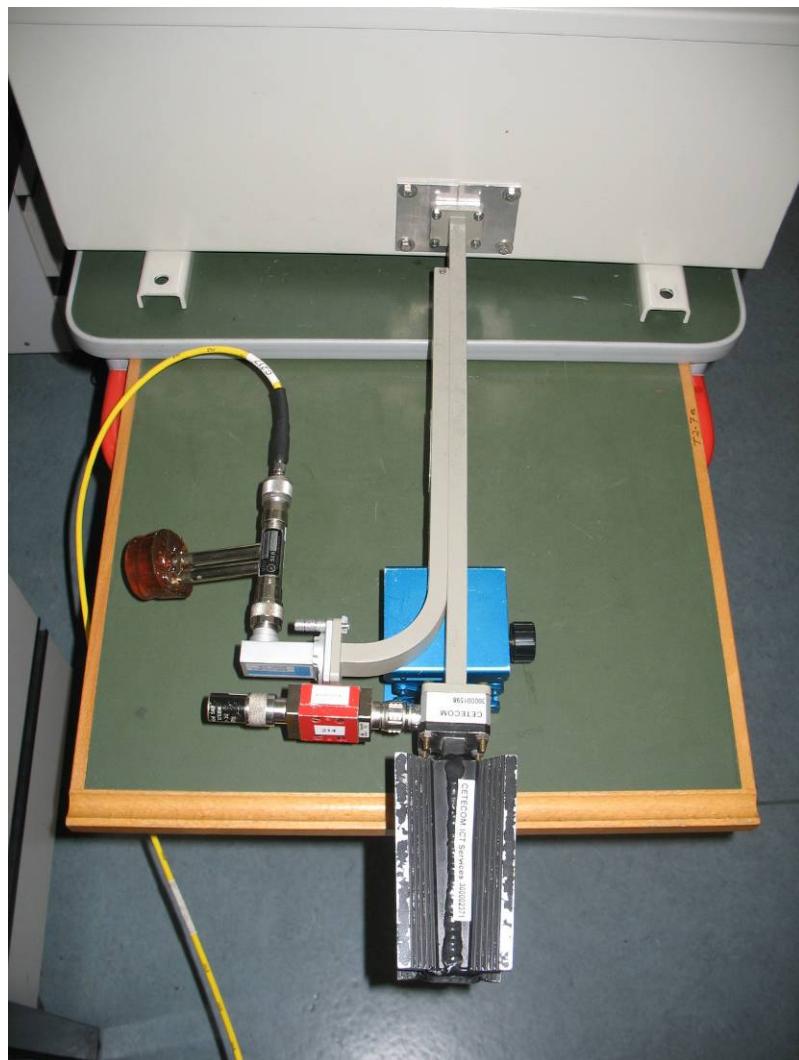
Photo No. 3: conducted measurements, spurious emissions (with stub tuner)

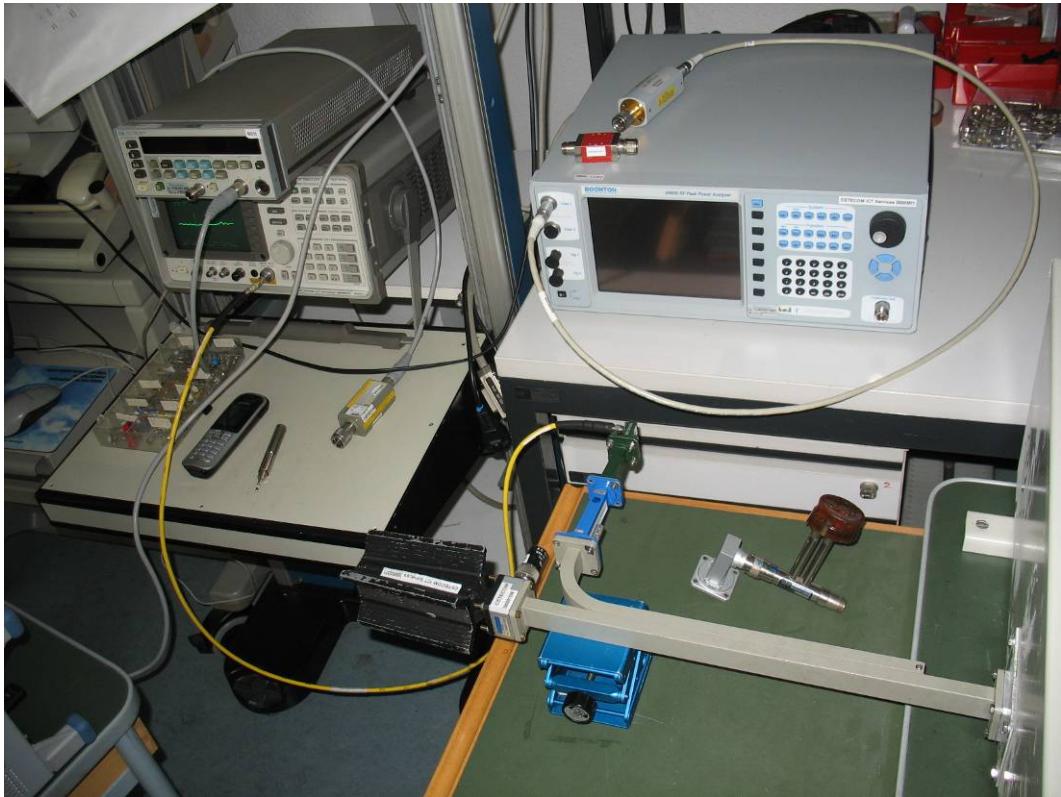
Photo No. 4: conducted measurements, spurious emissions > 15 GHz

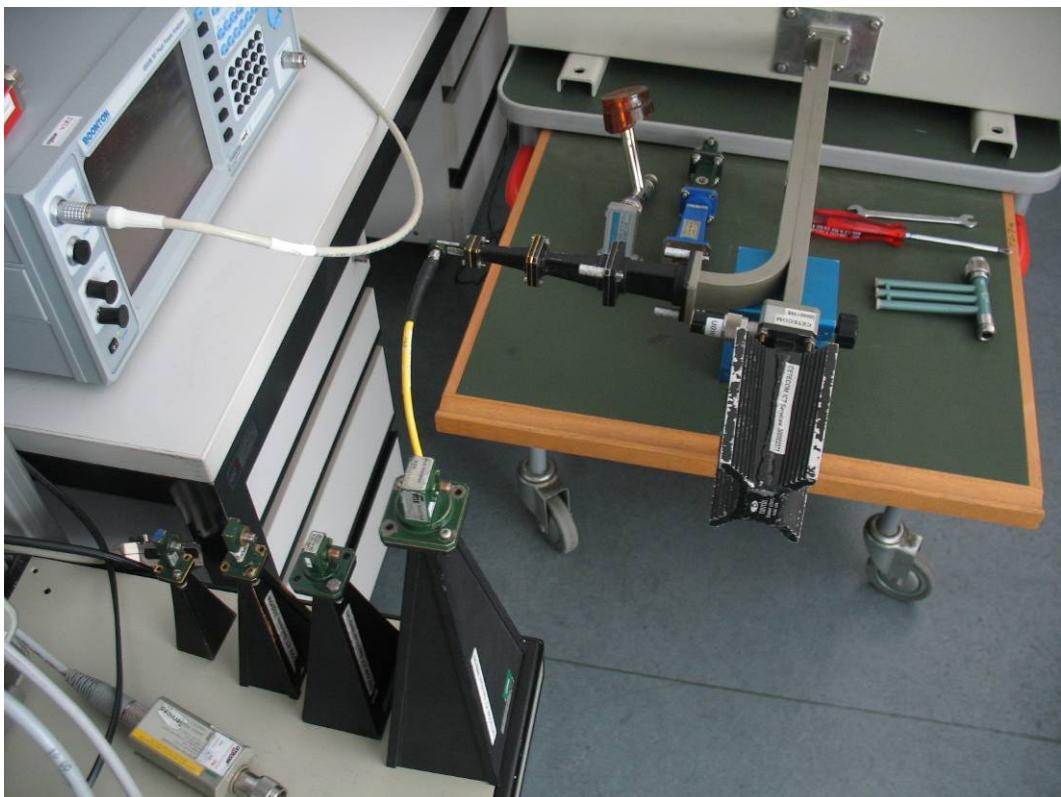
Photo No. 5: conducted measurements, spurious emissions up to 40 GHz
