## Setup photos for HAC RF Emissions and T-Coil Test Report

| <b>Test report no.:</b> | HAC_Photo_RM-497_06 | <b>Date of report:</b> | 2010-07-16 |
| <b>Tested devices:</b> | RM-497 | | |
| <b>Testing has been carried out in accordance with:</b> | <b>ANSI C63.19-2007</b><br>American National Standard for Methods of Measurement of Compatibility between Wireless Communications Devices and Hearing Aids | | |

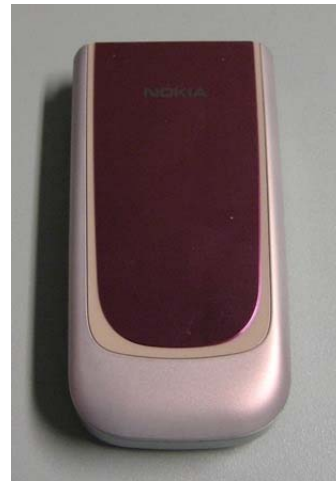
Flip open

Flip closed
