## Setup photos for HAC RF Emissions and T-Coil Test Report

| Test report no.: | HAC_Photo_RM-497_14 | Date of report: | 2010-08-03 |
| Tested devices: | RM-497 | | |
| Testing has been carried out in accordance with: | <b>ANSI C63.19-2007</b><br>American National Standard for Methods of Measurement of Compatibility between Wireless Communications Devices and Hearing Aids | | |

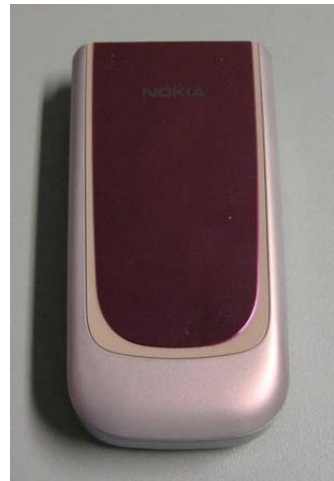
Flip open

Flip closed

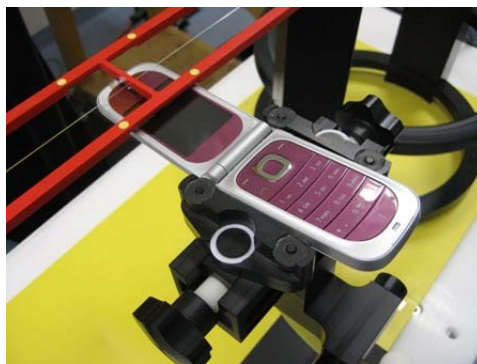
The device was positioned such that Device Reference plane was touching the bottom of the Test Arch. The scan is centered at the acoustic output by aligning the acoustic output with the intersection of the Test Arch's middle bar and dielectric wire.

Photo of the device positioned under Test Arch
