**Setup photos for HAC RF Emissions  
and T-Coil Test Report**

<b>Test report no.:</b>	Salo_HAC_0924_05	<b>Date of report:</b>	2009-06-24
<b>Template version:</b>	1.1	<b>Number of pages:</b>	3
<b>Testing laboratory:</b>	TCC Salo P.O. Box 86 Joensuunkatu 7H / Kiila 1B FIN-24101 SALO, FINLAND Tel. +358 (0) 7180 08000 Fax. +358 (0) 7180 45220	<b>Client:</b>	Nokia Corporation Beijing Economic and Technological Development Area No.5 Donghuan Zhonglu Beijing PRC China 100176 Tel. +86 10 8711 8888 Fax. +86 10 8711 4550
<b>Responsible test engineer:</b>	Heikki Kuusela	<b>Product contact person:</b>	Helen Hu
<b>Measurements made by:</b>	Heikki Kuusela		
<b>Tested devices:</b>	RM-520 (Hearing aid mode active)		
<b>FCC ID:</b>	QTLRM-520		
<b>Supplement reports:</b>	Salo_HAC_0924_04, Salo_HAC_0924_06		
<b>Testing has been carried out in accordance with:</b>	<p><b>ANSI C63.19-2007</b> American National Standard for Methods of Measurement of Compatibility between Wireless Communications Devices and Hearing Aids</p>

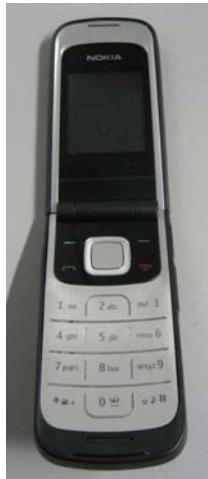
Flip open

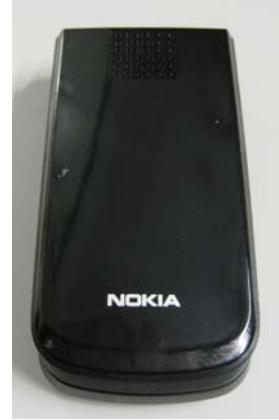
Flip closed

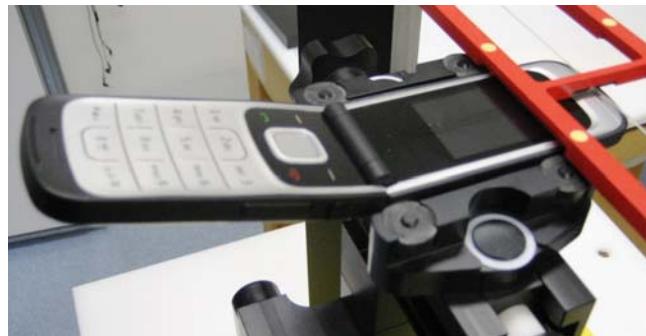
The device was positioned such that Device Reference plane was touching the bottom of the Test Arch. The scan is centered at the acoustic output by aligning the acoustic output with the intersection of the Test Arch's middle bar and dielectric wire.

Photo of the device positioned under Test Arch
