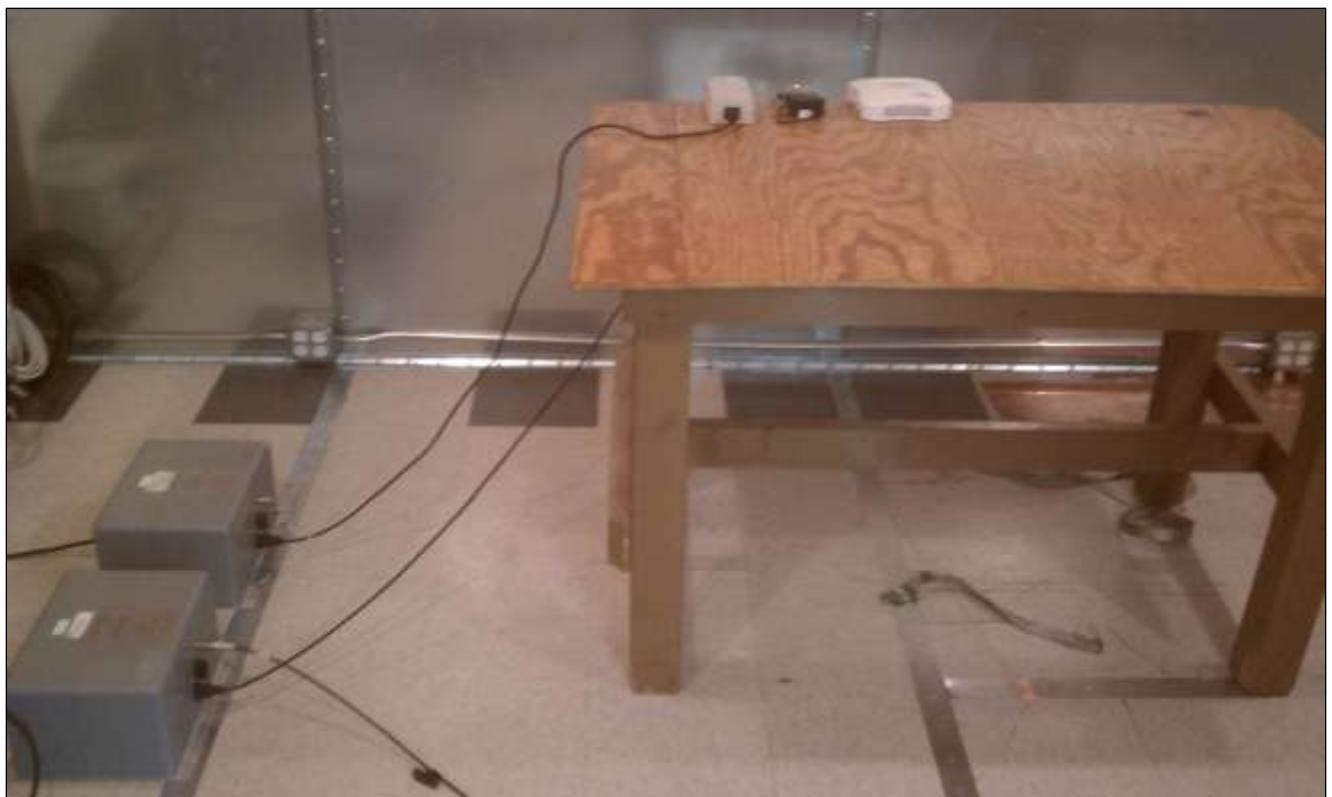
Photograph 1. Conducted Emissions, Test Setup

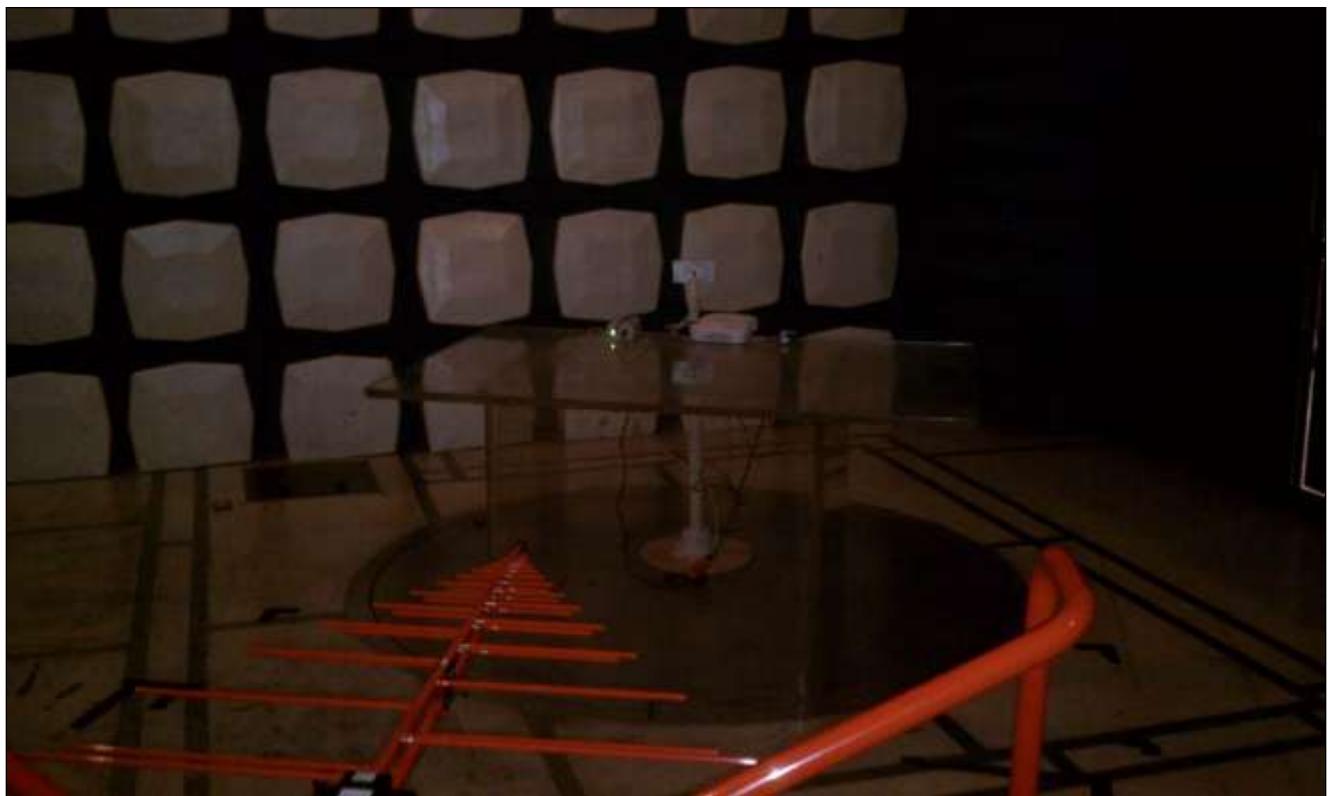
Photograph 2. Radiated Emission, Test Setup

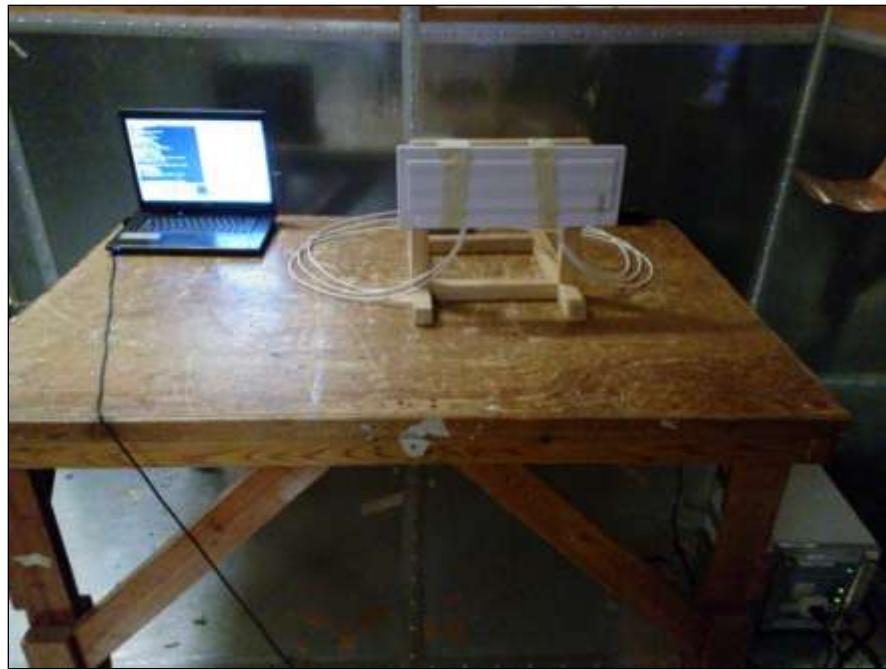
Photograph 3. Conducted Emissions, 15.207(a), Test Setup

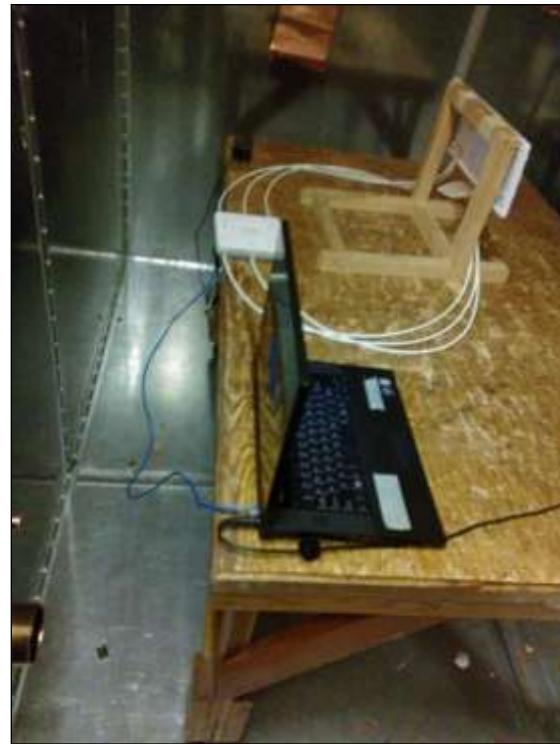
Photograph 4. Conducted Emissions, 15.207(a), Test Setup, Rear View

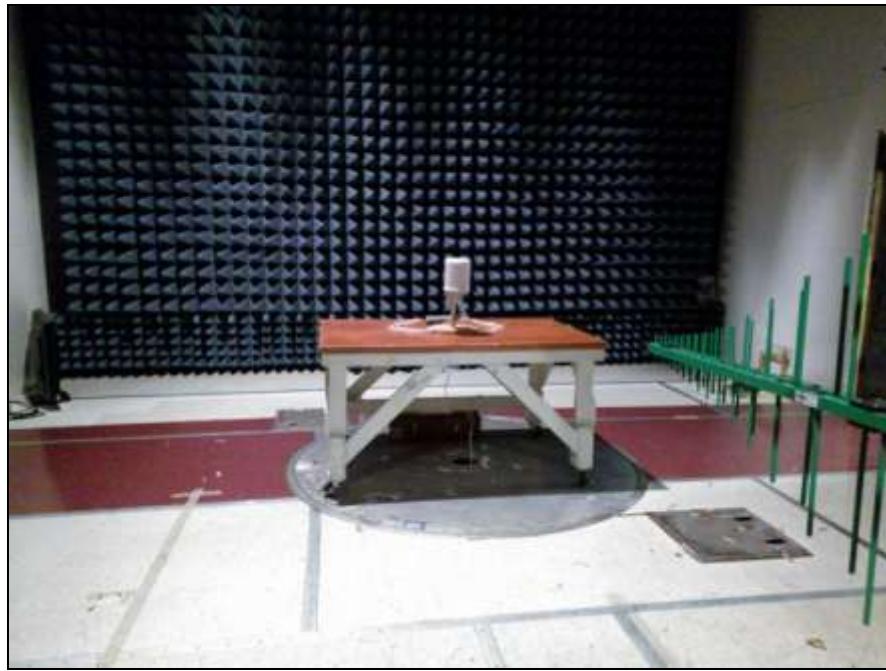
Photograph 5. Radiated Spurious Emissions, Test Setup, 6 dBi Omni, 30 MHz – 1 GHz

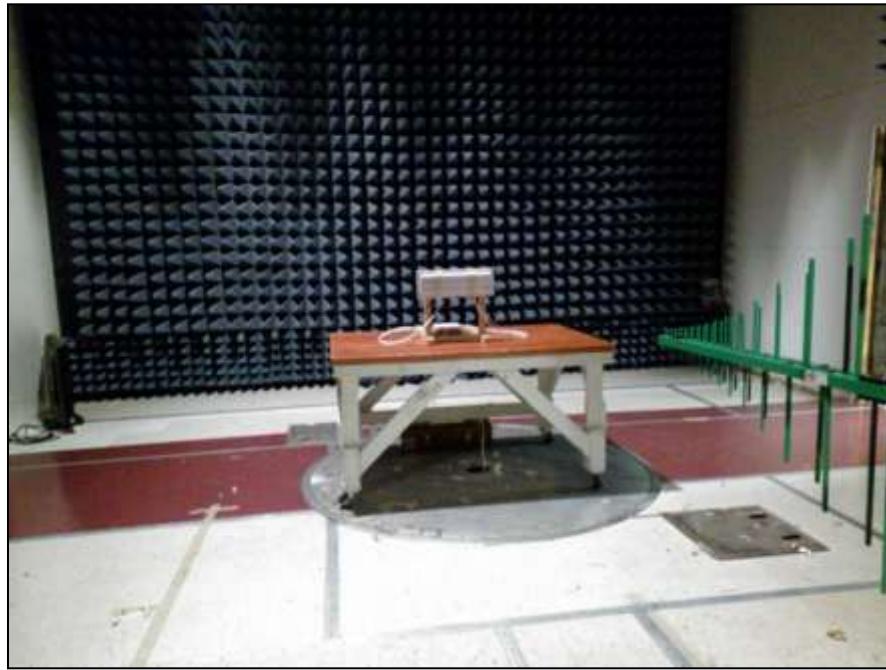
Photograph 6. Radiated Spurious Emissions, Test Setup, 6 dBi Patch, 30 MHz – 1 GHz

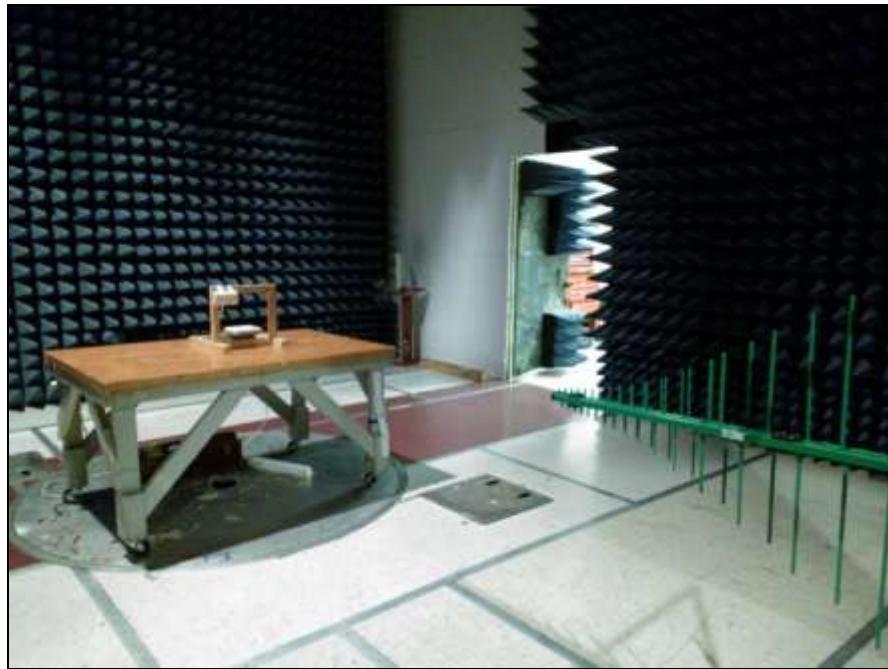
Photograph 7. Radiated Spurious Emissions, Test Setup, 3 dBi Ceiling Mount Omni, 30 MHz – 1 GHz

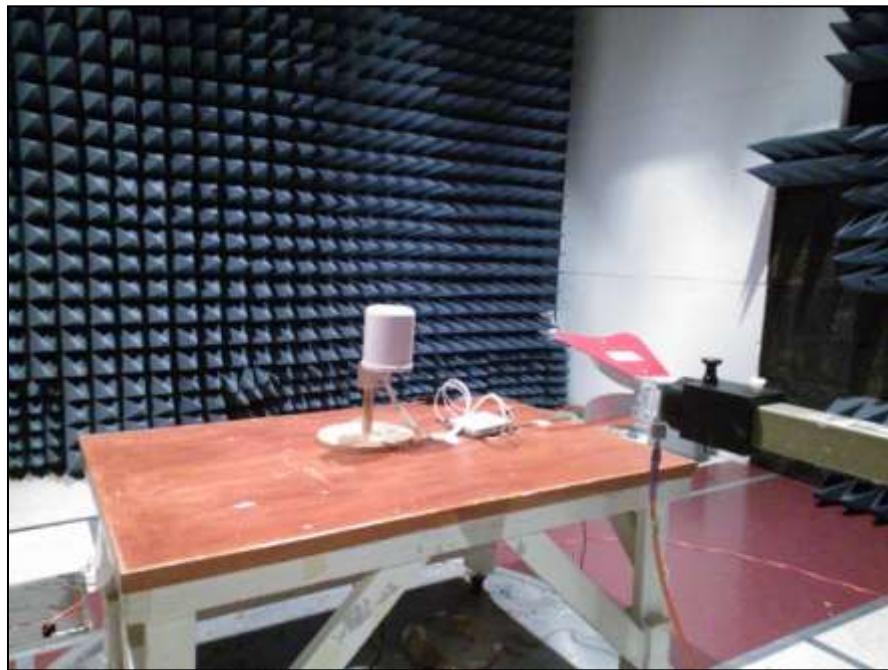
Photograph 8. Radiated Spurious Emissions, Test Setup, 6 dBi Omni, 1m

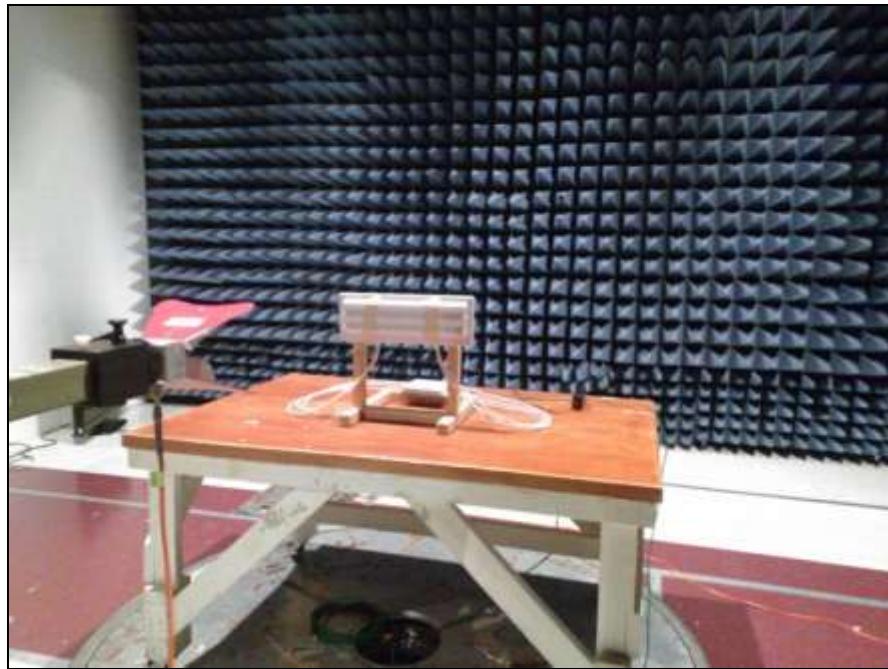
Photograph 9. Radiated Spurious Emissions, Test Setup, Patch Antenna, 1m

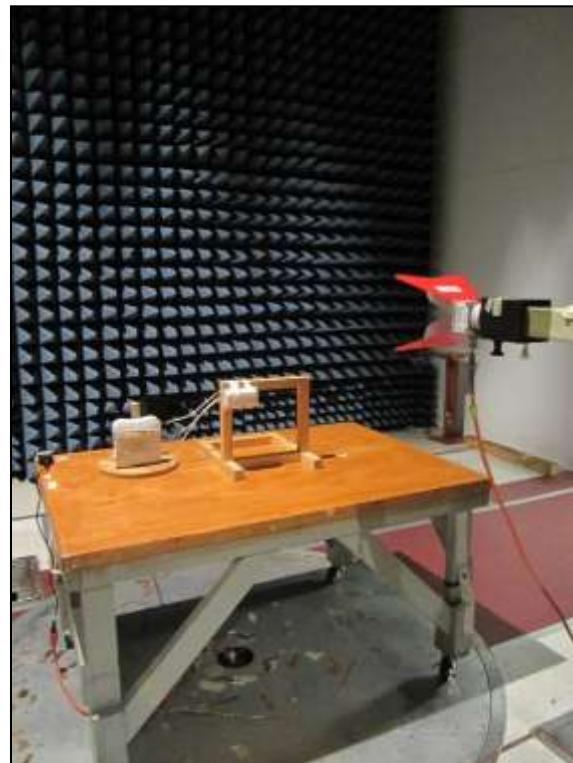
Photograph 10. Radiated Spurious Emissions, Test Setup, Ceiling Mount Omni Antenna

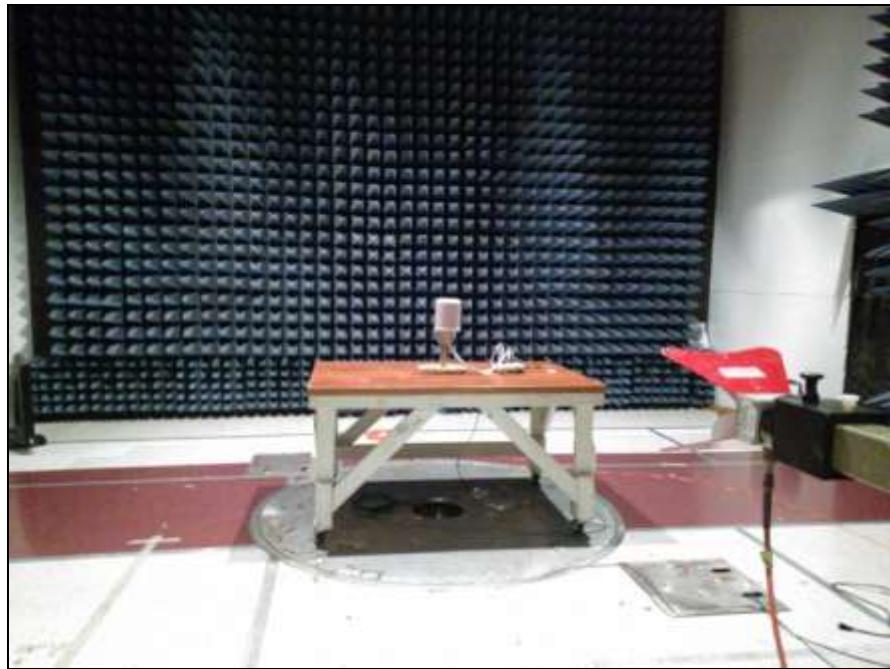
Photograph 11. Radiated Band Edge, Test Setup, Omni Antenna, 3m

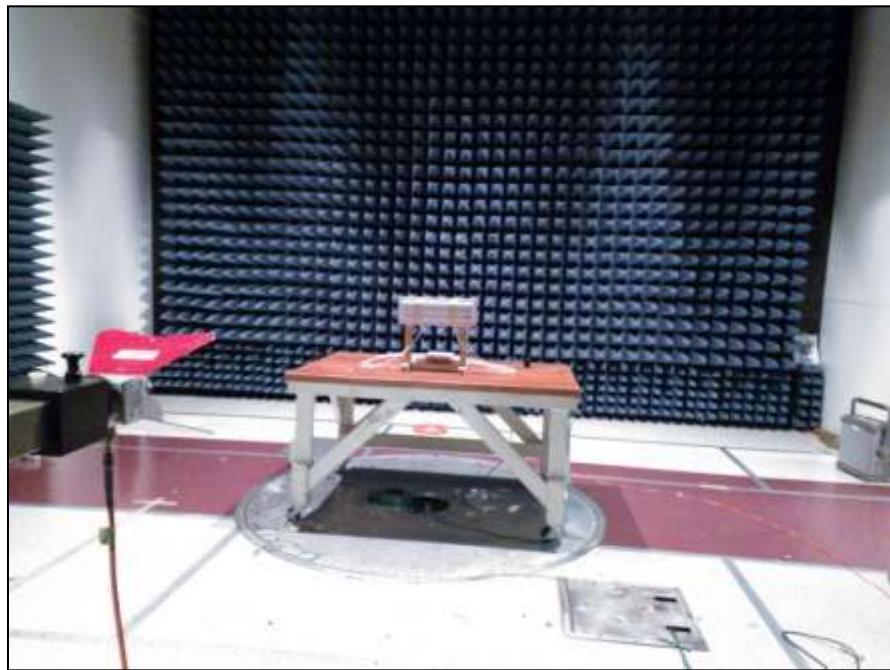
Photograph 12. Radiated Band Edge, Test Setup, Patch Antenna, 3m

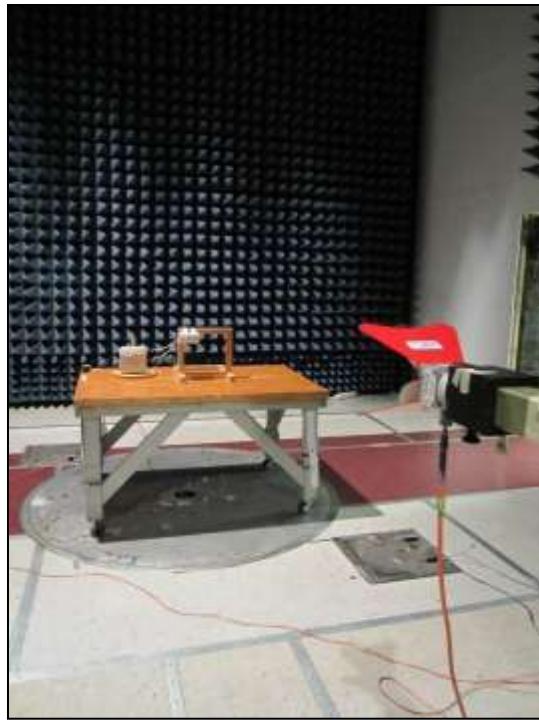
Photograph 13. Radiated Band Edge, Test Setup, Ceiling Mount Omni Antenna, 3m
