**Prüfbericht - Nr.: 16002590 001**  
Test Report No.:

## 6 Photographs of the Test Set-Up

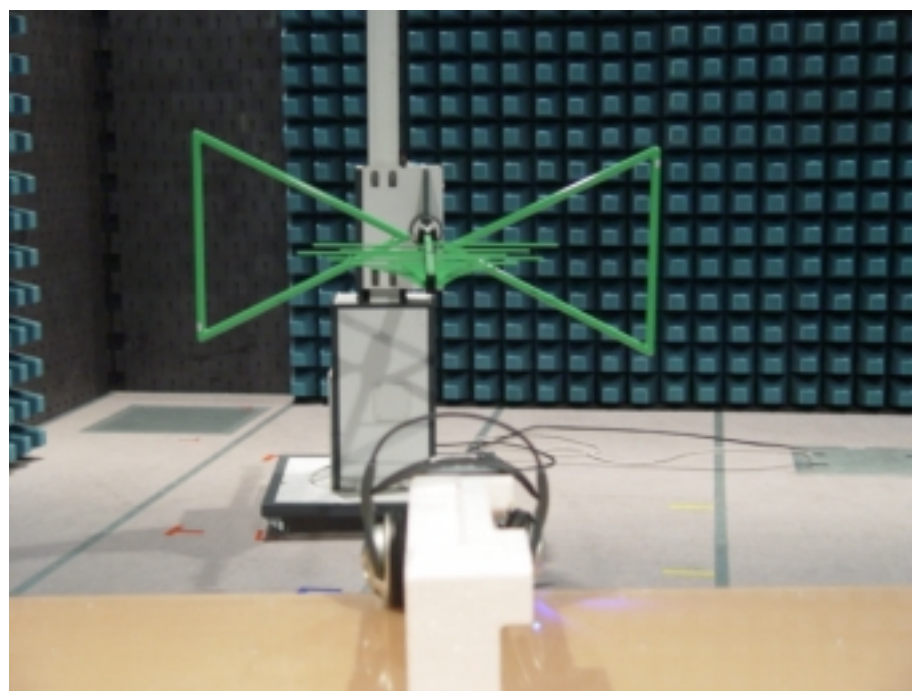
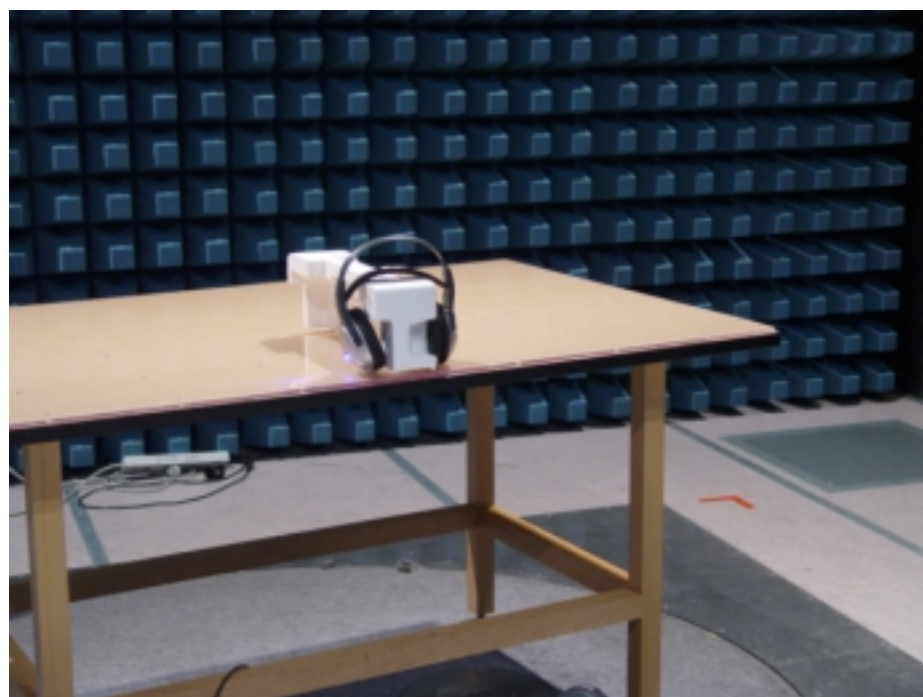
**Photograph 1: Set-up for Radiation Measurement Below 1GHz**

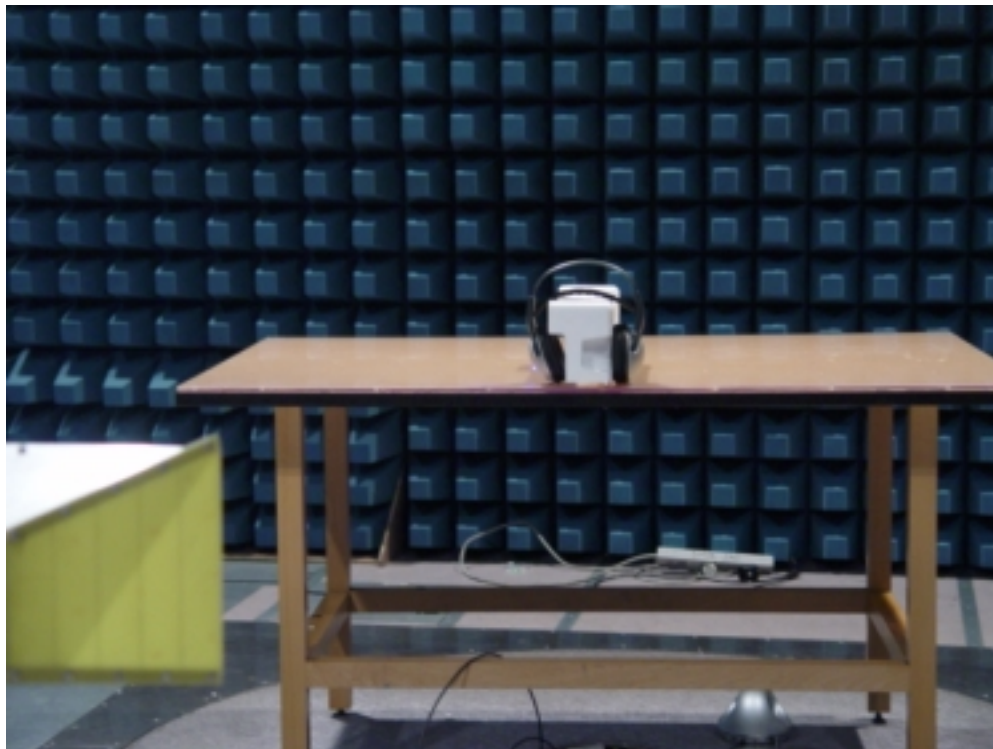
**Photograph 2: Set-up for Radiation Measurement Above 1GHz**
