**Prüfbericht - Nr.: 16002858 001**

## 6 Photographs of the Test Set-Up

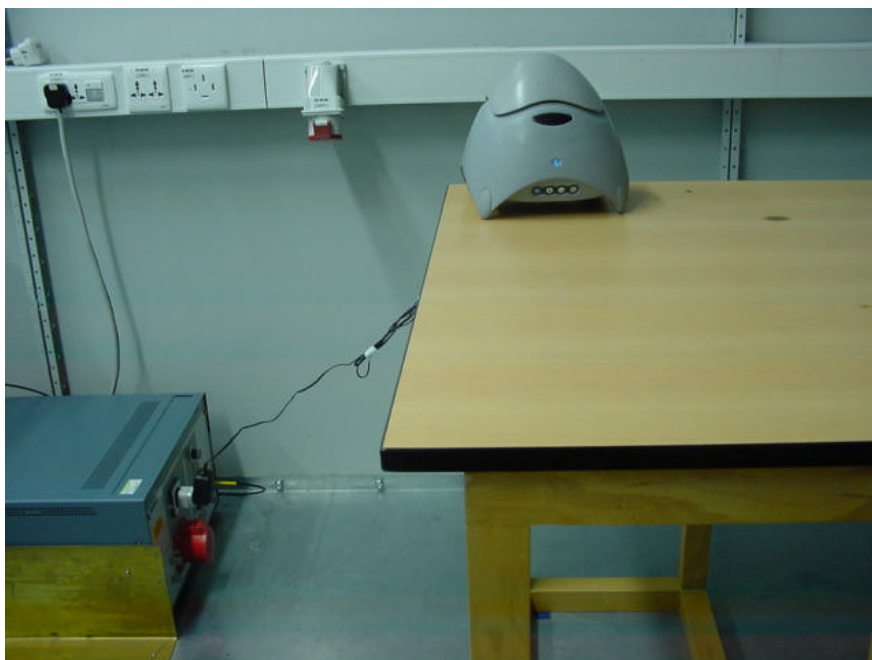
**Photograph 1: Set-up for Conducted Emission on AC Mains**

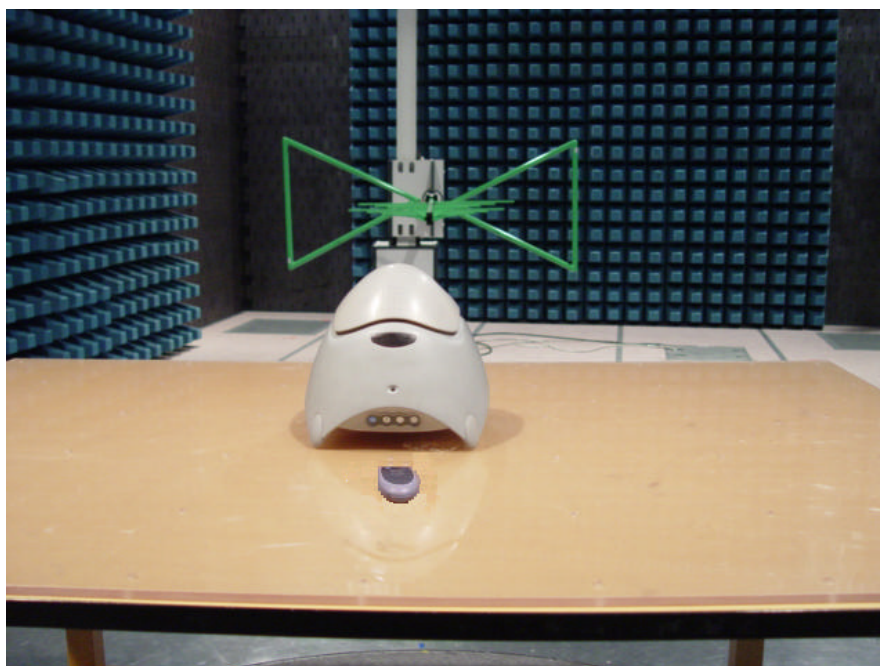
**Photograph 2: Set-up for Radiation Measurement Below 1GHz**

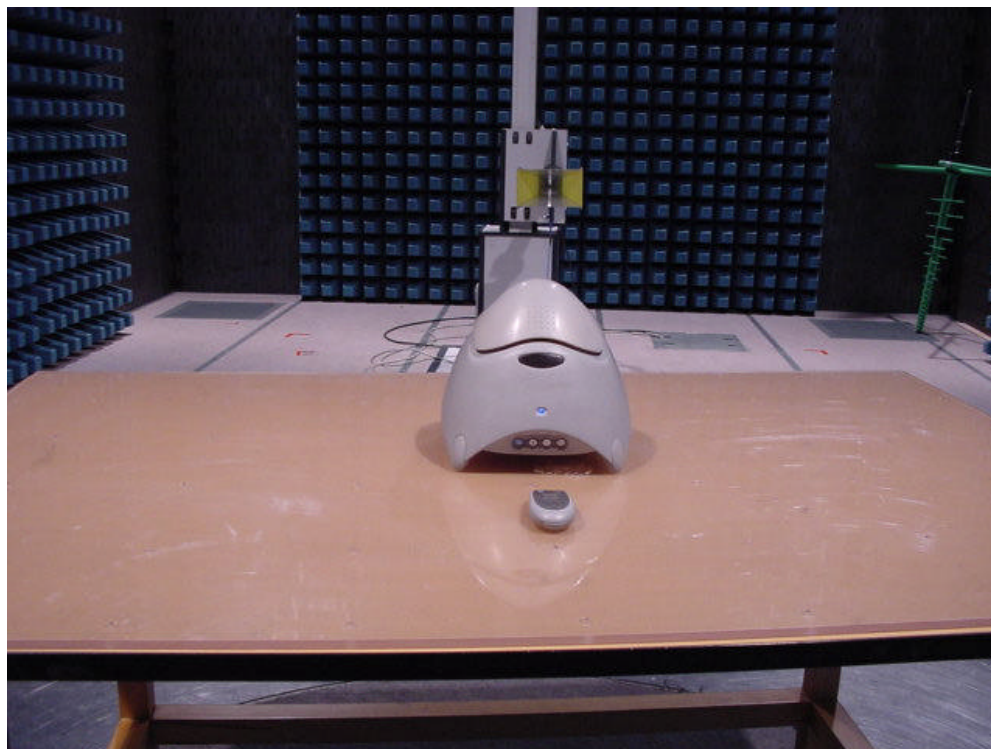
**Photograph 3: Set-up for Radiation Measurement Above 1GHz**
