**Prüfbericht - Nr.: 16002954 001**  
Test Report No.:

## 6 Photographs of the Test Set-Up

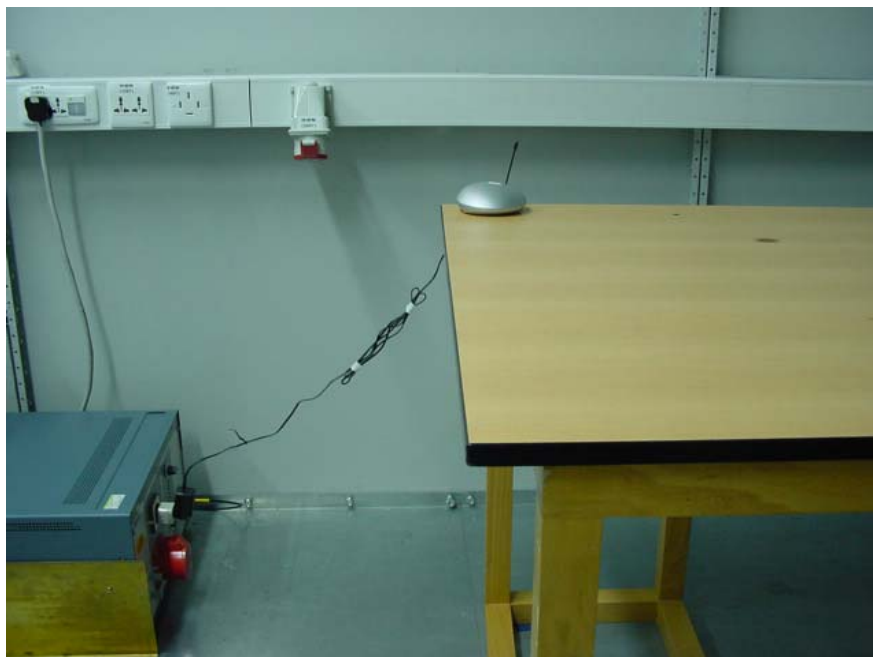
**Photograph 1: Set-up for Conducted Emission on AC Mains**

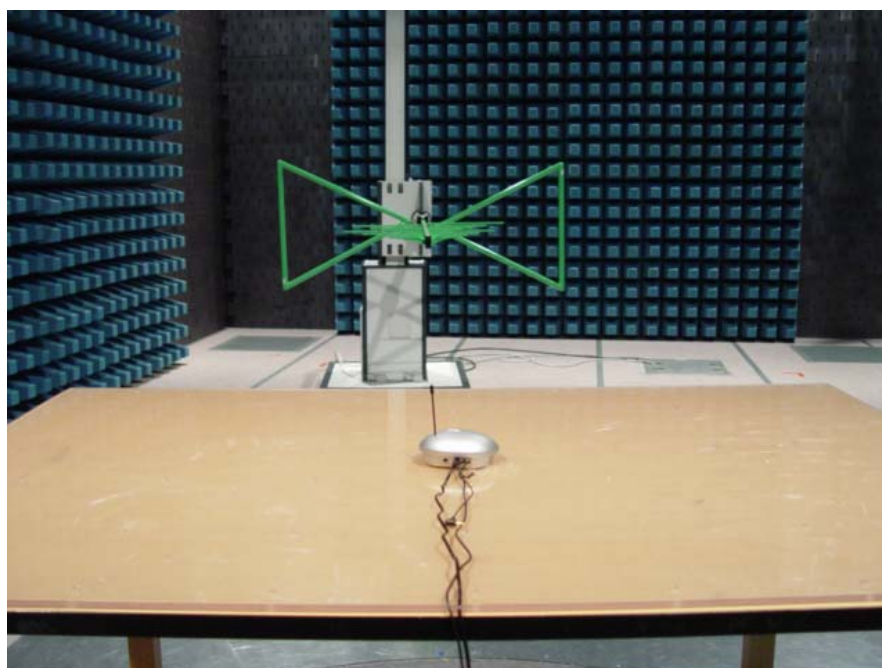
**Photograph 2: Set-up for Radiation Measurement Below 1GHz**

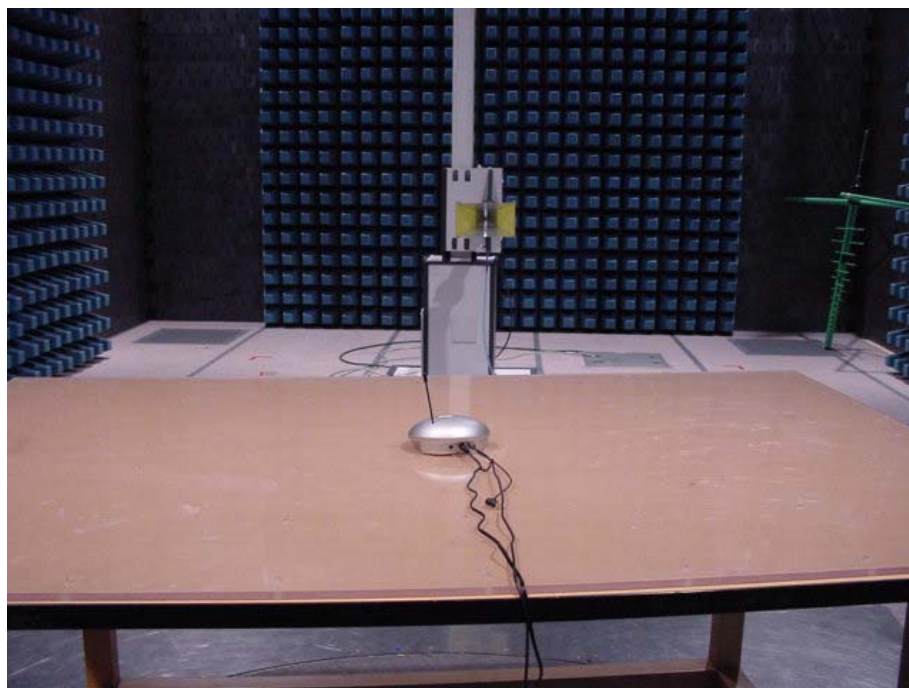
**Photograph 3: Set-up for Radiation Measurement Above 1GHz**
