### **APPENDIX 3: Photographs of test setup**

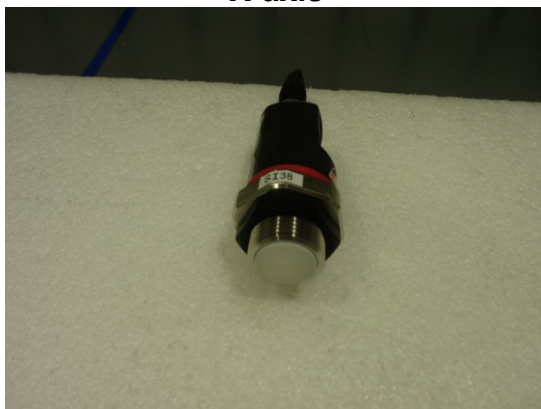
**X-axis**

### Worst Case Position

| Test range | Horizontal | Vertical |
|---|---|---|
| Fundamental (57 GHz to 71 GHz) | X-axis | Y-axis |
| Other | X-axis | X-axis |

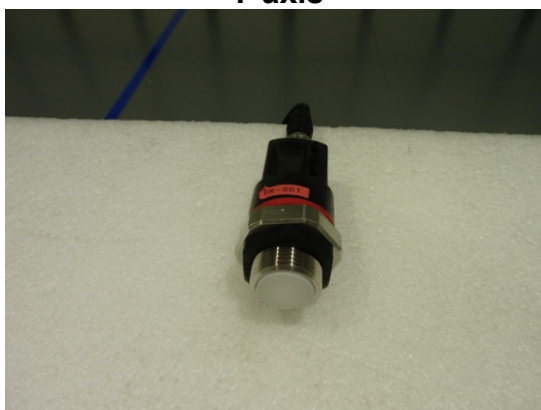
**Y-axis**

| Test range | Horizontal | Vertical |
|---|---|---|
| 30 MHz to 1 GHz | Y-axis | Z-axis |
