## Reliability Test Report

Report No.:20230325004

| Product Name | PCB Antenna | Sample Q'TY | 5PCS | | |
| Test Purpose | Verify Pad Tension | Test Purpose | / | | |

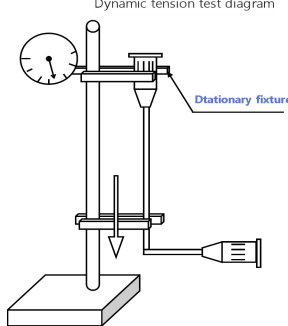
| Test Item : Tension Test Place: laboratory<br>Test Standard : <u>Reference AQA-SIP-C5036-009</u><br>Test SPEC<br>Pad Tension $\cong$ 2.0 kgf<br>Equipment : <u>Tension Testing Machine ZP-200</u><br>Conclusion Due Date : <u>16<sup>th</sup> Feb, 2024</u> | | Test status diagram:<br> | | | |

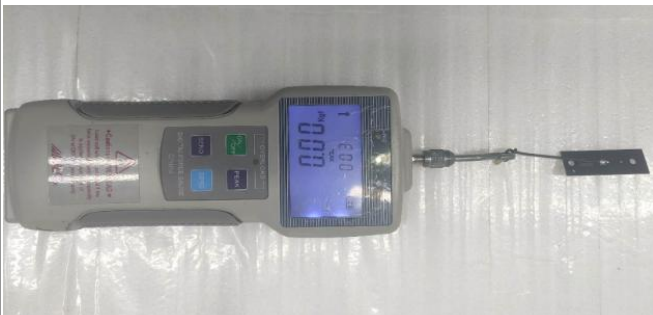
| Connector Tension $\cong$ 1.0kgf | 3.11 | 3.19 | 3.05 | 3.18 | 3.21 |
| Judgement : OK | | | | | |
| Mark : The pull is far beyond the standard pull | | | | | |

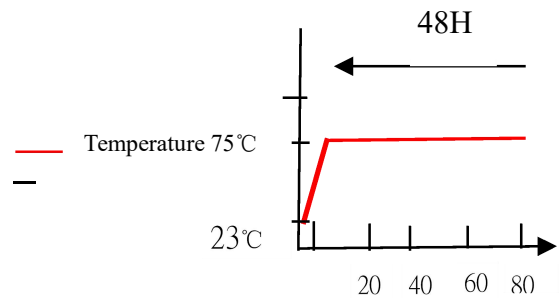
Test status diagram:

Test Item: high temperature test Place: laboratory  
 Test Standard: GB/T 2423.3  
 Test Time: 48H  
 Test SPEC: Temperate 75°C  
 Equipment: High temperature and high humidity testing machine

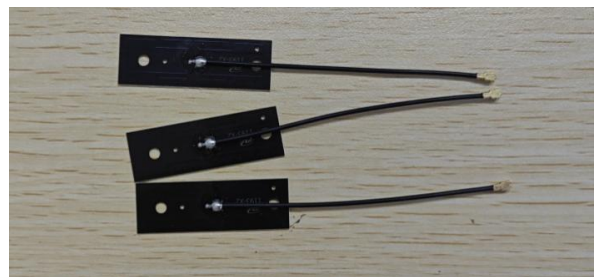
sample after test

| Sample | Sample1 | Sample2 | Sample 3 | | | | | | |
|---|---|---|---|--|--|--|--|--|--|
| Variation | ok | ok | ok | | | | | | |
| Come Away | ok | ok | ok | | | | | | |
| Crack | ok | ok | ok | | | | | | |

Judgement: OK

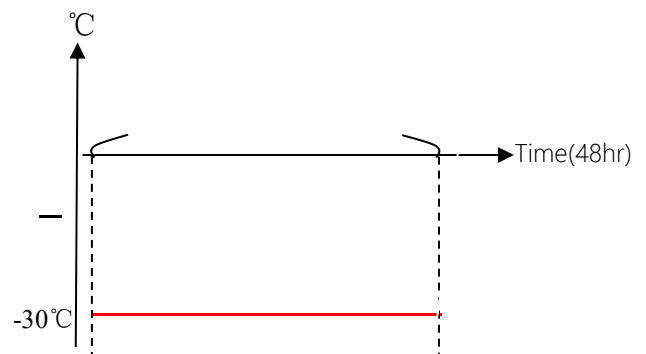
Test status diagram:

Test Item: low temperature test Place: laboratory  
 Test Standard: GB/T 2423.1  
 Test Time: 48H  
 Test SPEC: Temperate -30°C  
 Equipment: TEMP&HUMI chamber

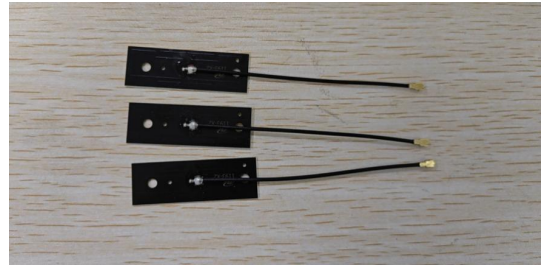
sample after test

| Sample | Sample1 | Sample2 | Sample 3 | | | | | | |
|---|---|---|---|--|--|--|--|--|--|
| Variation | ok | ok | ok | | | | | | |
| Aberration | ok | ok | ok | | | | | | |
| Crack | ok | ok | ok | | | | | | |

Judgement: OK

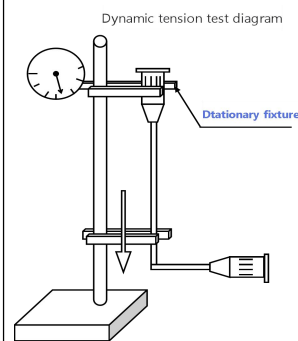
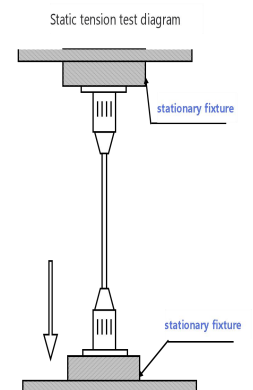
Test status diagram:

Test Item : Tension Test Place: laboratory

Connector Tension  $\geq$  1.0 kgfEquipment : Tension Testing Machine NK-300Conclusion Due Date : 2024.02.16

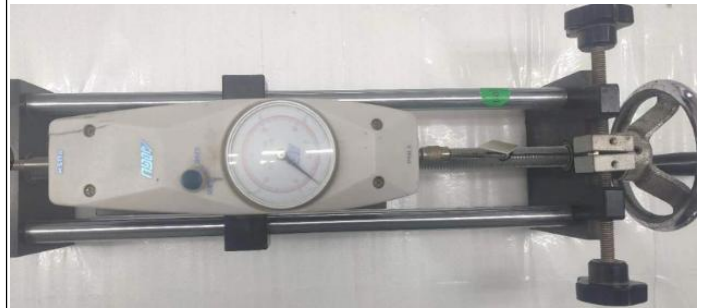
Sample after test

| Connector Tension $\geq$ 1.0kgf | 2.8 | 3.1 | 3.3 | 3.2 | 3.0 |

Judgement : OK

Mark : The pull is far beyond the standard pull
