Test data, continued

## EUT photos

### 9.1 External photos

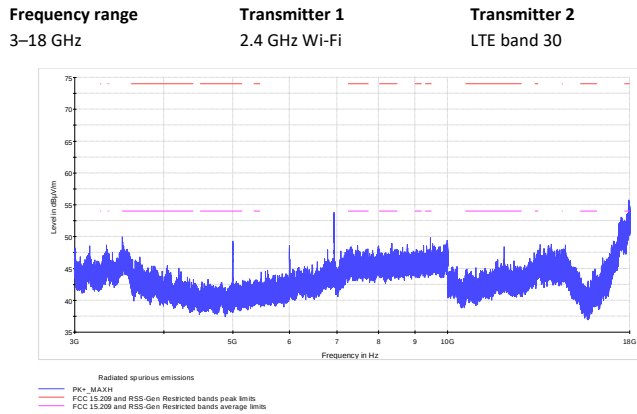
**Figure 8.1-25: Radiated spurious emissions**

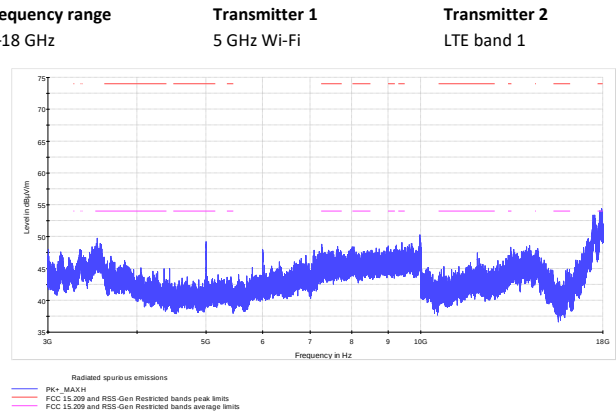
**Figure 8.1-26: Radiated spurious emissions**

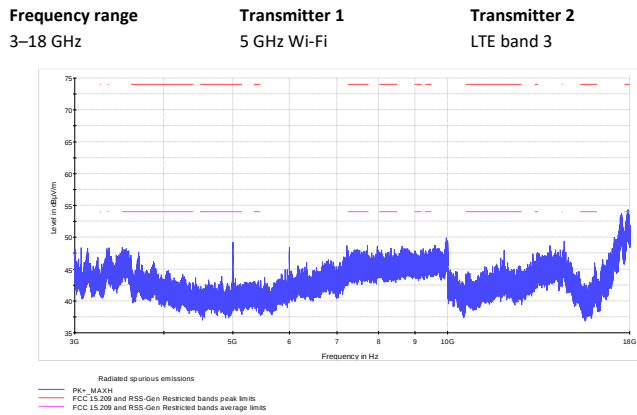
**Figure 8.1-27: Radiated spurious emissions**

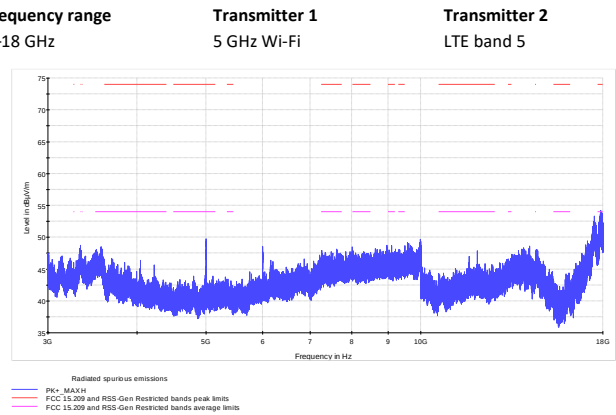
**Figure 8.1-28: Radiated spurious emissions**

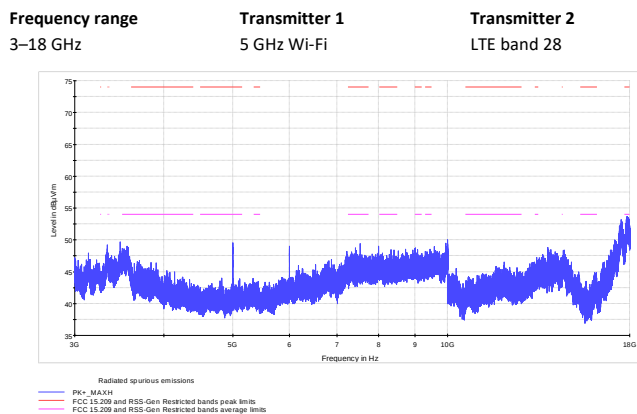
**Figure 8.1-29: Radiated spurious emissions**

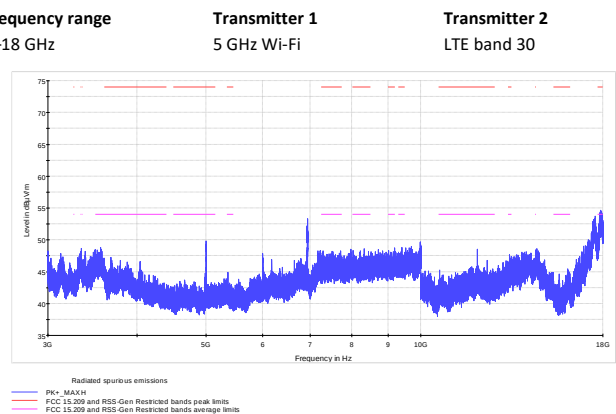
**Figure 8.1-30: Radiated spurious emissions**

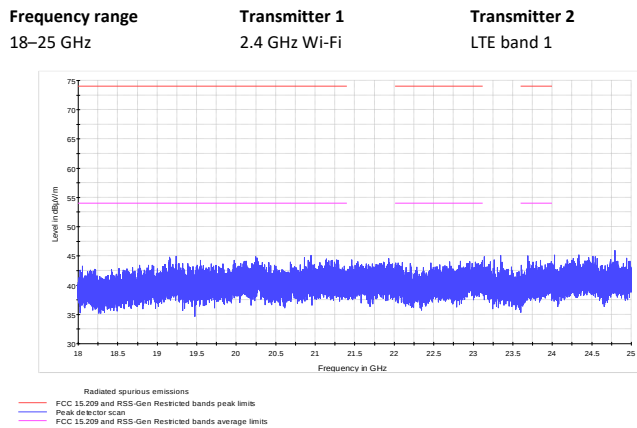
**Figure 8.1-31:** Radiated spurious emissions

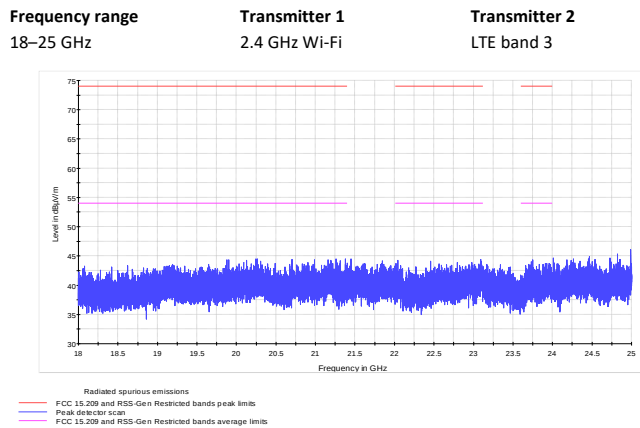
**Figure 8.1-32:** Radiated spurious emissions

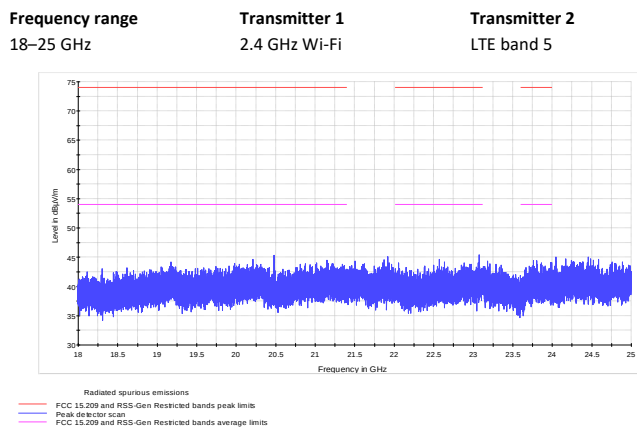
**Figure 8.1-33:** Radiated spurious emissions

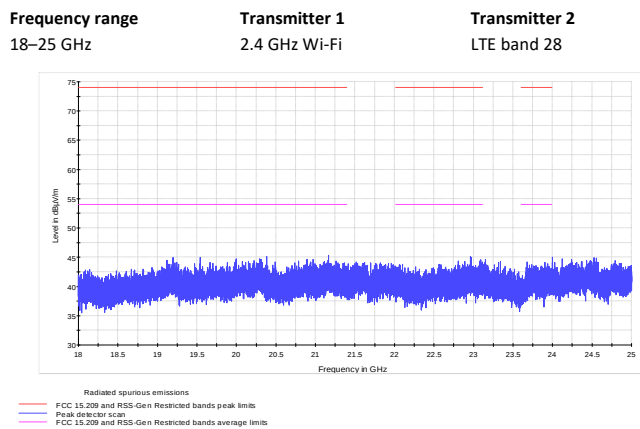
**Figure 8.1-34:** Radiated spurious emissions

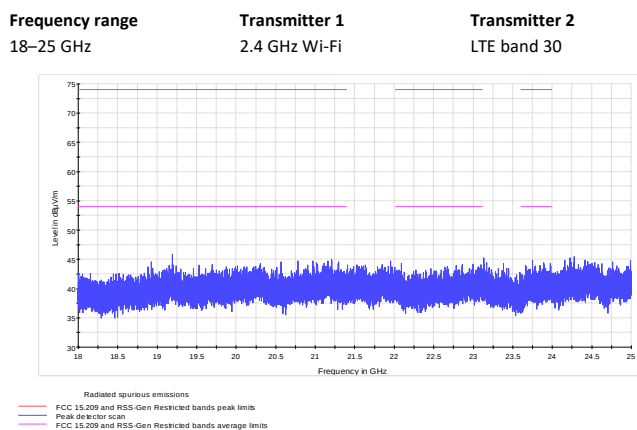
**Figure 8.1-35:** Radiated spurious emissions

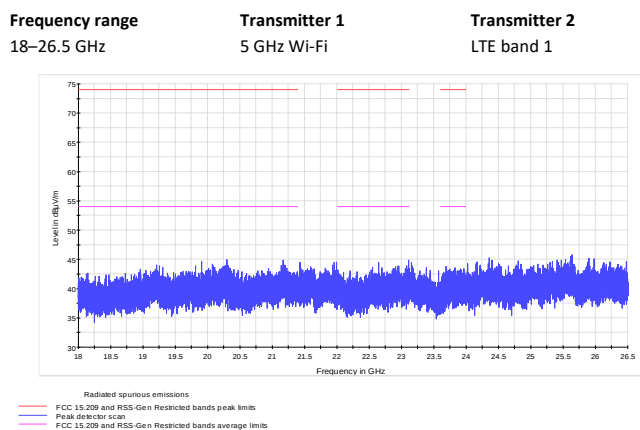
**Figure 8.1-36:** Radiated spurious emissions

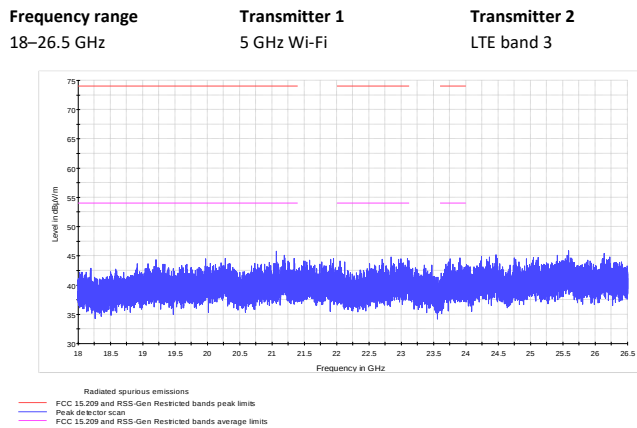
**Figure 8.1-37: Radiated spurious emissions**

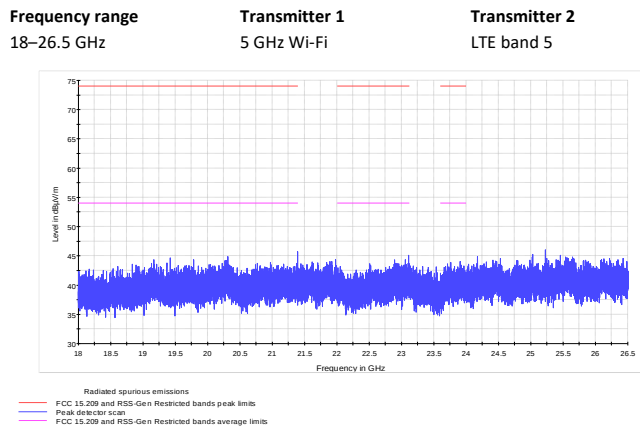
**Figure 8.1-38: Radiated spurious emissions**

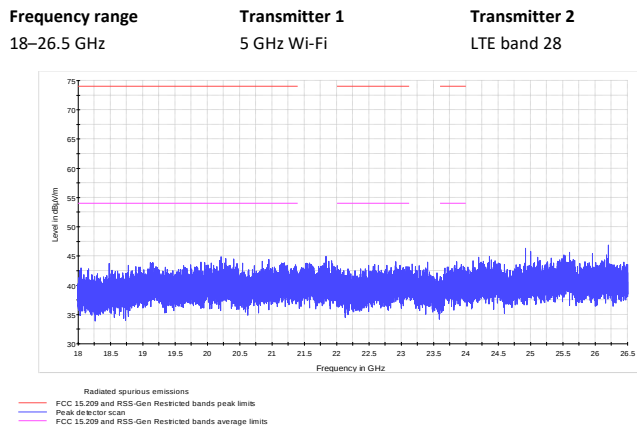
**Figure 8.1-39: Radiated spurious emissions**

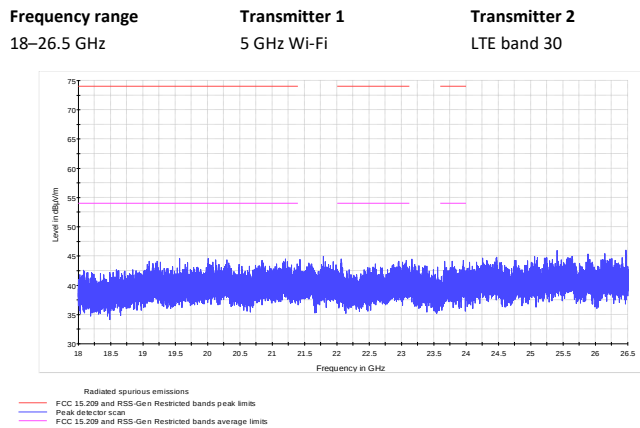
**Figure 8.1-40: Radiated spurious emissions**

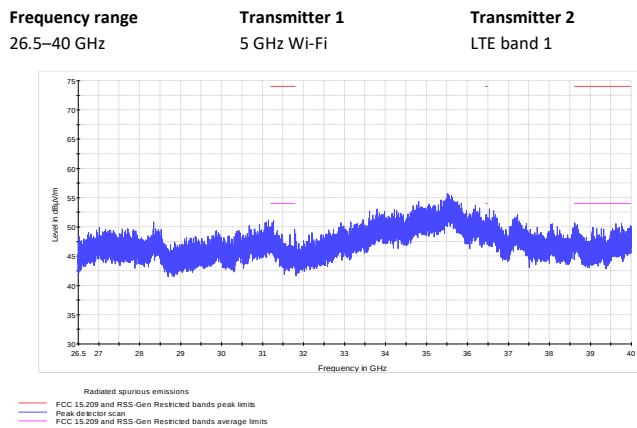
**Figure 8.1-41: Radiated spurious emissions**

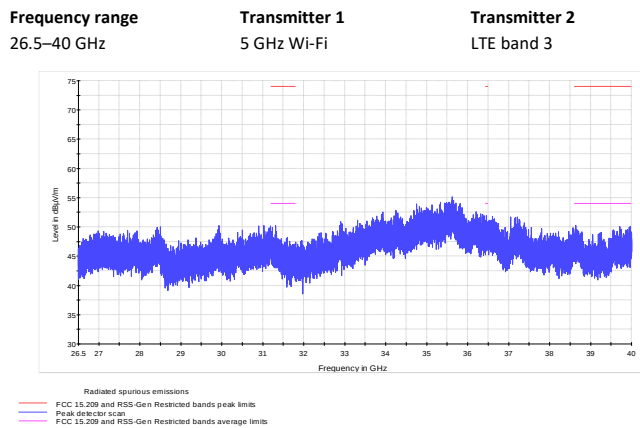
**Figure 8.1-42: Radiated spurious emissions**

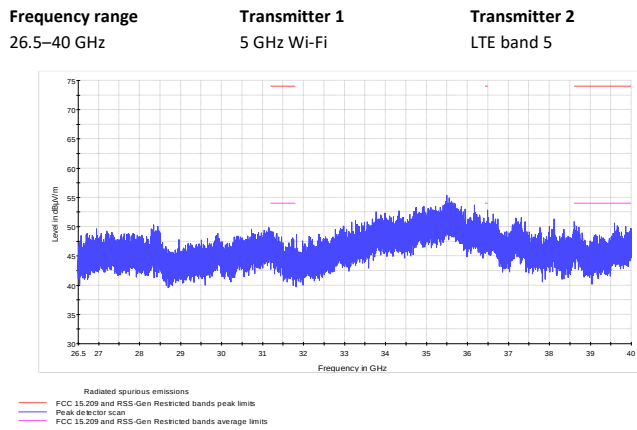
**Figure 8.1-43:** Radiated spurious emissions

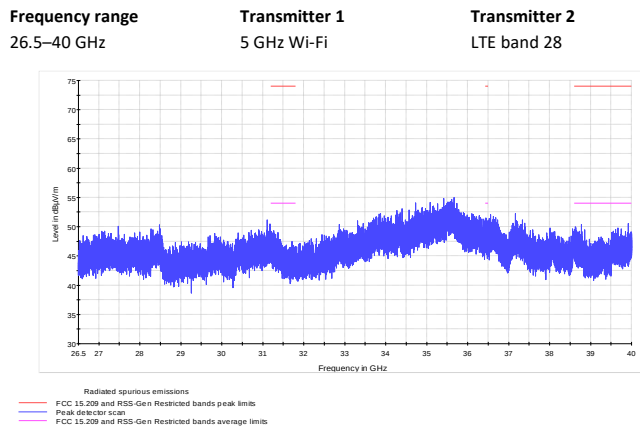
**Figure 8.1-44:** Radiated spurious emissions

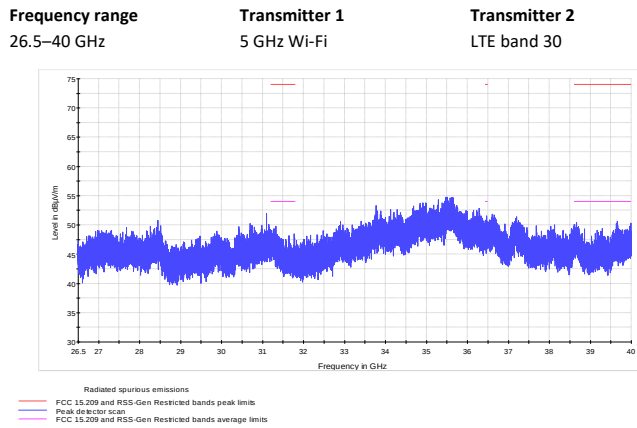
**Figure 8.1-45:** Radiated spurious emissions

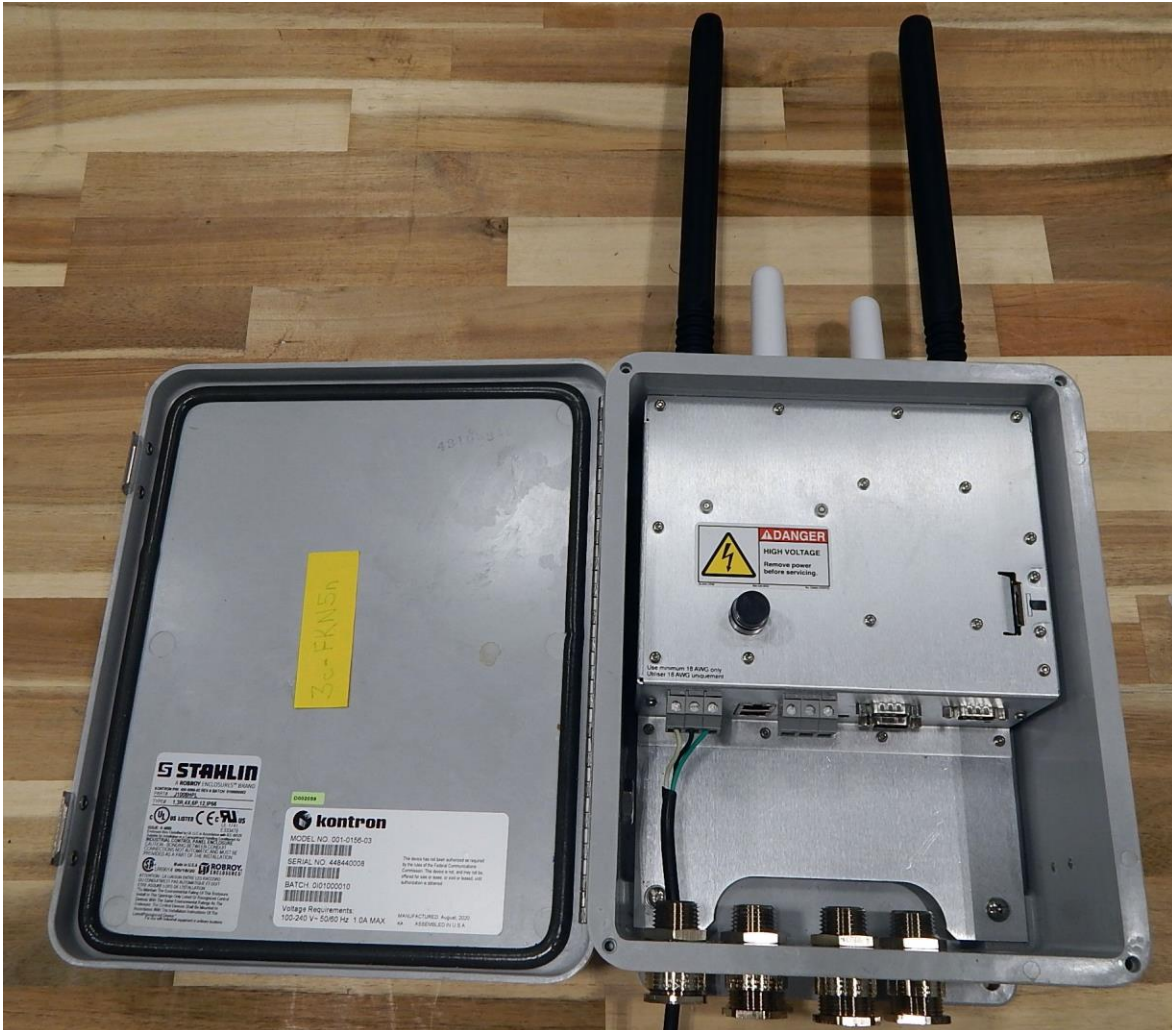
Figure 9.1-1: Front view photo with open cover (001-0156-03)

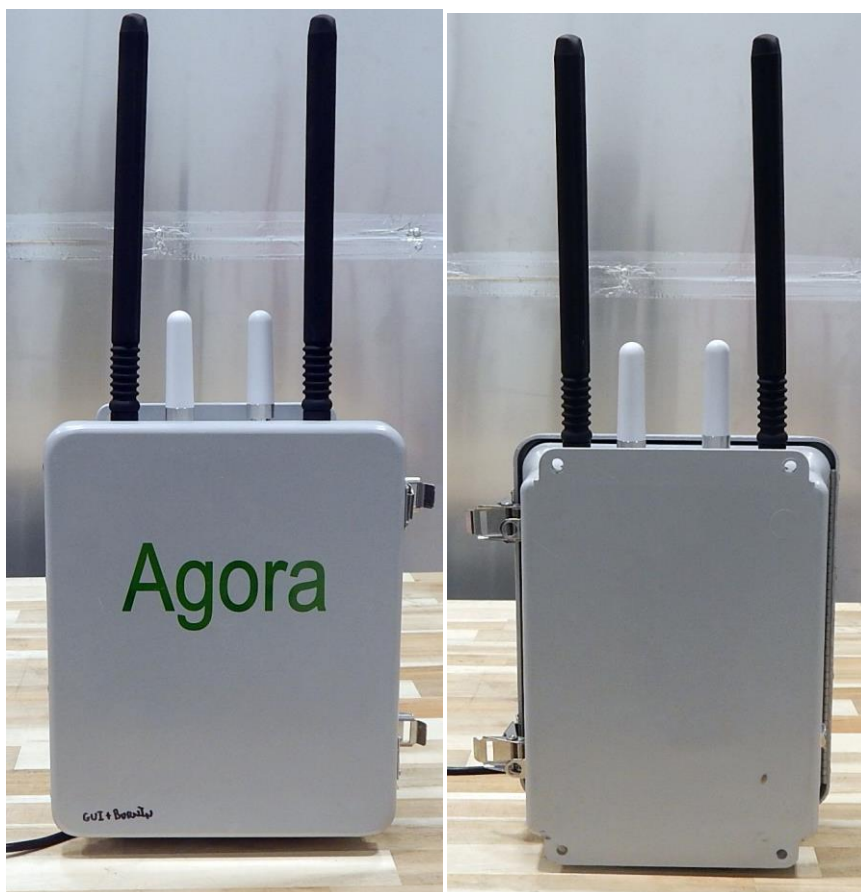
**Figure 9.1-2:** Front and rear view photos (001-0156-03)

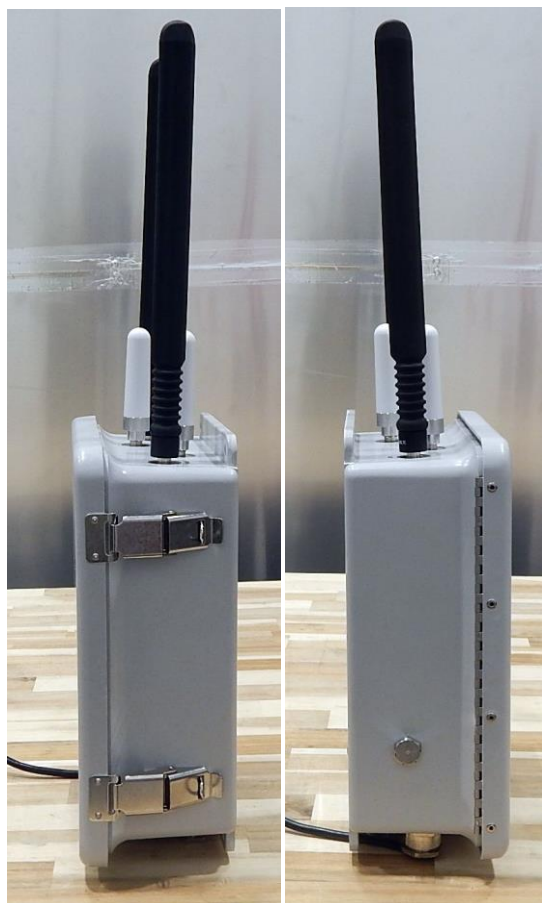
**Figure 9.1-3:** Side view photos (001-0156-03)

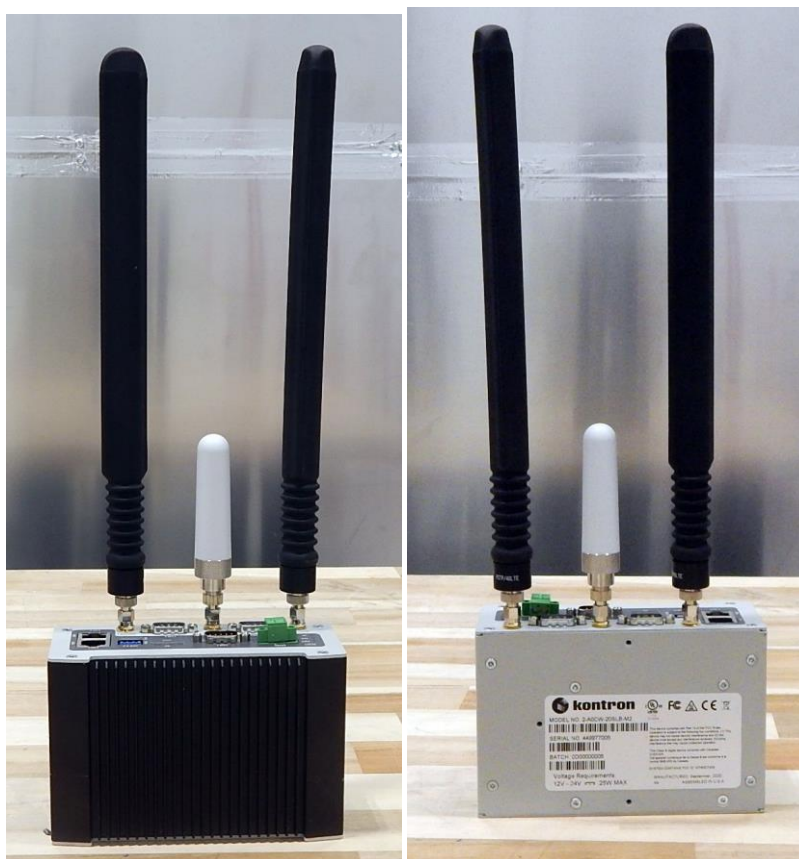
Figure 9.1-4: Front and rear view photos (2-A0CW-20SLB-M2)

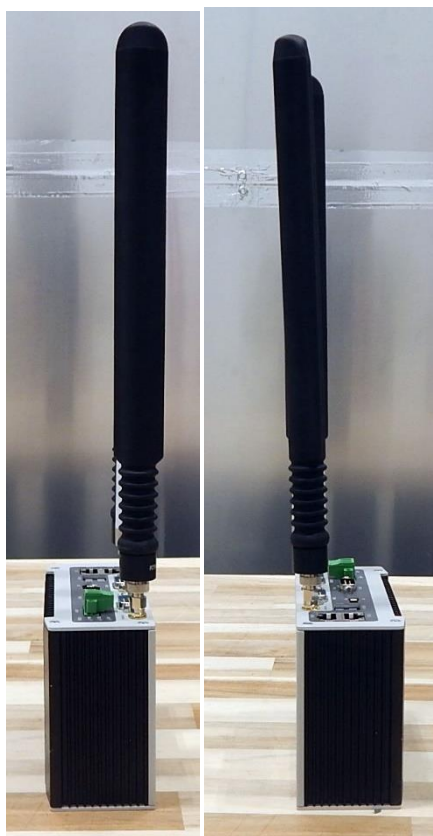
**Figure 9.1-5:** Side view photos (2-AOCW-20SLB-M2)
