Test Setup Photographs

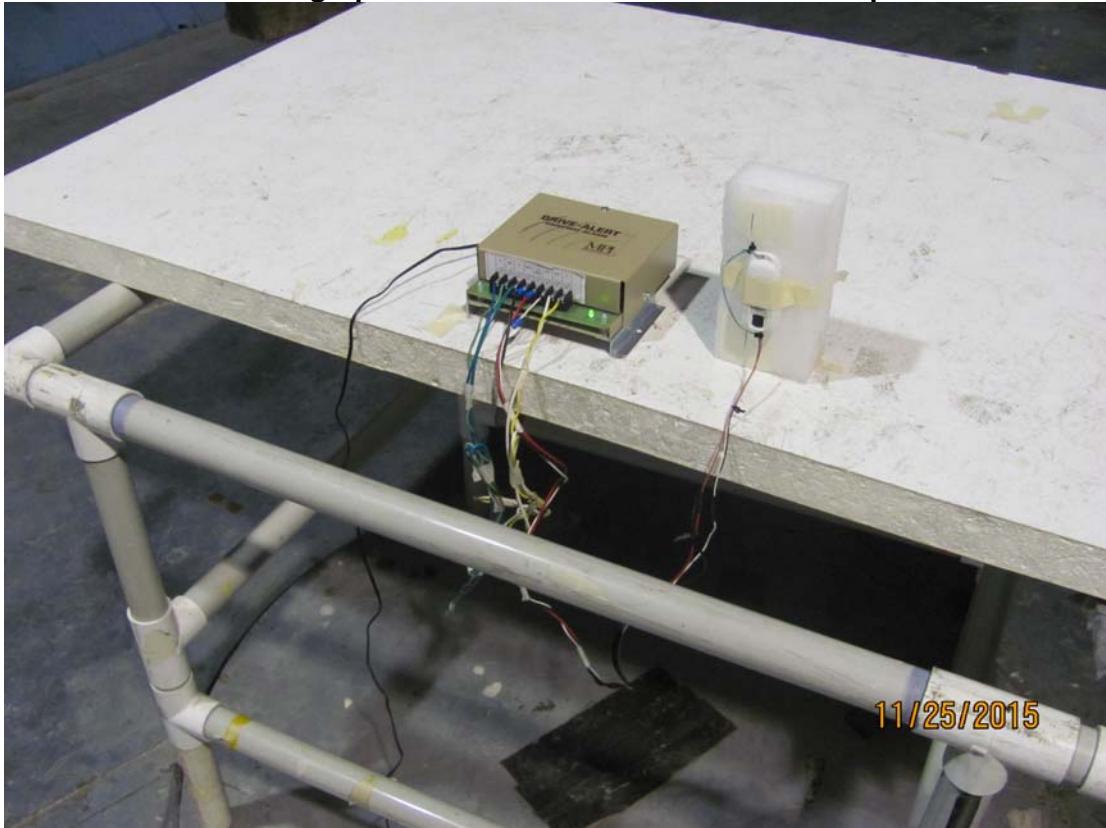
Photographs of Radiated Emissions Test Setup

The EUT was taped to a foam stand in order to change the axis of rotation.
