## Shenzhen Hexing Electronics Factory

Responses to inquiry for the FM TRANSMITTER (FCC ID:  
**T83H100**)

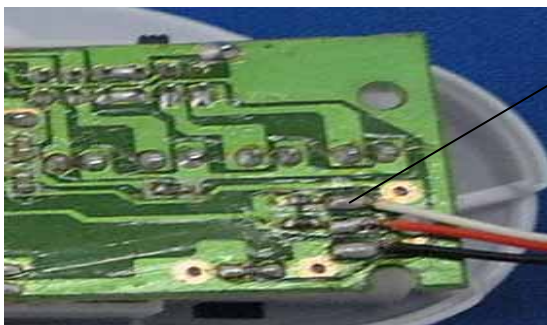
Antenna

The antenna is a dipole antenna .

(please see the attached picture)
