Prüfbericht - Nr.: 16005529 001

radiated emission

EUT: Car Radar (Sensor) M/N: FW048R41  
Manufacturer: Coligen  
Operating Condition:  
Test Site: SMD LAB  
Operator:  
Test Specification: FCC Part 18  
Comment:  
Start of Test:

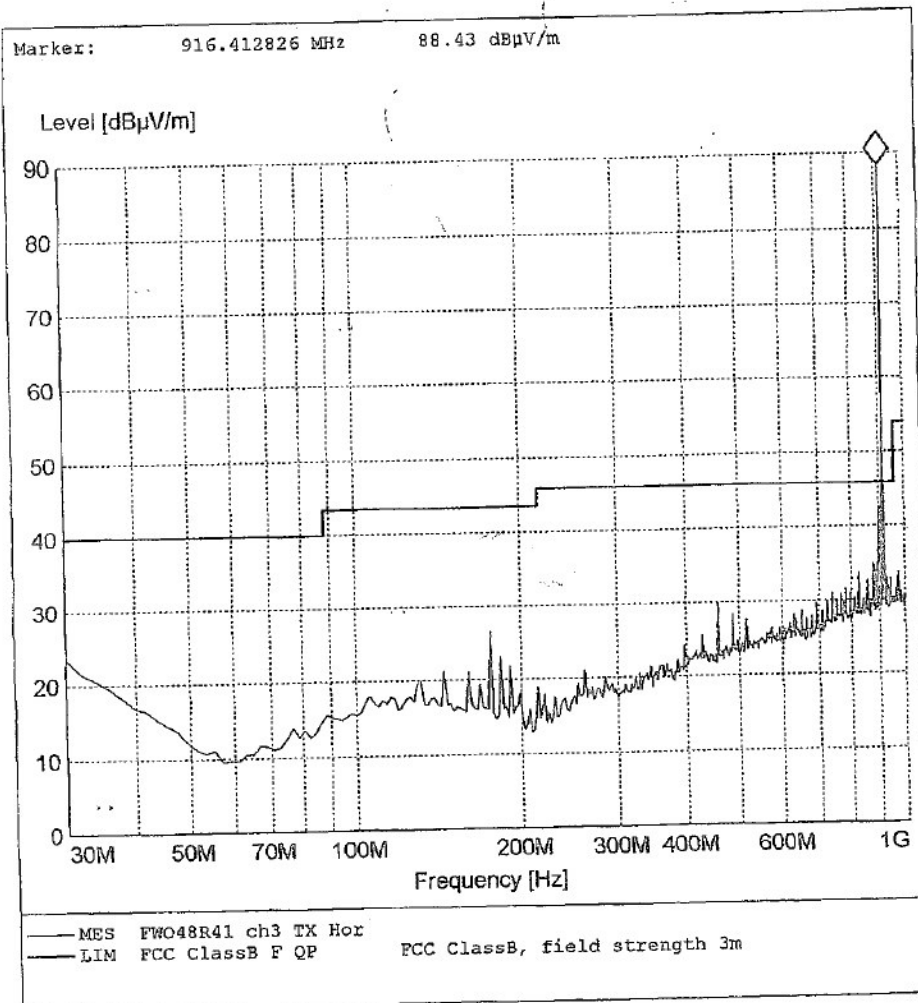
*Radiated Disturbance*

EUT: M/N:FWO48R41  
Manufacturer:  
Operating Condition: ch3 TX  
Test Site: SMQ EMC Lab:SAC  
Status:  
Test Specification: Horizontal  
Comment: DC 12V

**Note:** The marker only shows the un-weighted peak value and freq. point recorded in pre-scan stage. Please refer to the test report for the actual freq. point in the final measurement.

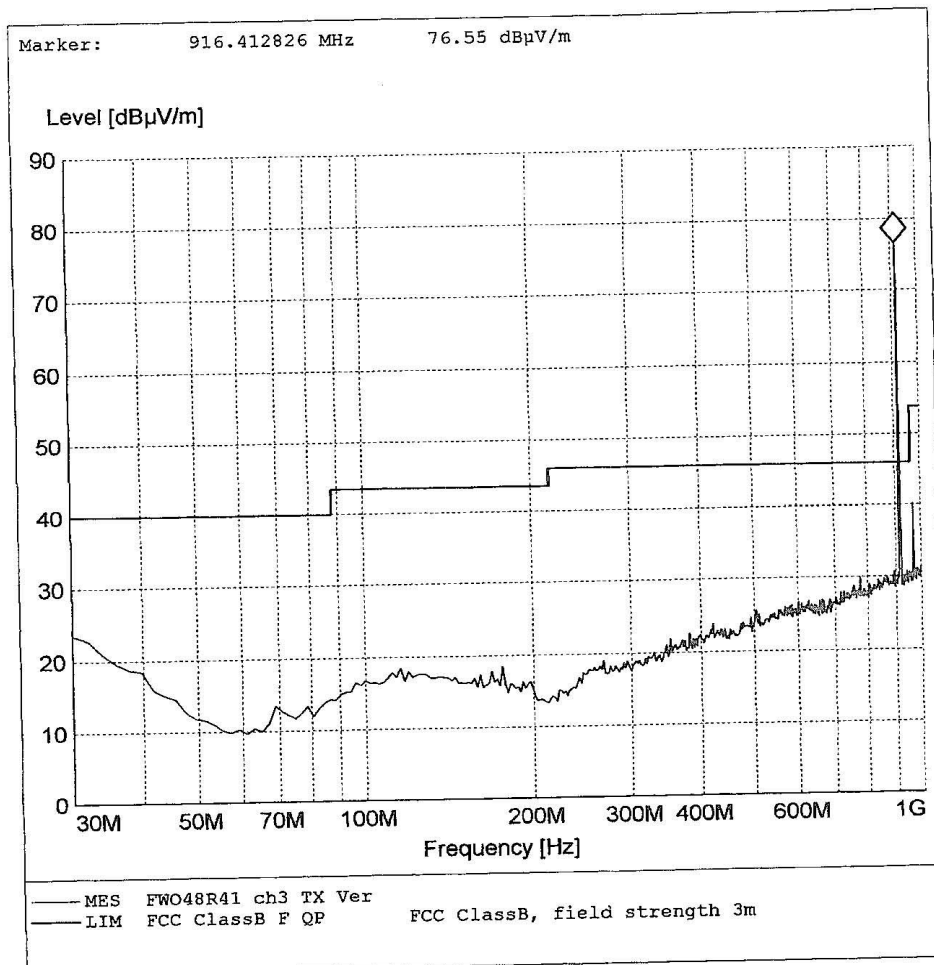
*Radiated Disturbance*

EUT: M/N:FOW48R41  
Manufacturer:  
Operating Condition: ch3 TX  
Test Site: SMQ EMC Lab.SAC  
Status:  
Test Specification: Vertical  
Comment: DC 12V

**Note:** The marker only shows the un-weighted peak value and freq. point recorded in pre-scan stage. Please refer to the test report for the actual freq. point in the final measurement.

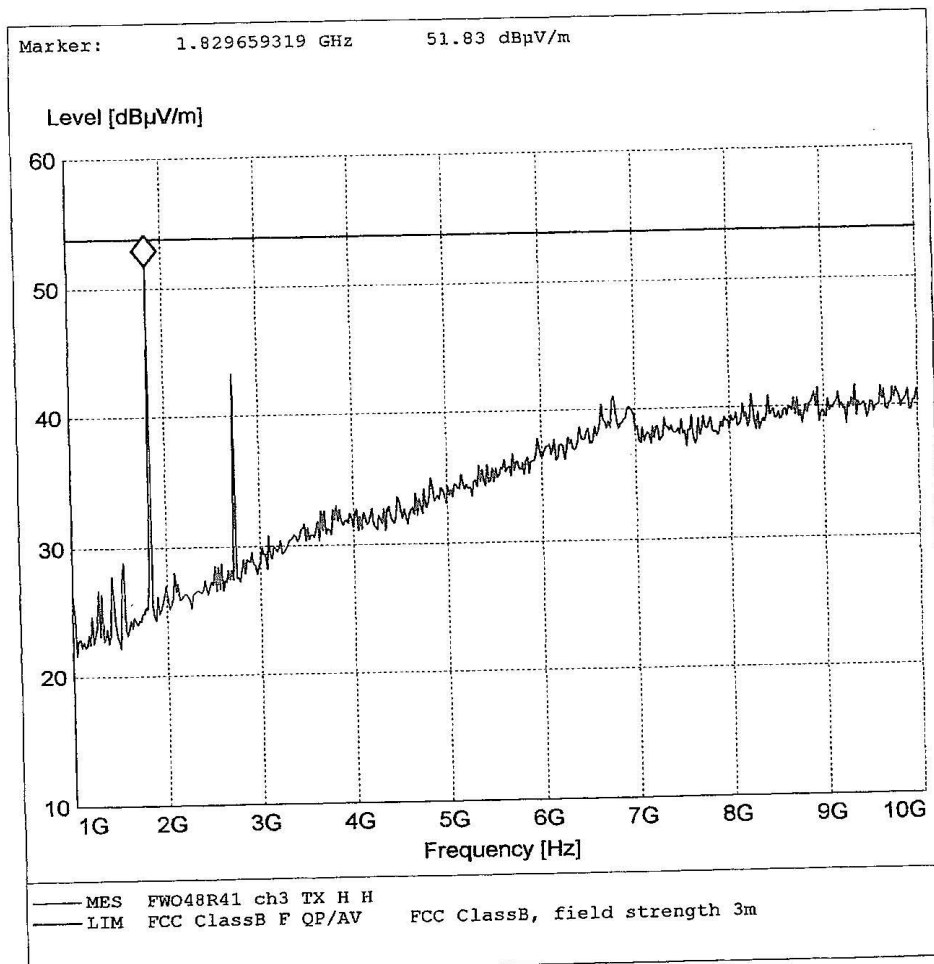
*Radiated Disturbance*

EUT: M/N:FWO48R41  
Manufacturer:  
Operating Condition: ch3 TX  
Test Site: SMQ EMC Lab.SAC  
Operator:  
Test Specification: Horizontal  
Comment : DC 12V

**Note:** The marker only shows the un-weighted peak value and freq. point recorded in pre-scan stage. Please refer to the test report for the actual freq. point in the final measurement.

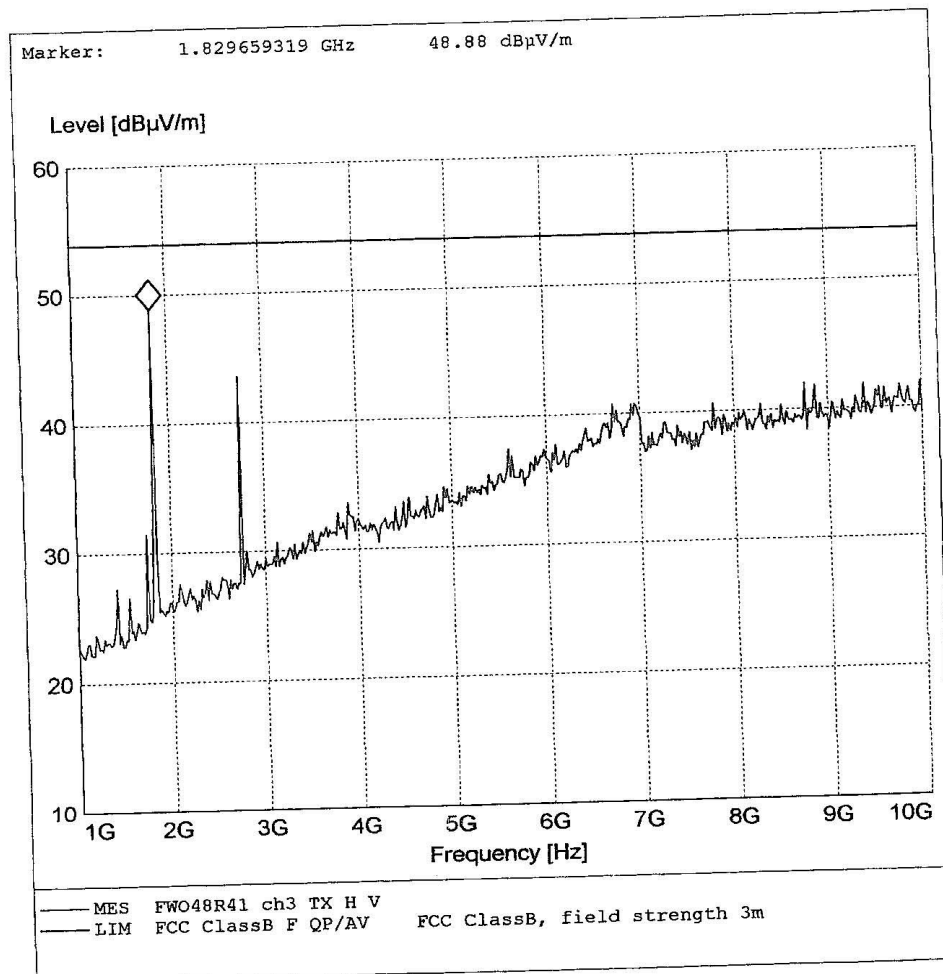
*Radiated Disturbance*

EUT: M/N:FWO48R41  
Manufacturer:  
Operating Condition: ch3 TX  
Test Site: SMQ EMC Lab.SAC  
Operator:  
Test Specification: Vertical  
Comment : DC 12V

**Note:** The marker only shows the un-weighted peak value and freq. point recorded in pre-scan stage. Please refer to the test report for the actual freq. point in the final measurement.

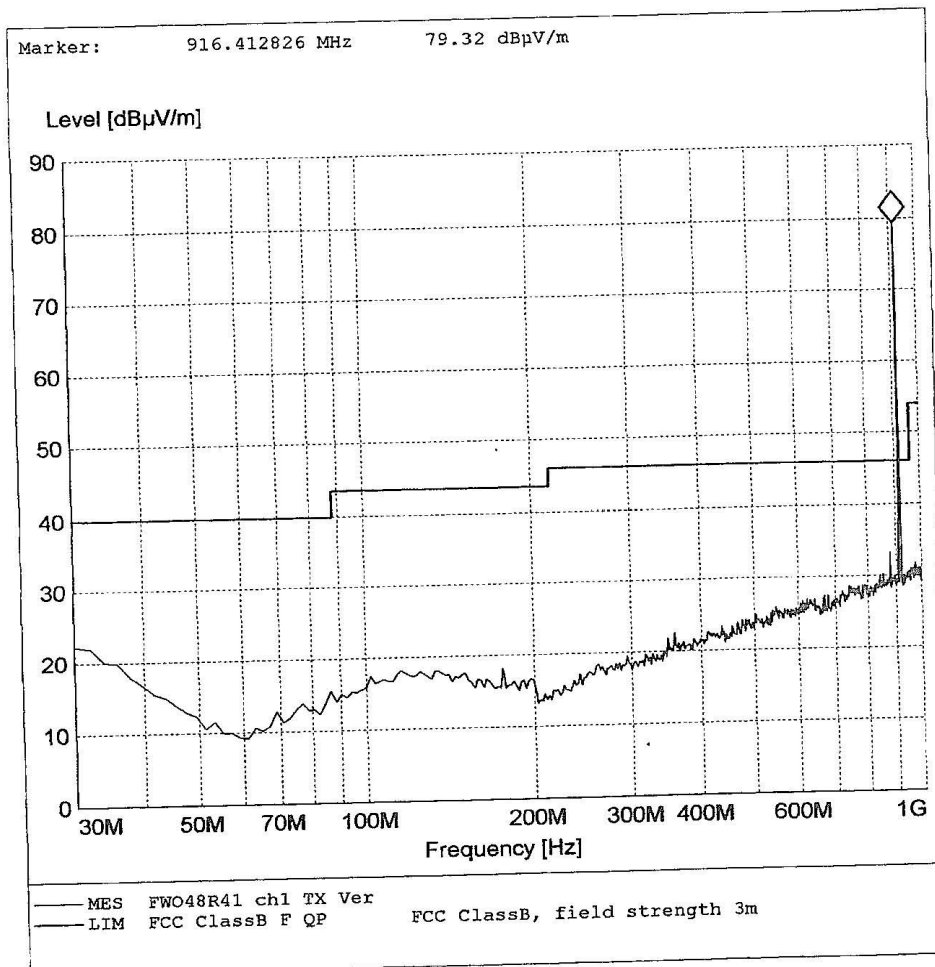
*Radiated Disturbance*

EUT: M/N:FWO48R41  
Manufacturer:  
Operating Condition: chl TX  
Test Site: SMQ EMC Lab.SAC  
Status:  
Test Specification: Vertical  
Comment: DC 12V

**Note:** The marker only shows the un-weighted peak value and freq. point recorded in pre-scan stage. Please refer to the test report for the actual freq. point in the final measurement.

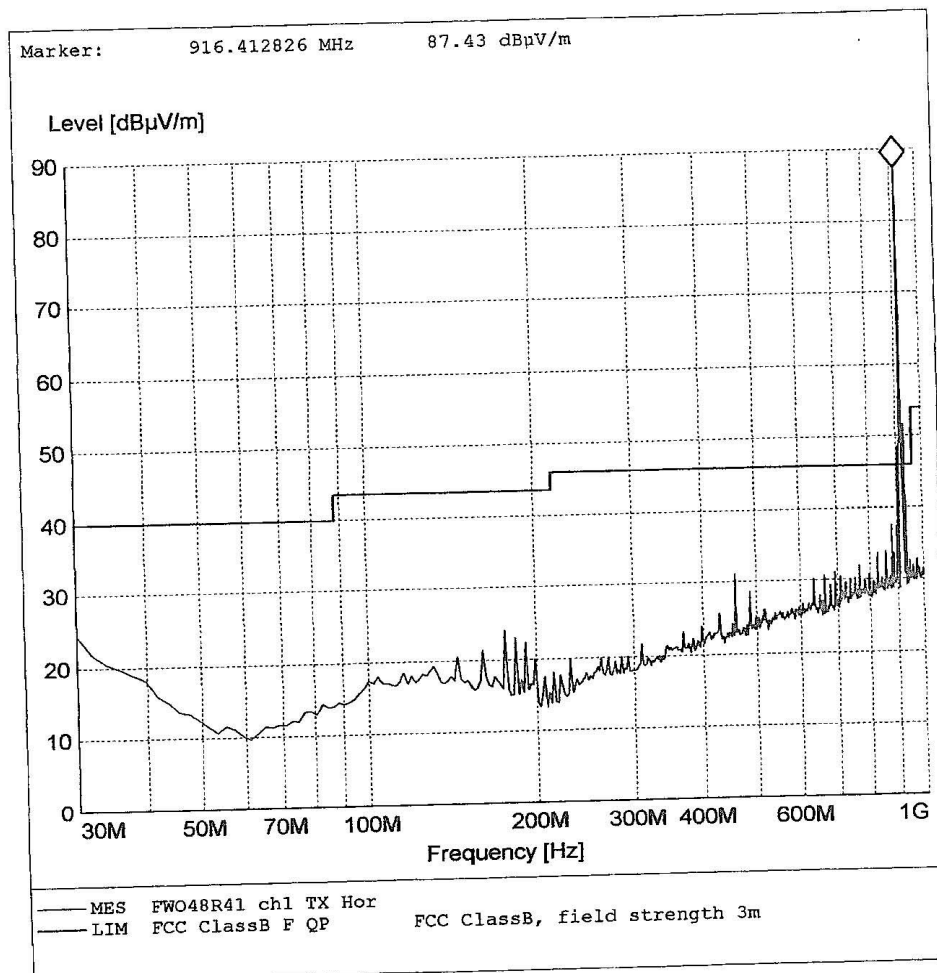
*Radiated Disturbance*

EUT: M/N:FWO48R41  
Manufacturer:  
Operating Condition: chl TX  
Test Site: SMQ EMC Lab.SAC  
Status:  
Test Specification: Horizontal  
Comment: DC 12V

**Note:** The marker only shows the un-weighted peak value and freq. point recorded in pre-scan stage. Please refer to the test report for the actual freq. point in the final measurement.

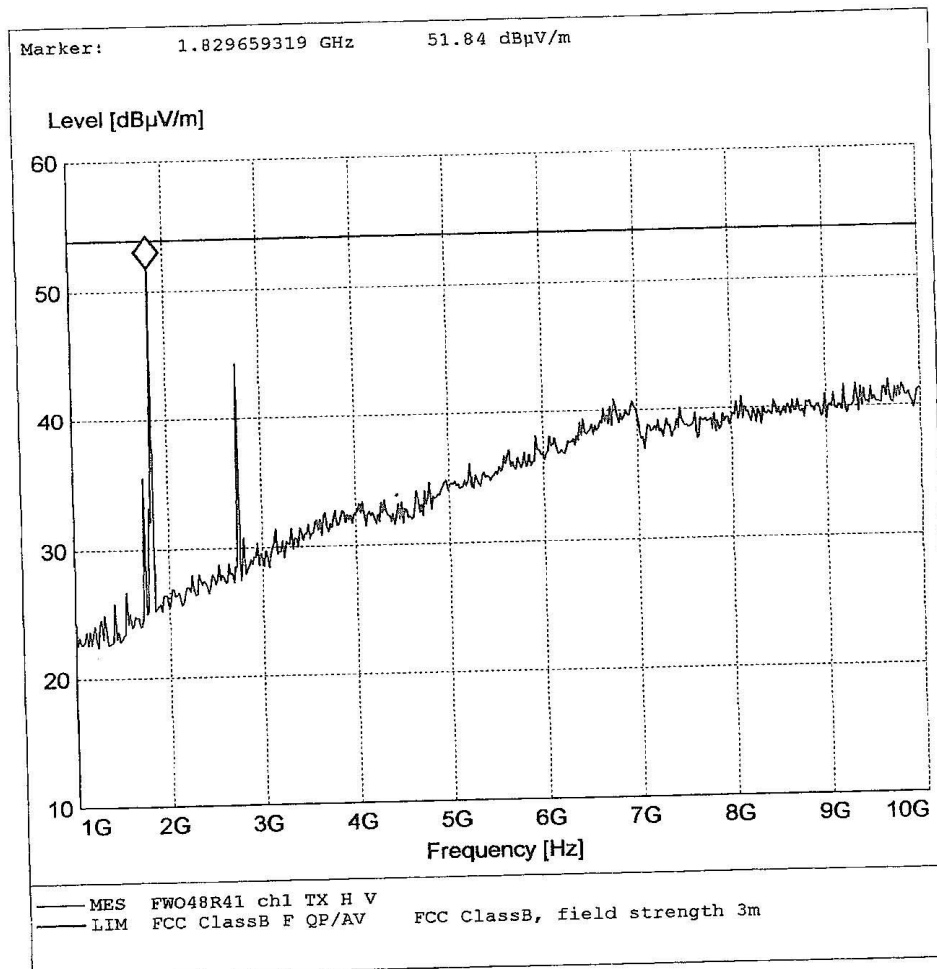
*Radiated Disturbance*

EUT: M/N:FWO48R41  
Manufacturer:  
Operating Condition: chl TX  
Test Site: SMQ EMC Lab.SAC  
Operator:  
Test Specification: Vertical  
Comment : DC 12V

**Note:** The marker only shows the un-weighted peak value and freq. point recorded in pre-scan stage. Please refer to the test report for the actual freq. point in the final measurement.

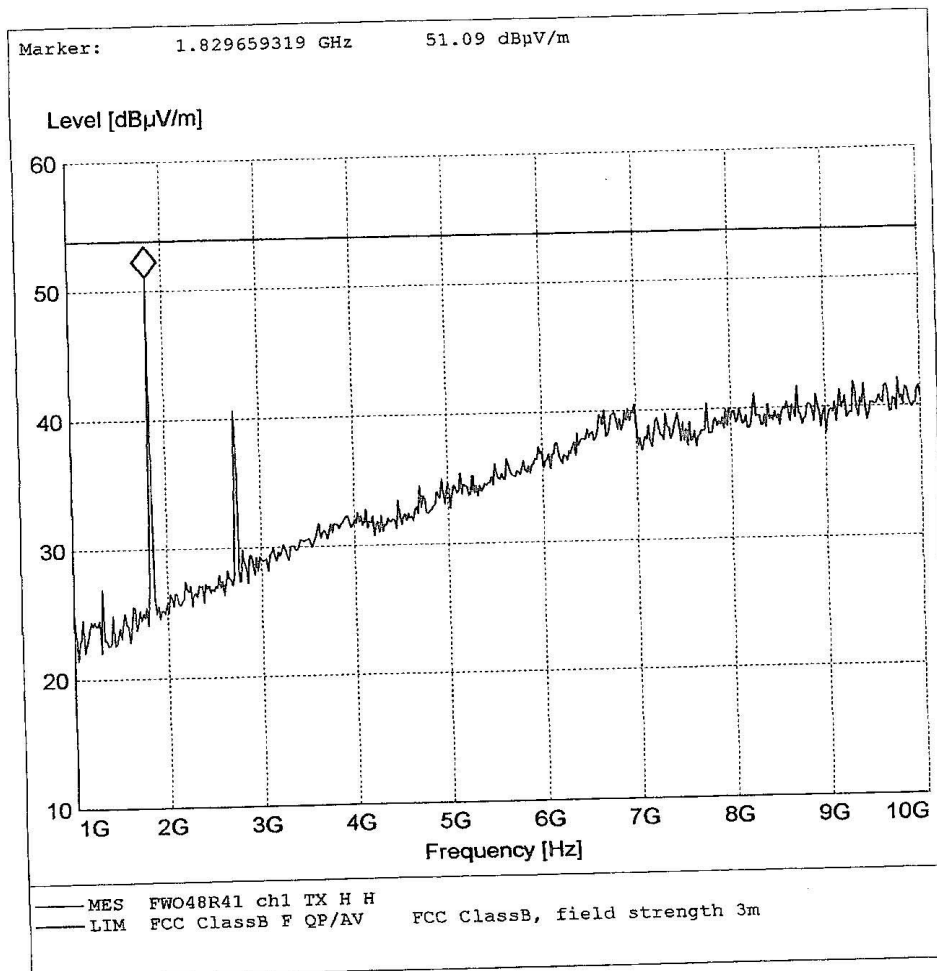
*Radiated Disturbance*

EUT: M/N:FWO48R41  
Manufacturer:  
Operating Condition: chl TX  
Test Site: SMQ EMC Lab.SAC  
Operator:  
Test Specification: Horizontal  
Comment : DC 12V

**Note:** The marker only shows the un-weighted peak value and freq. point recorded in pre-scan stage. Please refer to the test report for the actual freq. point in the final measurement.

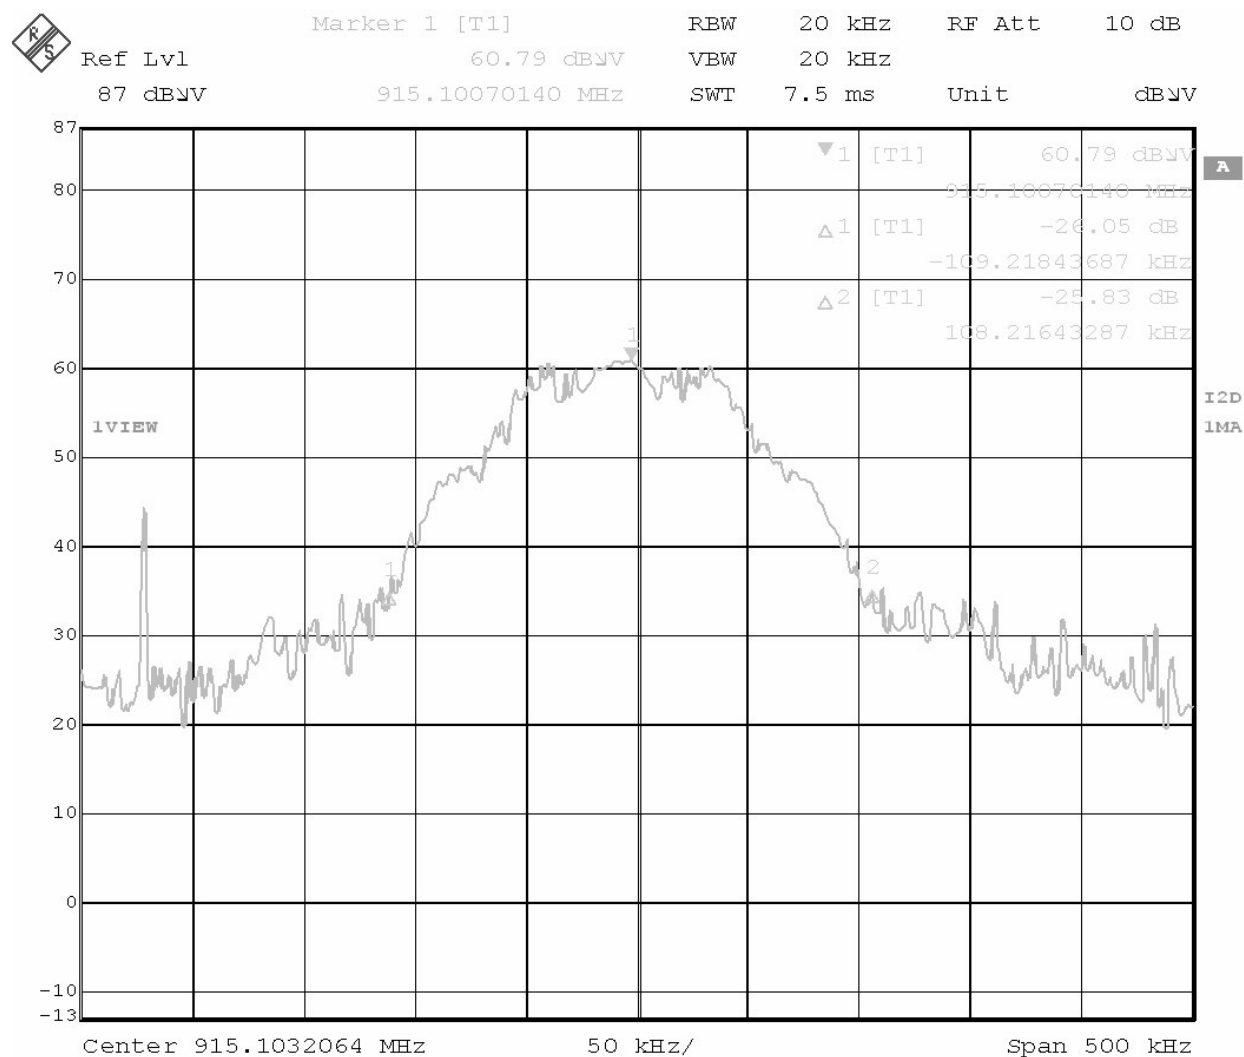
**-26dB Bandwidth:**
