Label location and size photograph

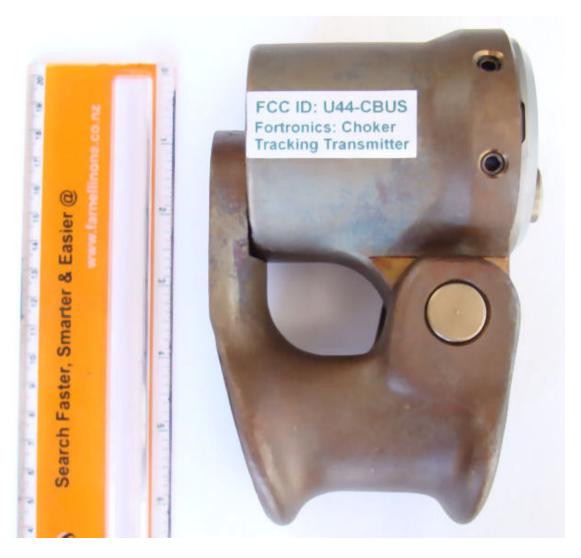
The full label with warning has not been placed on the device.

The client intends to only place a small label on the device.

Therefore the client is requesting that the warning be placed in the manual (as per Section 15.19(a)(5)) as a large label will not last long on the product as the Choker will have a very hard life as it will be dropped from great heights, be buried in soil, water and really get a hammering.
