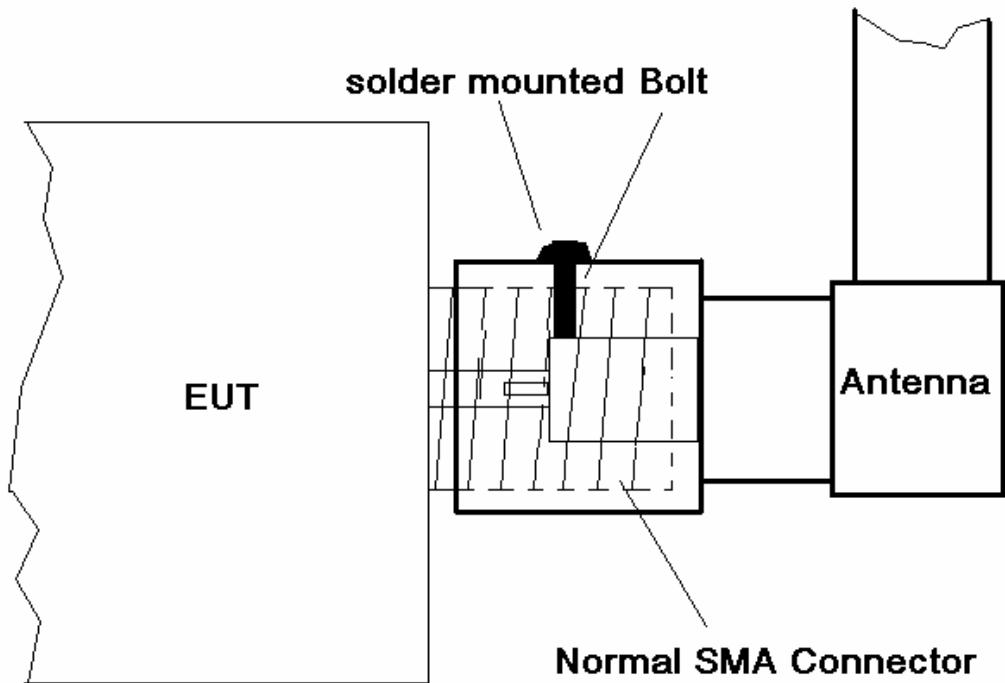
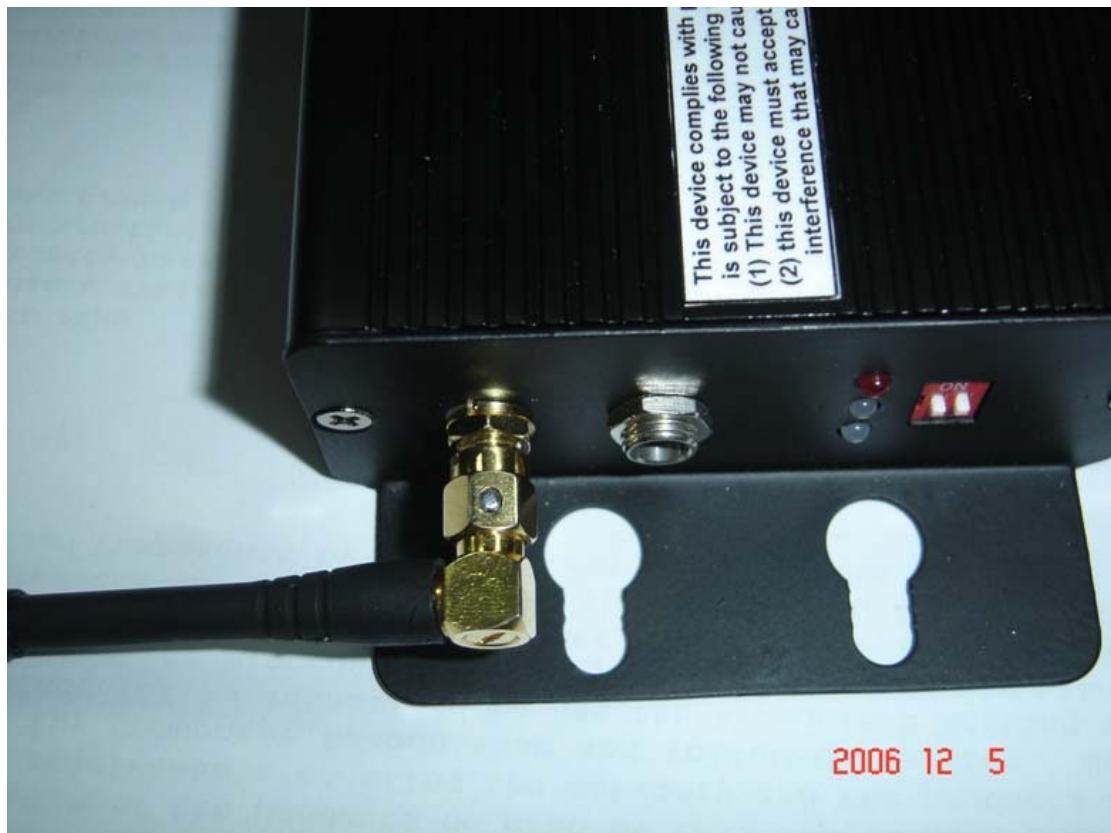
The manufacturer fixed a solder mounted bolt through out the male and female SMA connector of the antenna, so that the end user will not able to remove or replace the original antenna unless breaking and removing the bolt.
