## **APPENDIX A. Photographs of EUT**

## Model D00111 Protective Cover

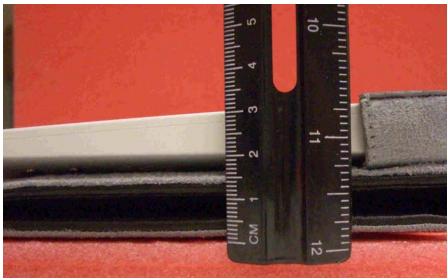
Figure 1. Top Edge View of Operational D00111 in Cover

Figure 1 is a photograph of the device in typical operating mode with the protective cover. The cover is marketed with the product and provides over 1.5 cm (1.8 cm typical) of separation between the antenna (located at the top edge of the device) and the user.

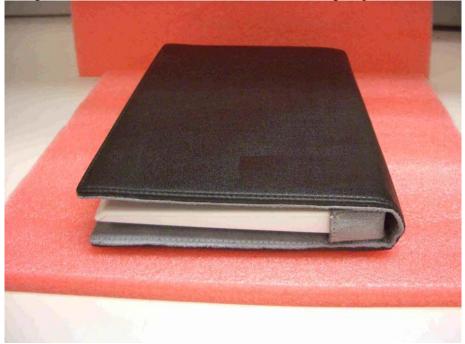
Figure 2. Top Edge View of D00111 Within Cover

Figure 2 provides a view of the model D00111 within the cover for transport or storage.

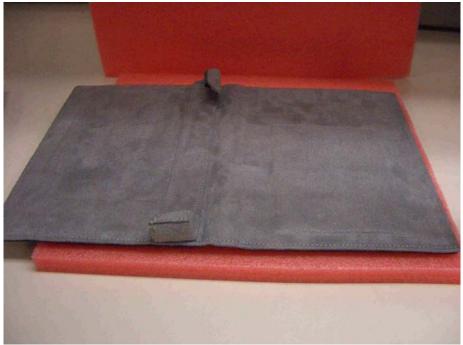
Figure 3. Inside View of Open Cover

Figure 3 shows the inside of the cover folded open.

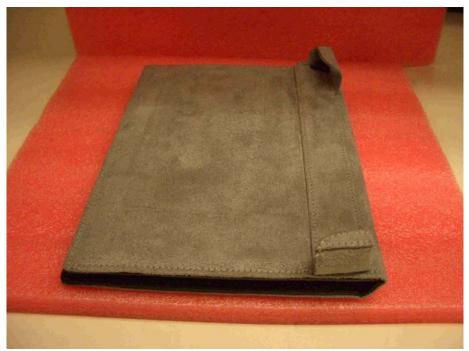
Figure 4. Inside View of Cover Folded Back (Device Operational View)

Figure 4 shows the inside of the cover folded back. This is the orientation of the cover when the device is in operational mode.
