Test report No.:
KES-SR-23T0014
Page (1) of (8)

APPENDIX F: DUT ANTENNA DIAGRAM & SAR TEST SETUP PHOTOGRAPHS

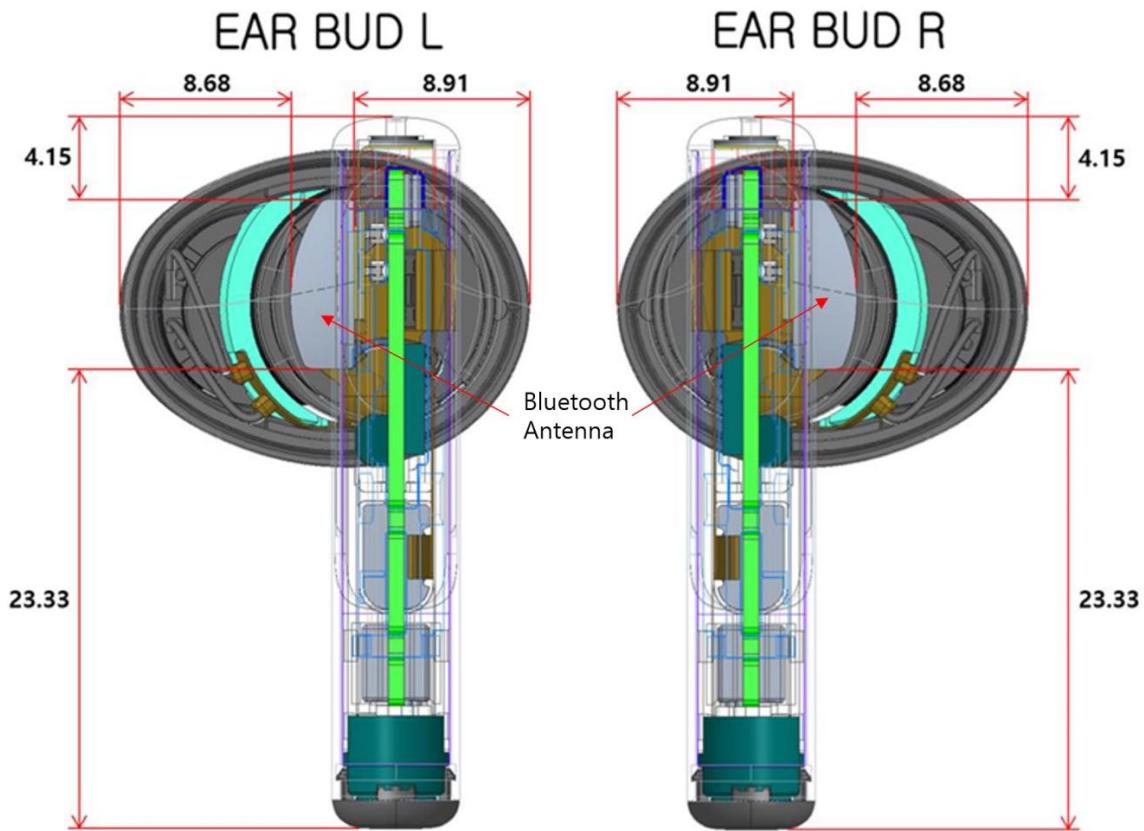
Figure E-1 Antenna Location (Rear Side View)

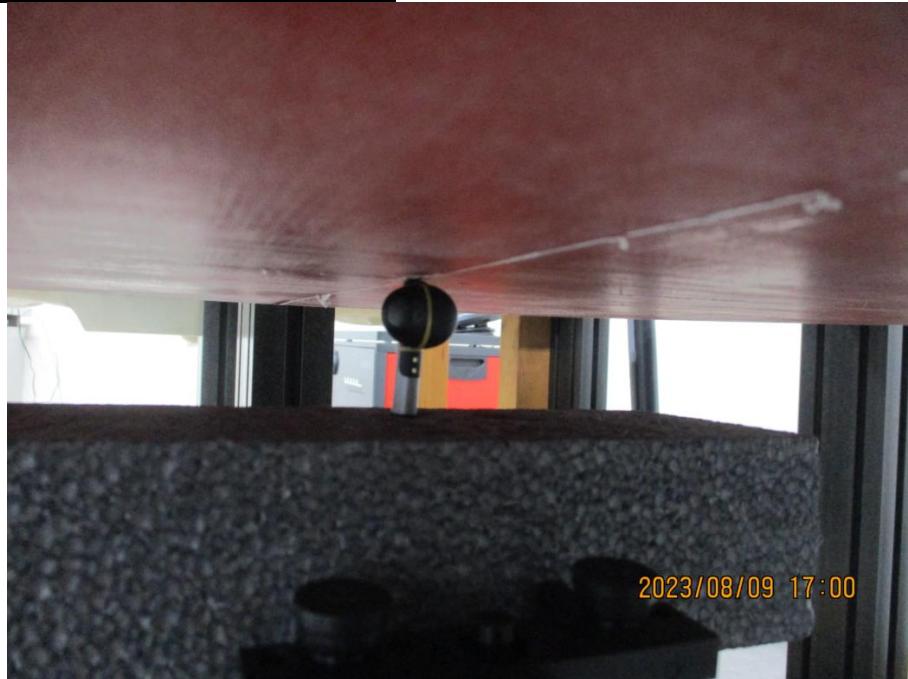
Top Side from Flat Phantom (Separation Distance: 0 cm) – Right Ear

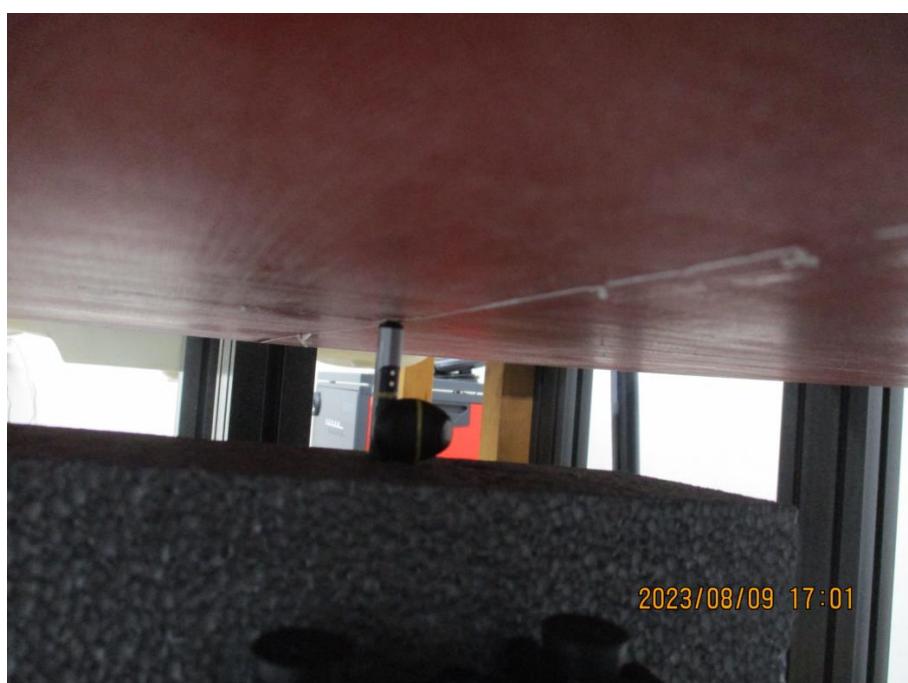
Bottom Side from Flat Phantom (Separation Distance: 0 cm) – Right Ear

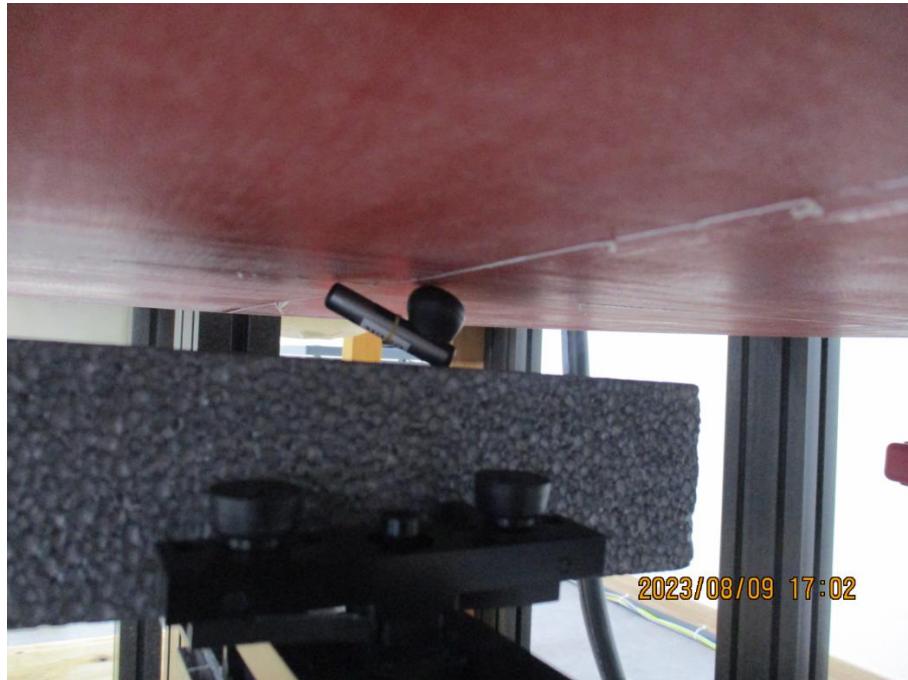
Right Ear & Front Side from Flat Phantom (Separation Distance: 0 cm) – Right Ear

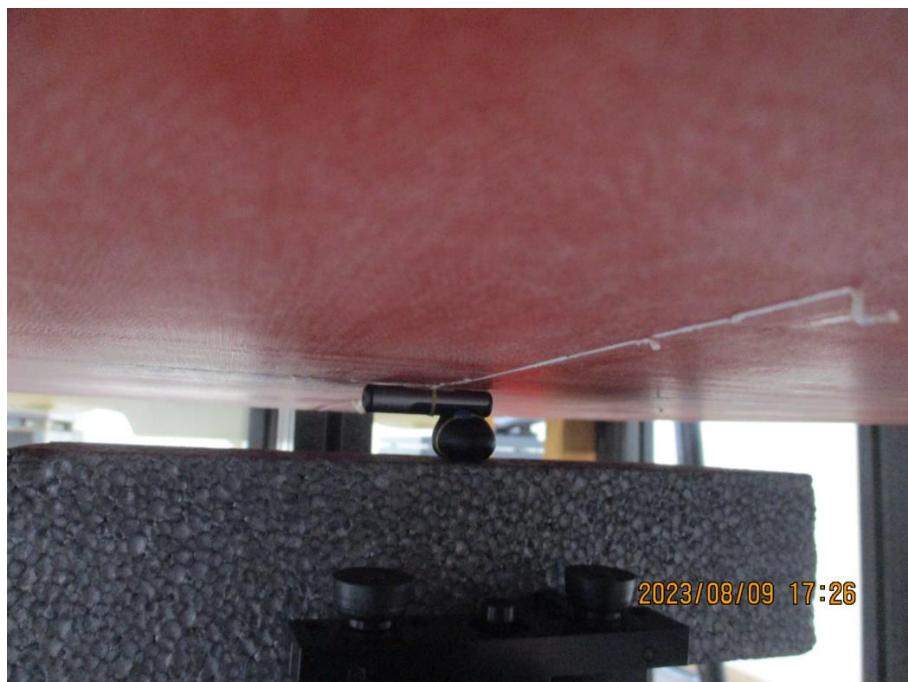
Rear from Flat Phantom (Separation Distance: 0 cm) – Right Ear

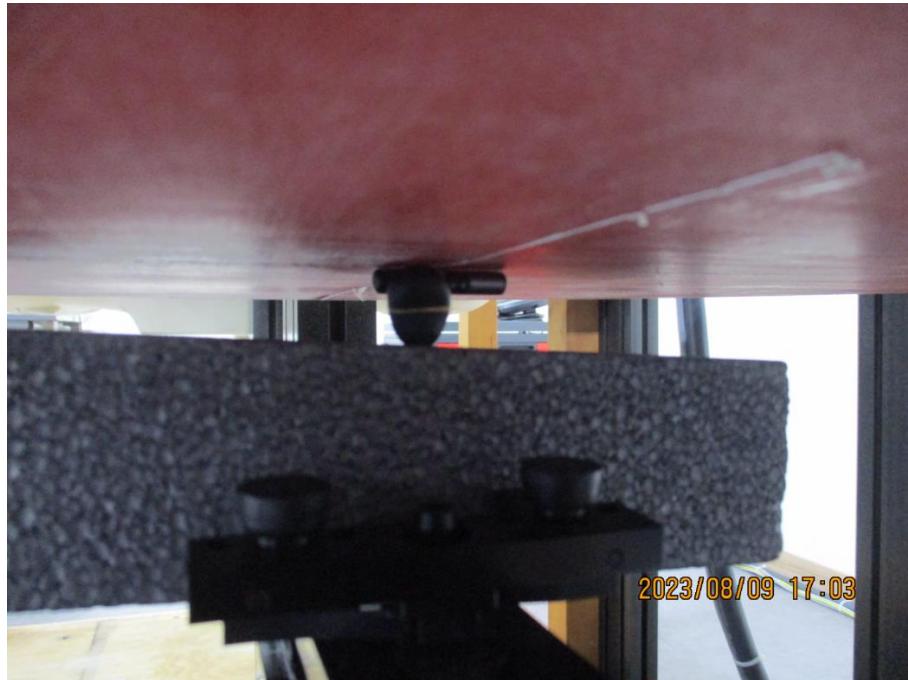
Right Side from Flat Phantom (Separation Distance: 0 cm) – Right Ear

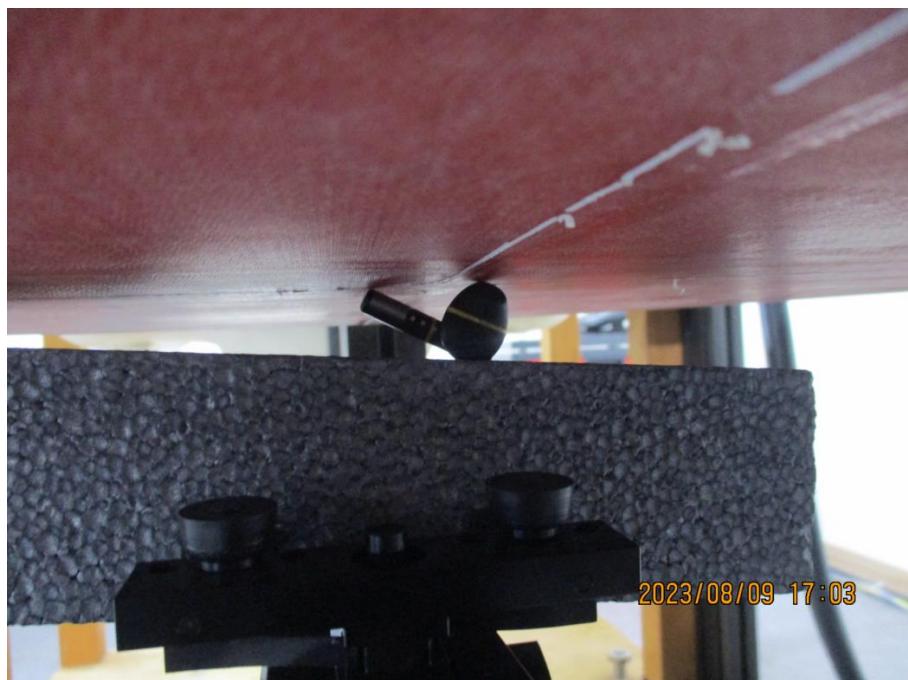
Left Side from Flat Phantom (Separation Distance: 0 cm) – Right Ear

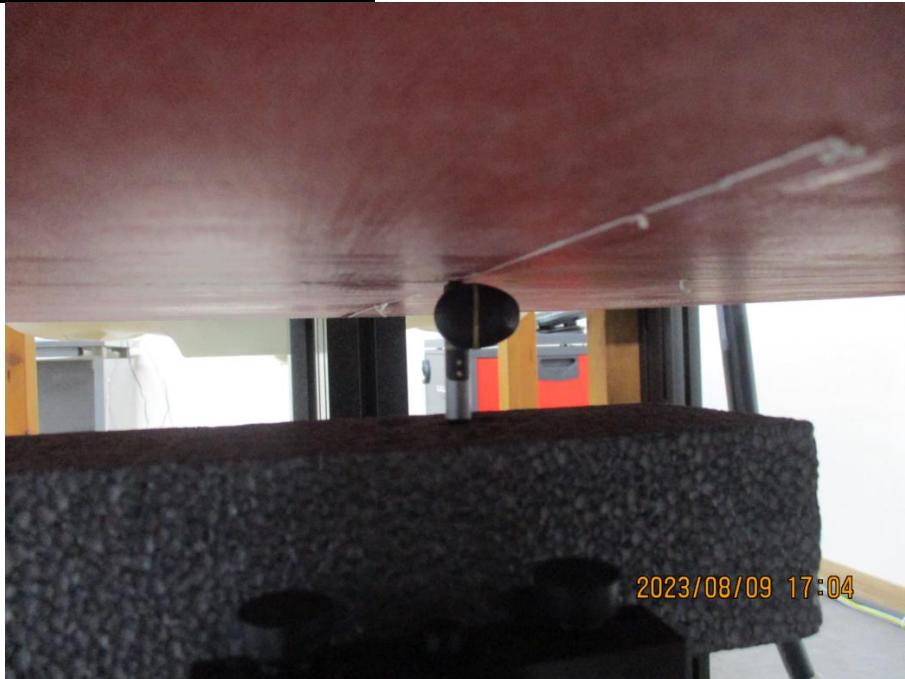
Top Side from Flat Phantom (Separation Distance: 0 cm) – Left Ear

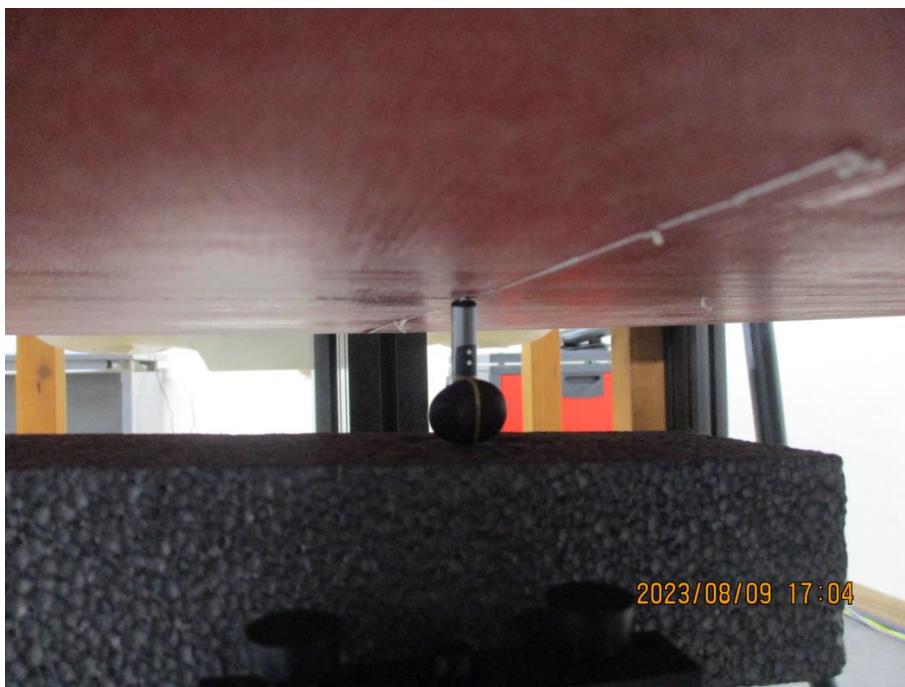
Bottom Side from Flat Phantom (Separation Distance: 0 cm) – Left Ear

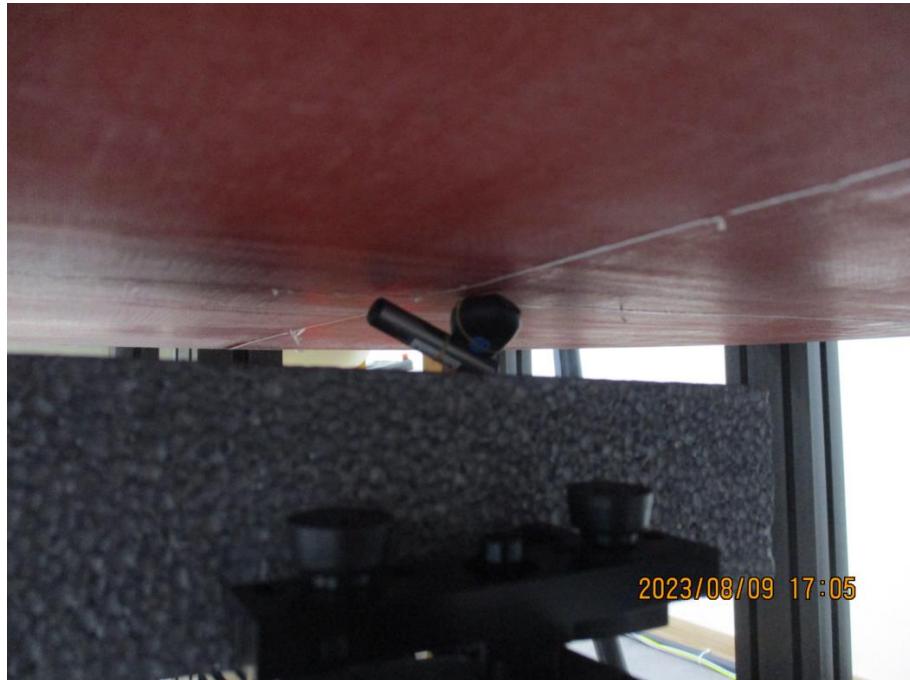
Right Ear & Front Side from Flat Phantom (Separation Distance: 0 cm) – Left Ear

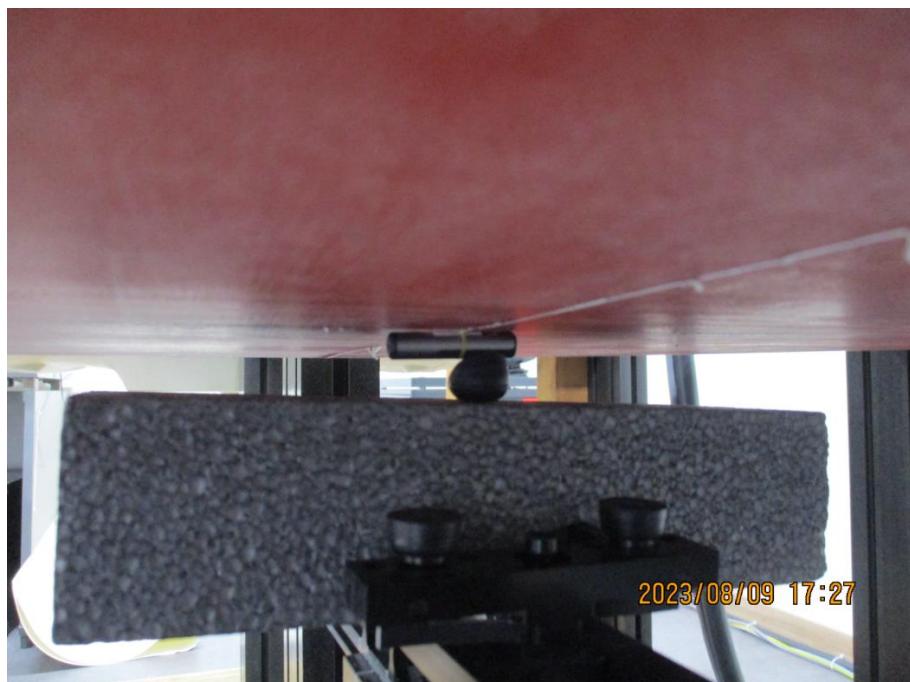
Rear from Flat Phantom (Separation Distance: 0 cm) – Left Ear

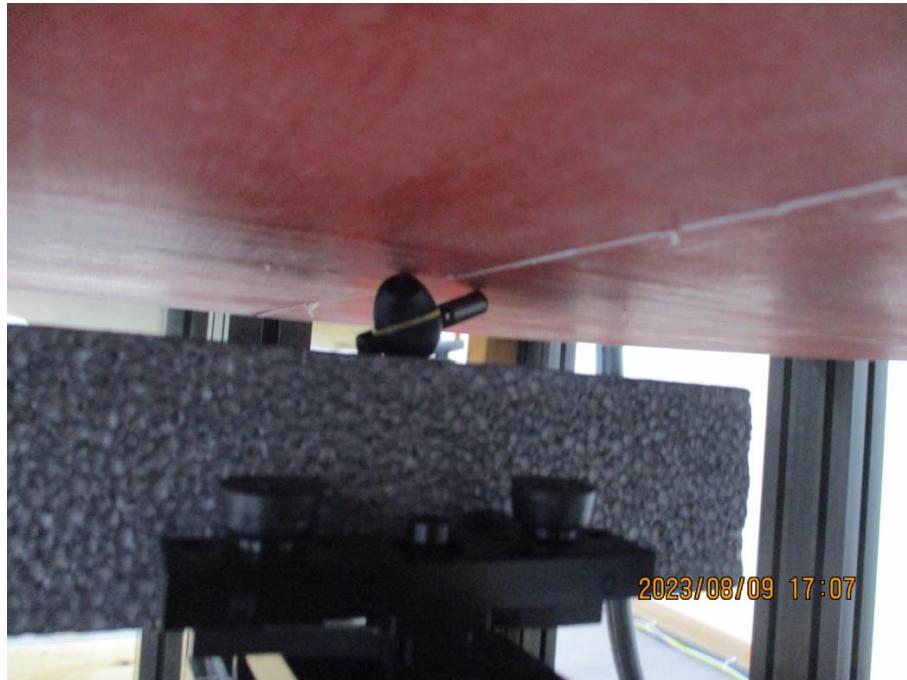
Right Side from Flat Phantom (Separation Distance: 0 cm) – Left Ear

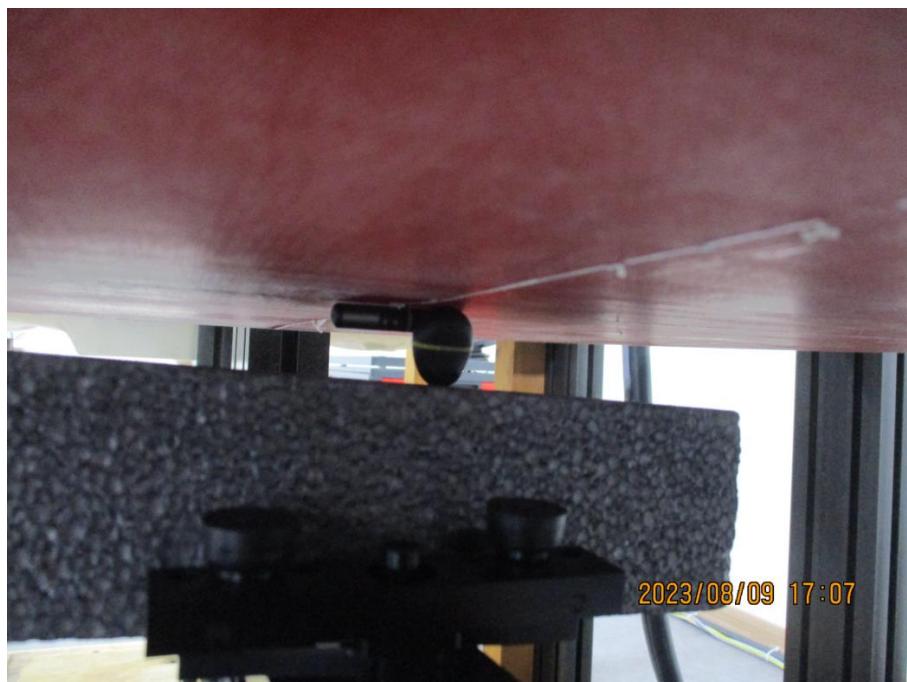
Left Side from Flat Phantom (Separation Distance: 0 cm) – Left Ear
