# **FCC TEST- REPORT**

**TEST REPORT NUMBER: EFGX25070372-IE-03-E01**  
**FCC ID: VG8TM934DYY**

Product type : Microwave Oven  
 Model name : EM934D##-SH0D, EM934D\*\*\*-SH0D, EM934D##-S00D, EM934D\*\*\*-S00D, TM934D##-SHND, TM934D\*\*\*-SHND, TM934D##-S0ND, TM934D\*\*\*-S0ND, TM934D##-SH0D, TM934D\*\*\*-SH0D, TM934D##-S00D, TM934D\*\*\*-S00D  
 Brand name : Midea  
 Sample ID : 250721-39-001  
 Ratings : Power Supply: 120VAC/60Hz  
 Rated Input Power (Microwave): 1500W  
 Rated output Power(microwave): 900W  
 Frequency: 2450MHz  
 Test voltage : 120V~, 60Hz  
 Additional information :  
 Magnetron Model : 2M539H  
 Magnetron Manufacturer : WITOL  
 EM934D##-SH0D, EM934D\*\*\*-SH0D, EM934D##-S00D, EM934D\*\*\*-S00D, TM934D##-SHND, TM934D\*\*\*-SHND, TM934D##-S0ND, TM934D\*\*\*-S0ND, TM934D##-SH0D, TM934D\*\*\*-SH0D, TM934D##-S00D, TM934D\*\*\*-S00D model designations as follow:  
 E: Indicates film type keypad; T: Touch type keypad;  
 M: Indicates microwave function;

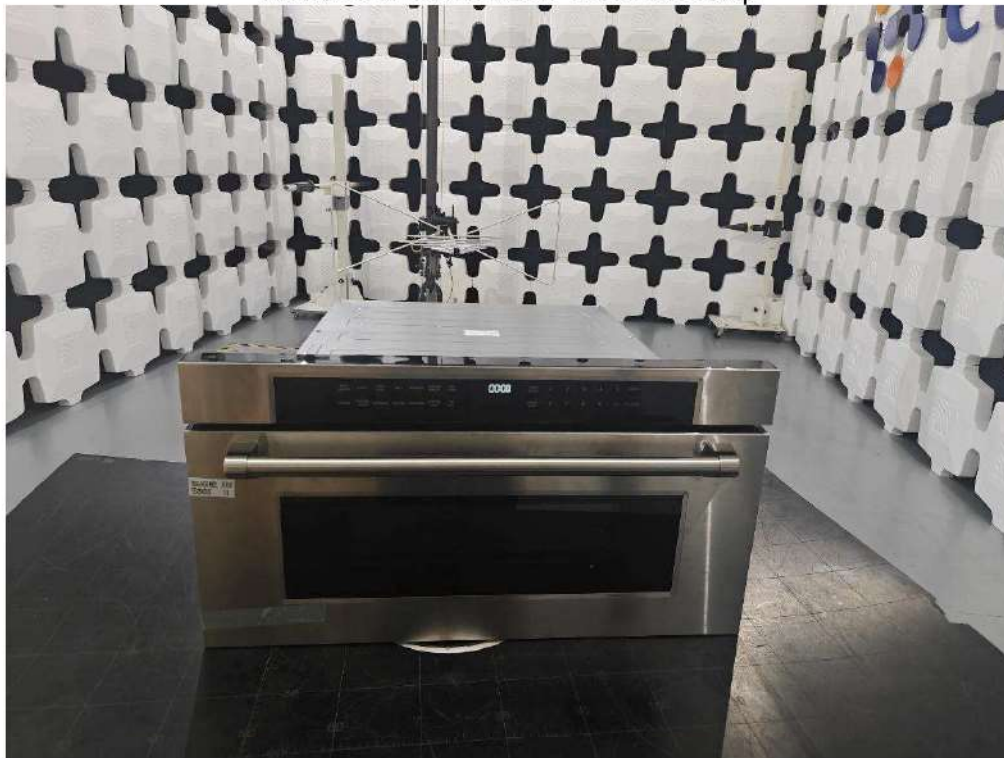
Radiated emission below 1GHz test setup

1. The radiated emissions test was conducted in a semi-anechoic chamber. The EUT was placed upon a non-metallic table 0.8m above the ground reference plane. And for floor-standing arrangement, the EUT was placed on the horizontal ground reference plane, but separated from metallic contact with the ground reference plane by 0.1m of insulation.

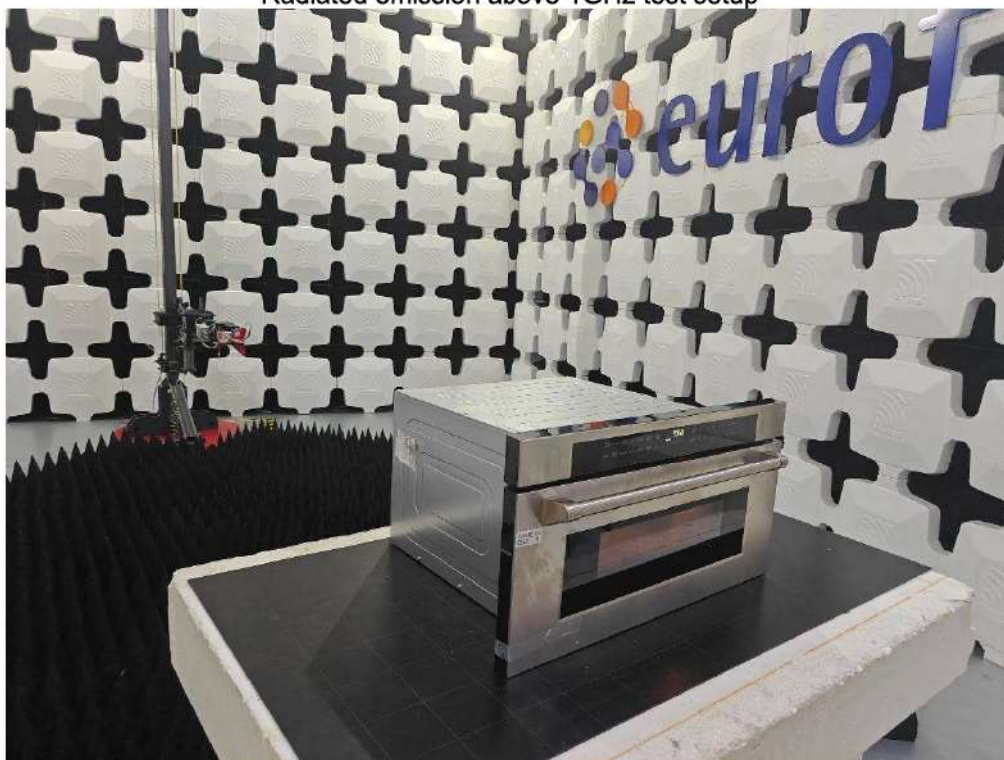
Radiated emission above 1GHz test setup

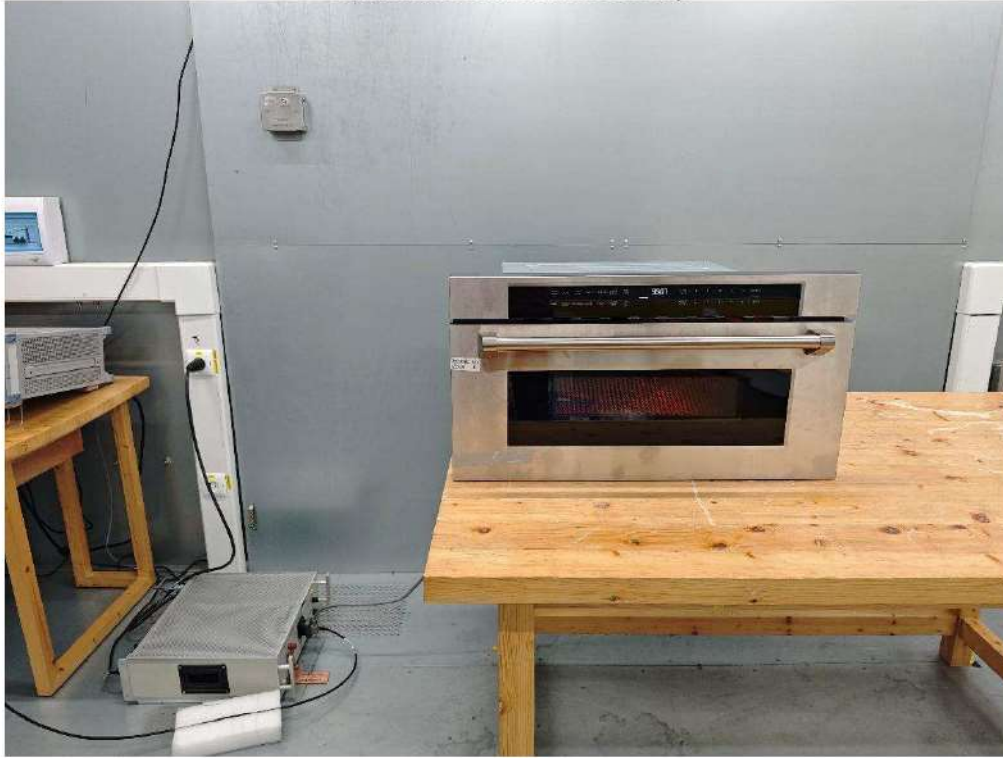
Conducted emission test setup

1. The mains terminal disturbance voltage was measured with the EUT in a shielded room.
2. The EUT was connected to AC power source through a LISN 1 (Line Impedance Stabilization Network) which provides a  $(50 \mu\text{H} + 5 \Omega) \parallel 50 \Omega$  linear impedance. The power cables of all other units of the EUT was connected to a second LISN, which was bonded to the ground reference plane in the same way as the LISN for the unit being measured.
3. The tabletop EUT was placed upon a non-metallic table 0.8m above the ground reference plane. And for floor-standing arrangement, the EUT was placed on the horizontal ground reference plane, but separated from metallic contact with the ground reference plane by 0.1m of insulation.

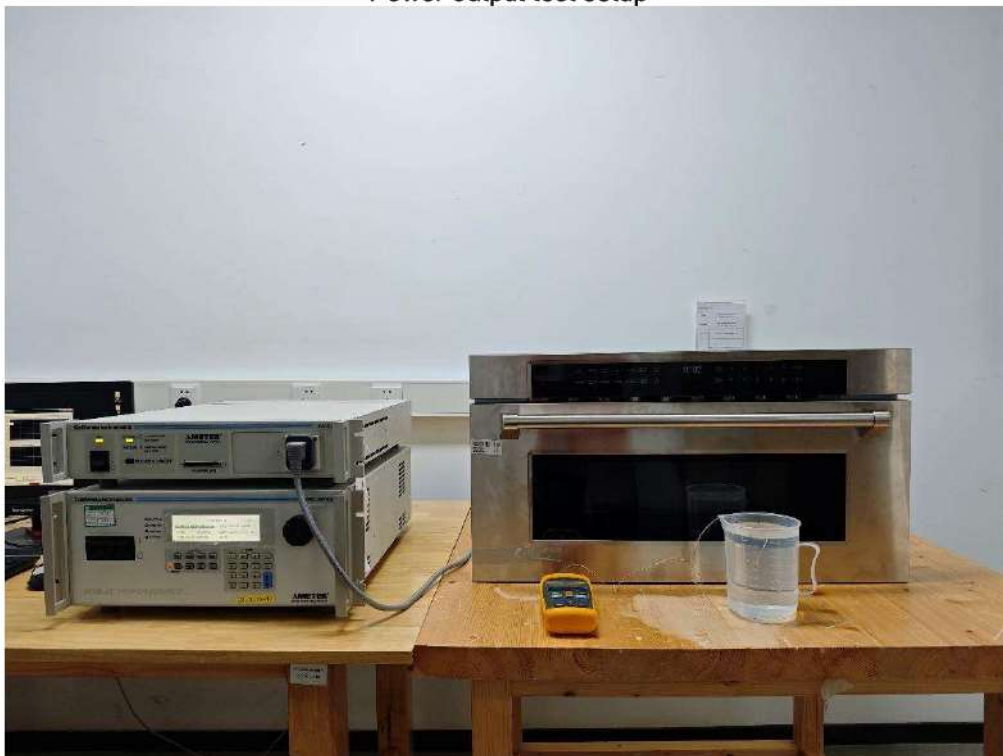
Power output test setup

To evaluate the RF power output and AC input power of the microwave oven under typical operating conditions, in accordance with FCC/OST MP-5 Section 4.3.

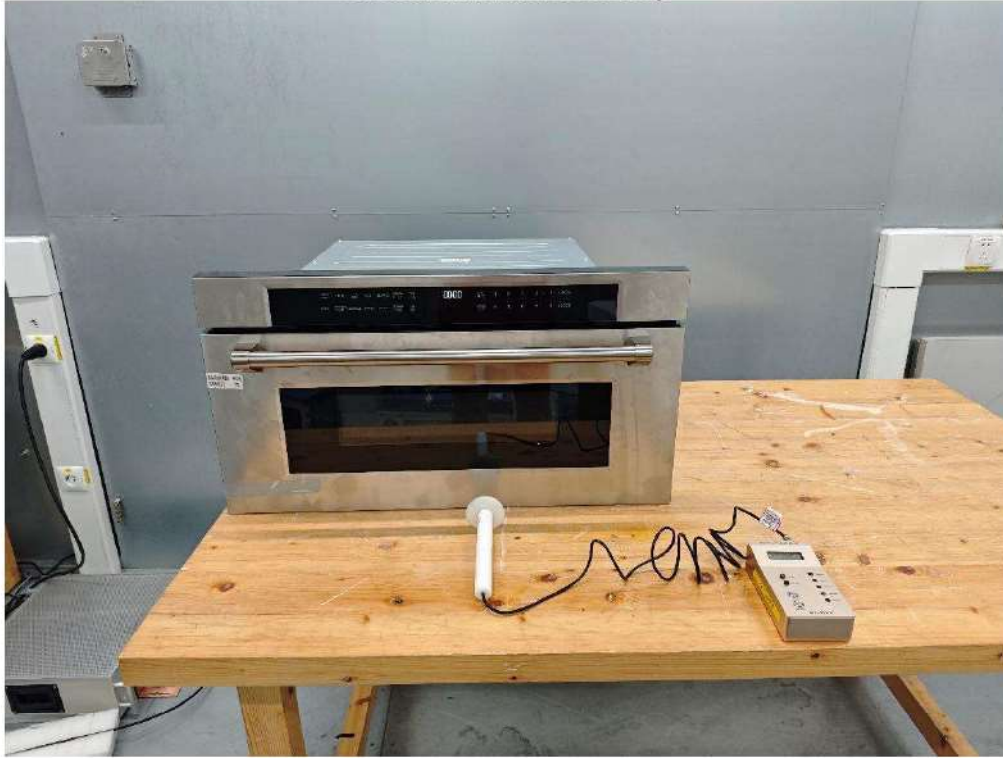
Radiation hazard test setup

Microwave leakage was measured using a calibrated leakage detector at a distance of 5 cm from the EUT surface, while the device was operating at full power with a standard load as specified in FCC/OST MP-5 Section 4.1. Scanning was performed along door seals, control panel, and vents.
