Report No.:  
KR20-SRF0029-B

## 7.6. AC Conducted emission

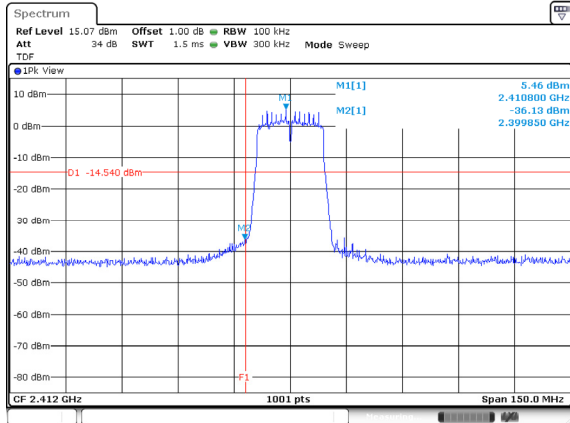
### Conducted band-edge / 2 412 MHz

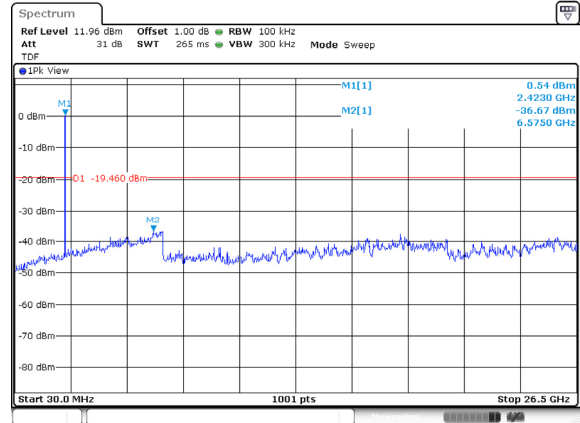
### Conducted spurious / 2 412 MHz

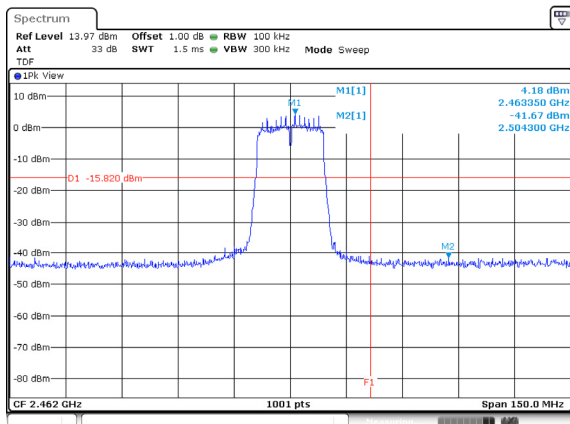
### Conducted band-edge / 2 462 MHz

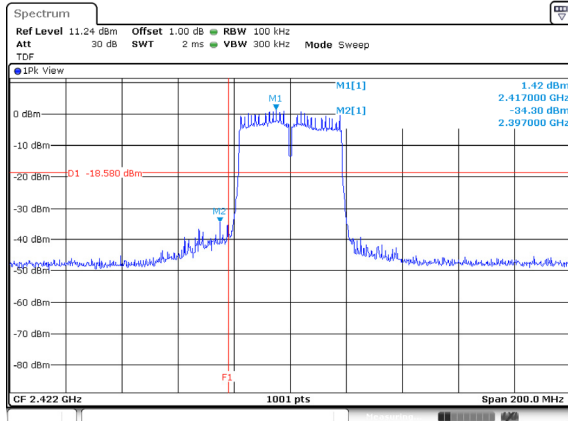
### Conducted band-edge / 2 422 MHz

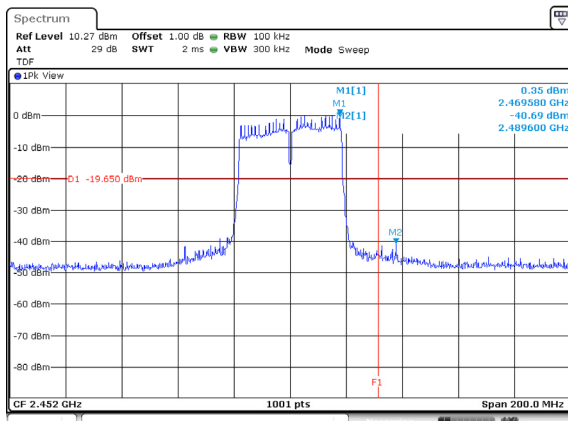
### Conducted band-edge / 2 452 MHz

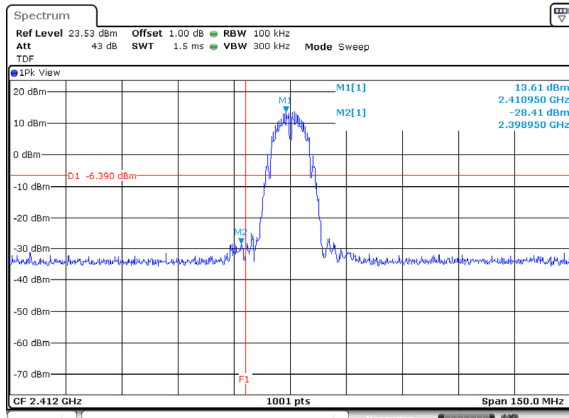
### Conducted band-edge / 2 412 MHz

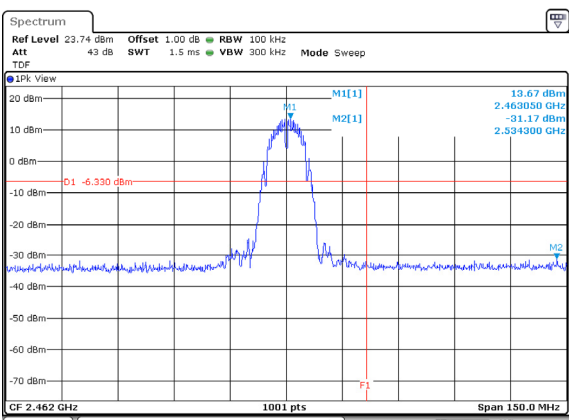
### Conducted band-edge / 2 462 MHz

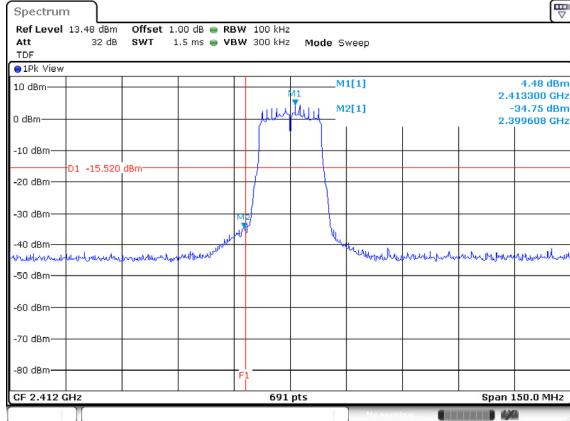
Conducted band-edge / 2 412 MHz

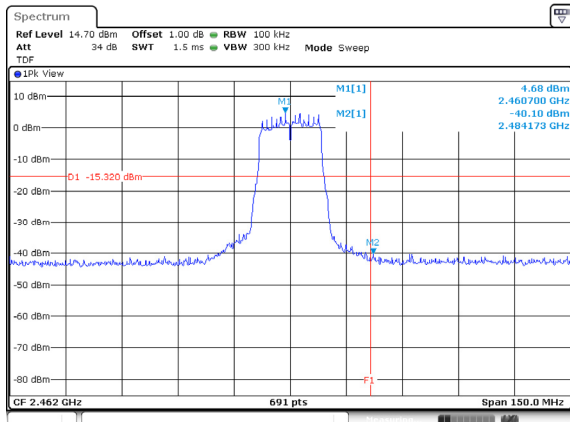
Conducted band-edge / 2 462 MHz

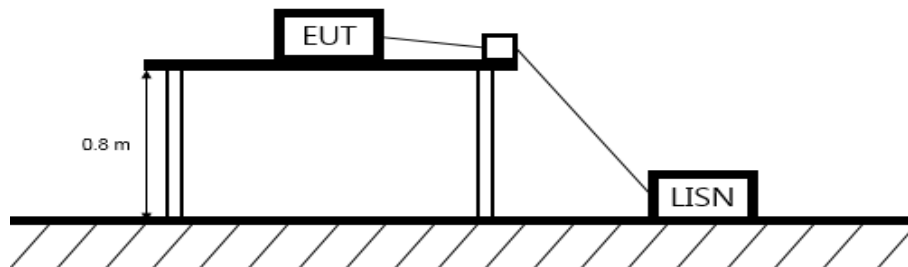
### Test setup

1. The EUT was placed on a wooden table of size, 1 m by 1.5 m, raised 80 cm in which is located 40 cm away from the vertical wall and 1.5m away from the side wall of the shielded room.

2. Each current-carrying conductor of the EUT power cord was individually connected through a 50 $\Omega$ /50 $\mu$ H LISN, which is an input transducer to a spectrum analyzer or an EMI/Field Intensity Meter, to the input power source.

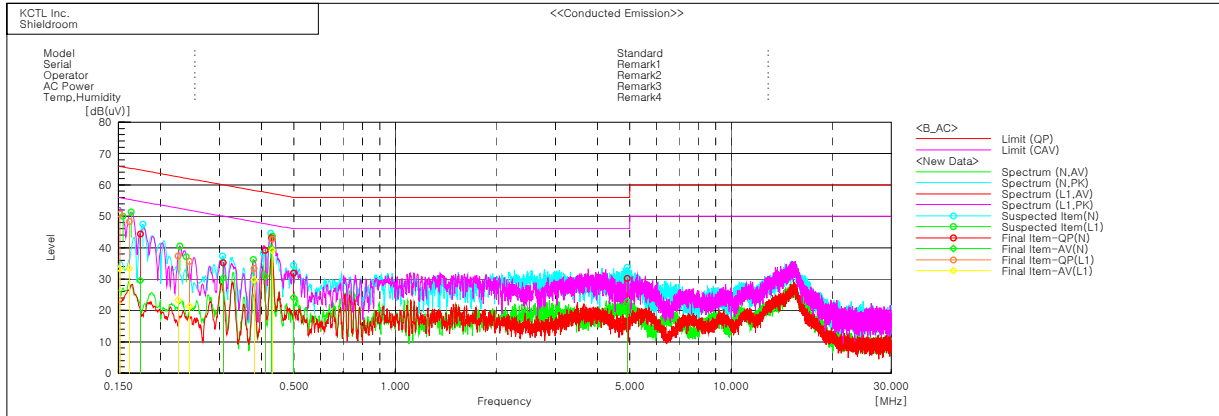
**Worst case: 802.11n HT20 / MIMO / 2 437 MHz**
