| Issue: | Mod No: | Date: | Title: | |
|---|---|---|---|---|
| | | | PCB Assy: ATA100 Main | |
| | | | AIS | Top Components |
| <i>[Signature]</i> | <i>[Signature]</i> | <i>[Signature]</i> | 800S-02463 | |

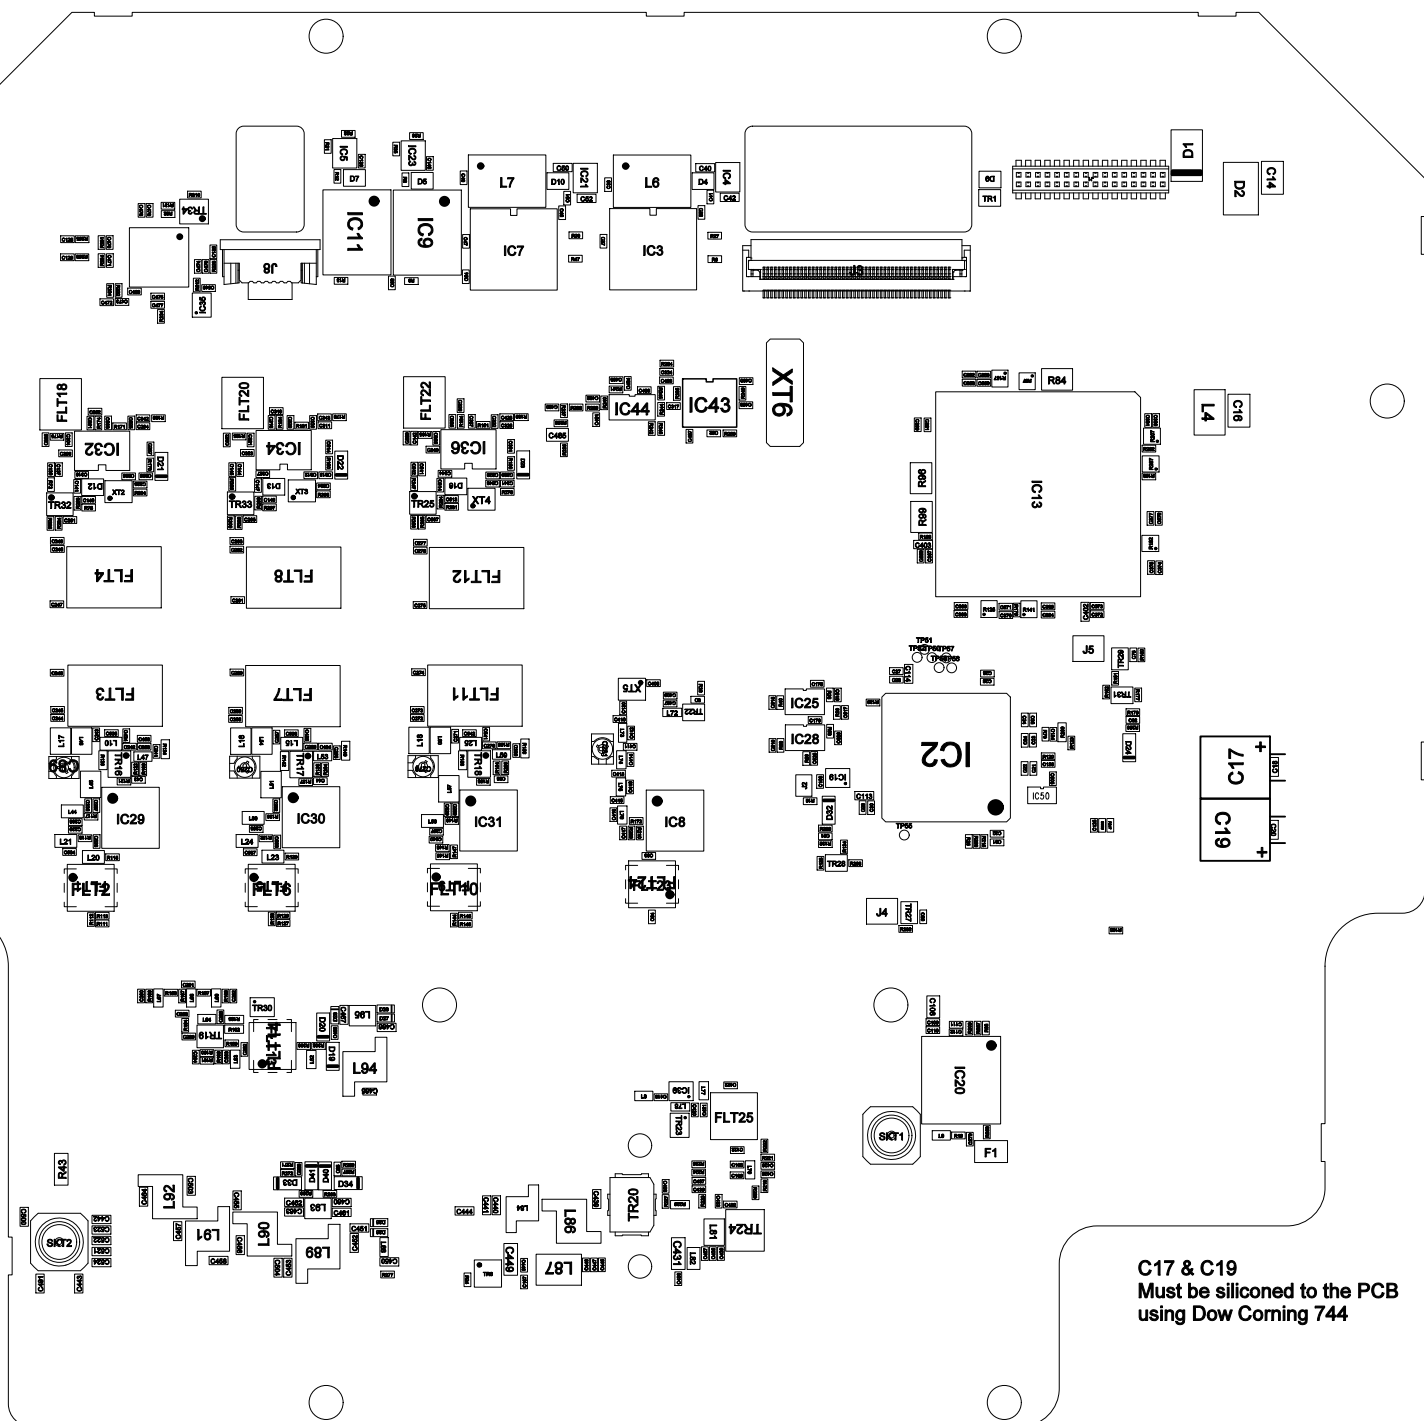
FLT18, FLT20 & FLT22  
Must be glued  
during the SM process

C17 & C19  
Must be siliconed to the PCB  
using Dow Corning 744

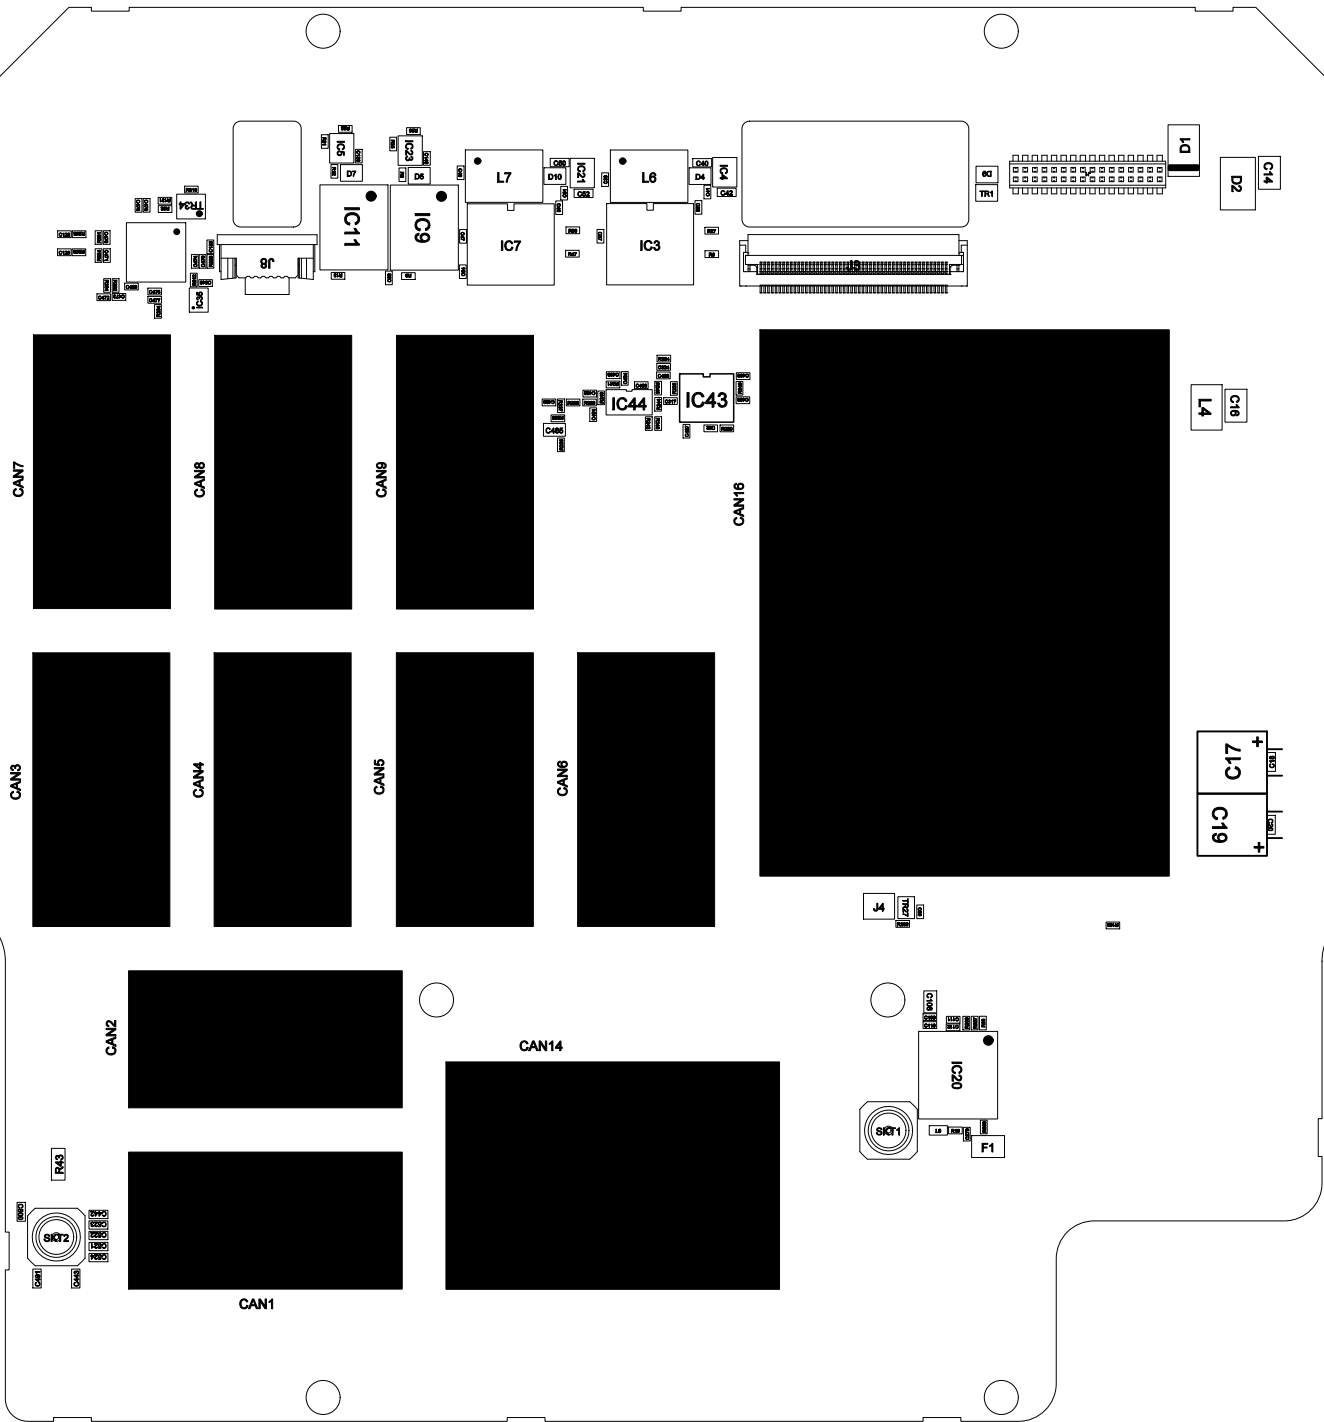
Ensure all pads of the screening cans are soldered

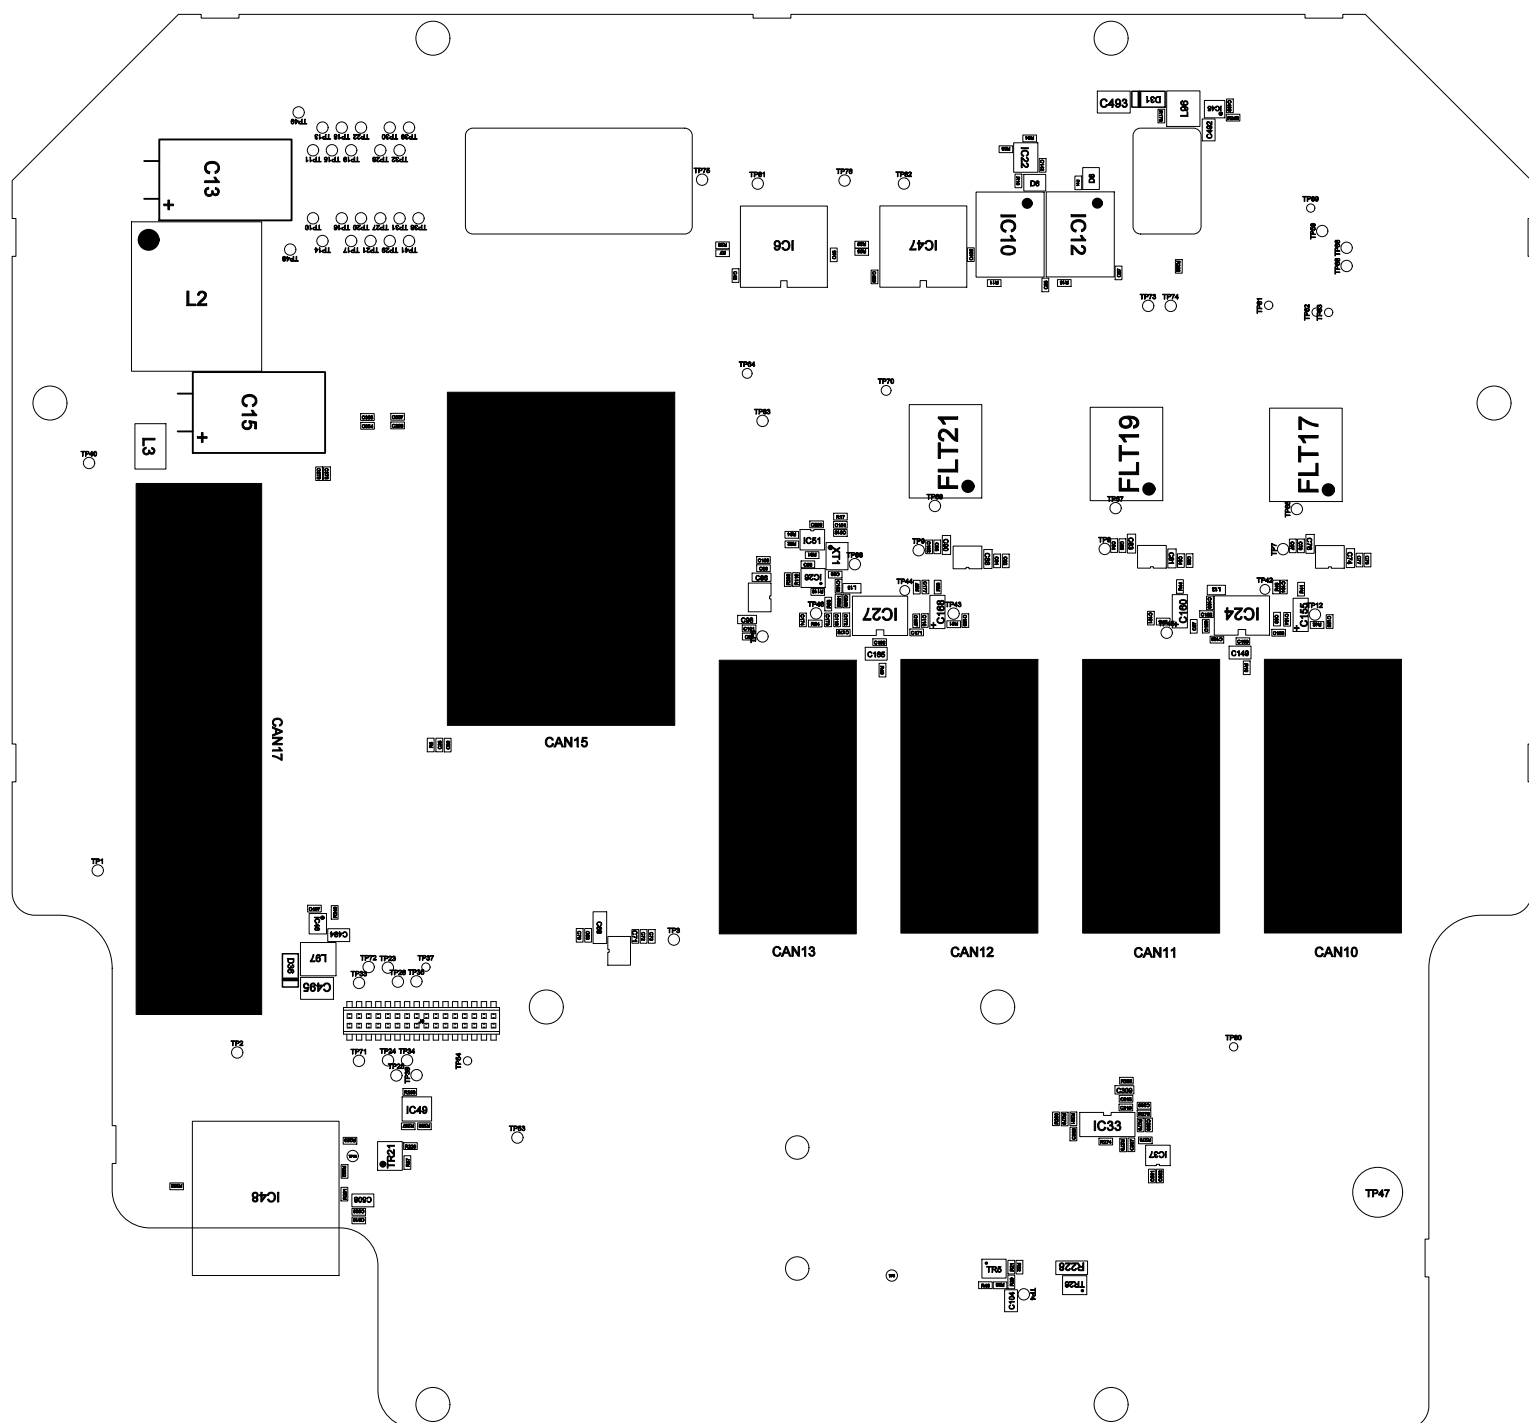
**Ensure all pads of the screening cans are soldered**
