Registration number: W6M21903-18857-C-54  
FCC ID: YY3-182010

## 3.12 Dynamic Frequency Selection (DFS)

### **3.13 Channel Move Time, Channel Closing Transmission Time**

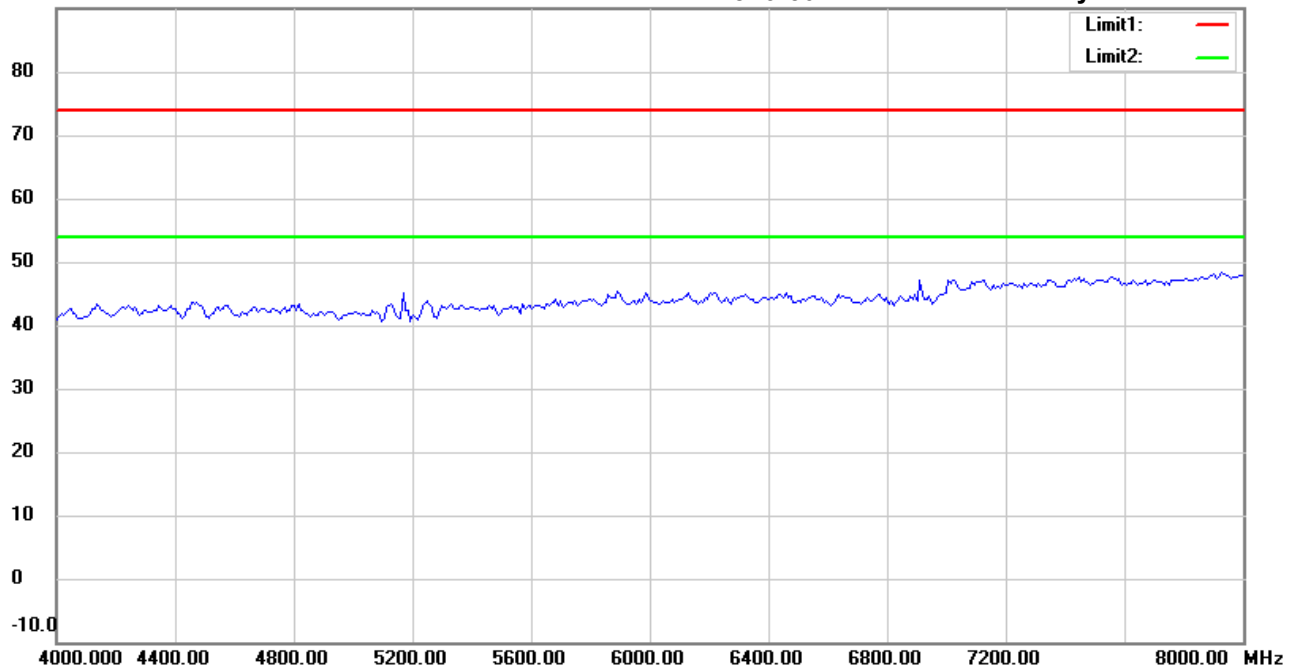
Site : Chamber

Condition : FCC\_part 15E RE\_Above 1GHz\_PK

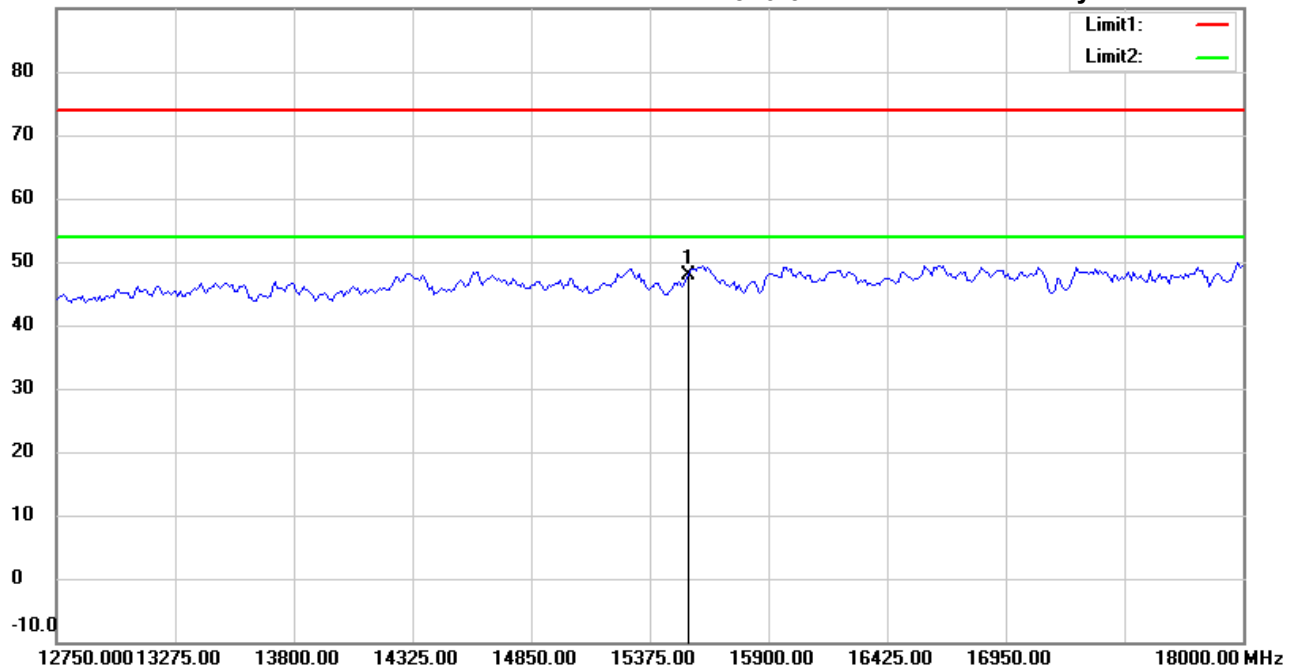
Site : Chamber

Condition : FCC\_part 15E RE\_Above 1GHz\_PK

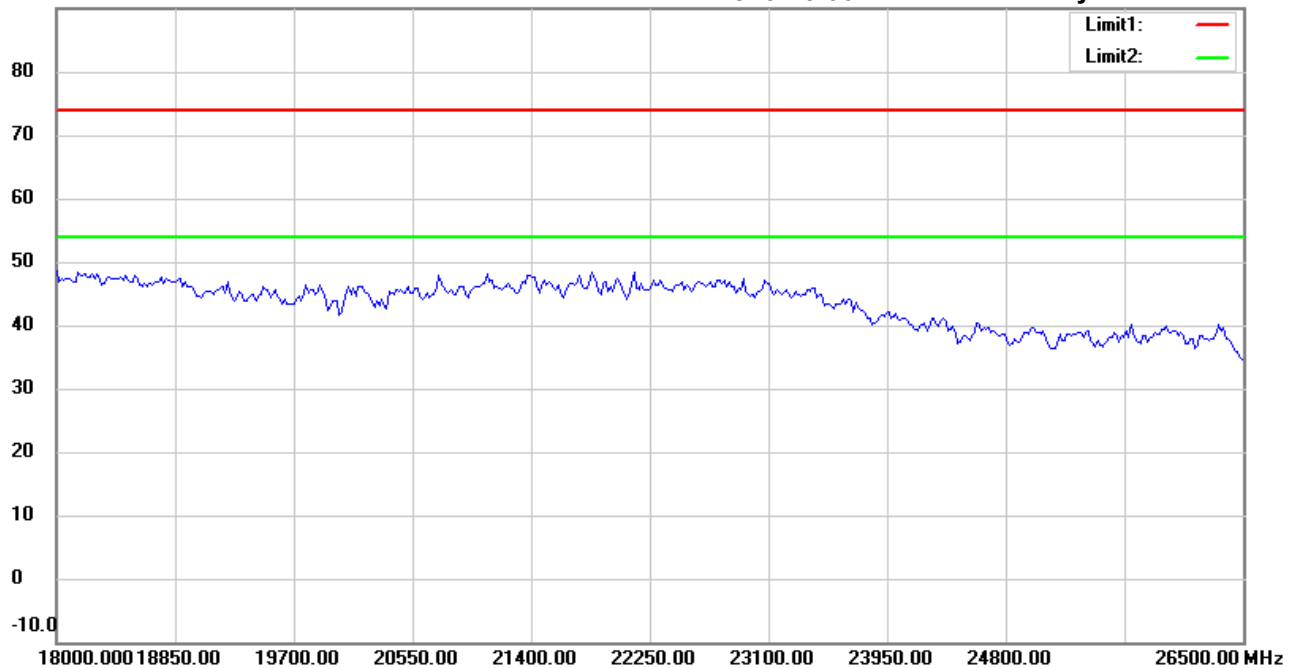
Site : Chamber

Condition : FCC\_part 15E RE\_Above 1GHz\_PK

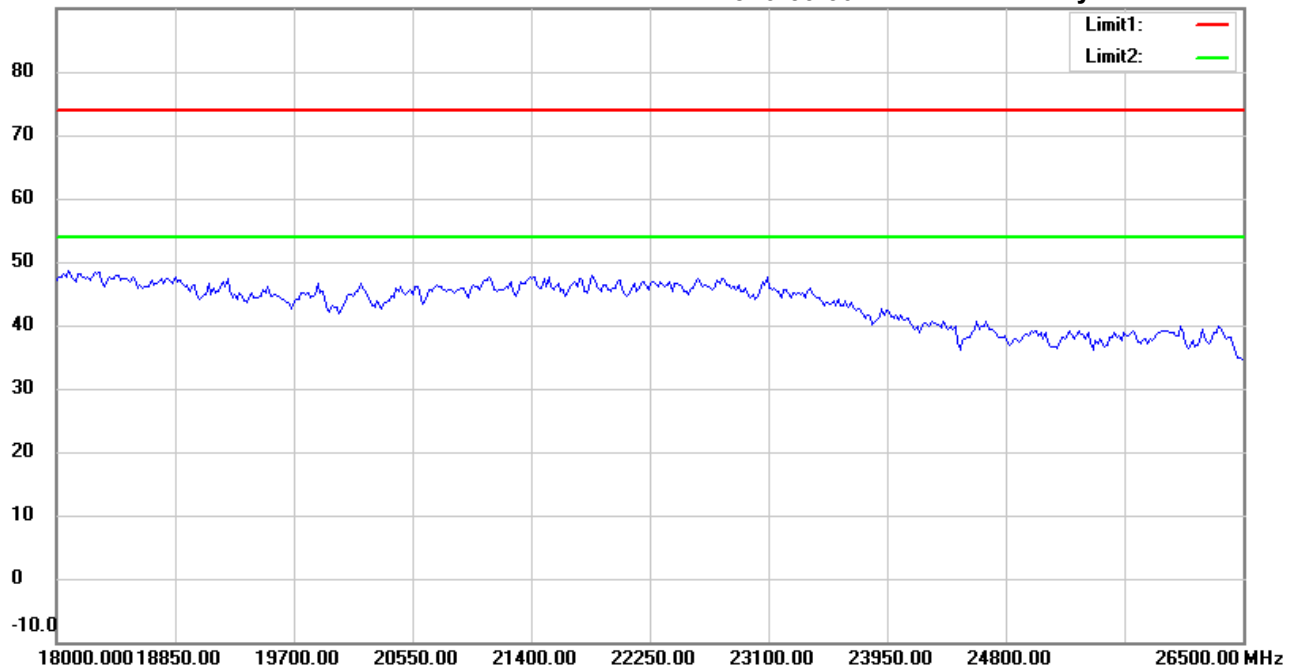
Site : Chamber

Condition : FCC\_part 15E RE\_Above 1GHz\_PK

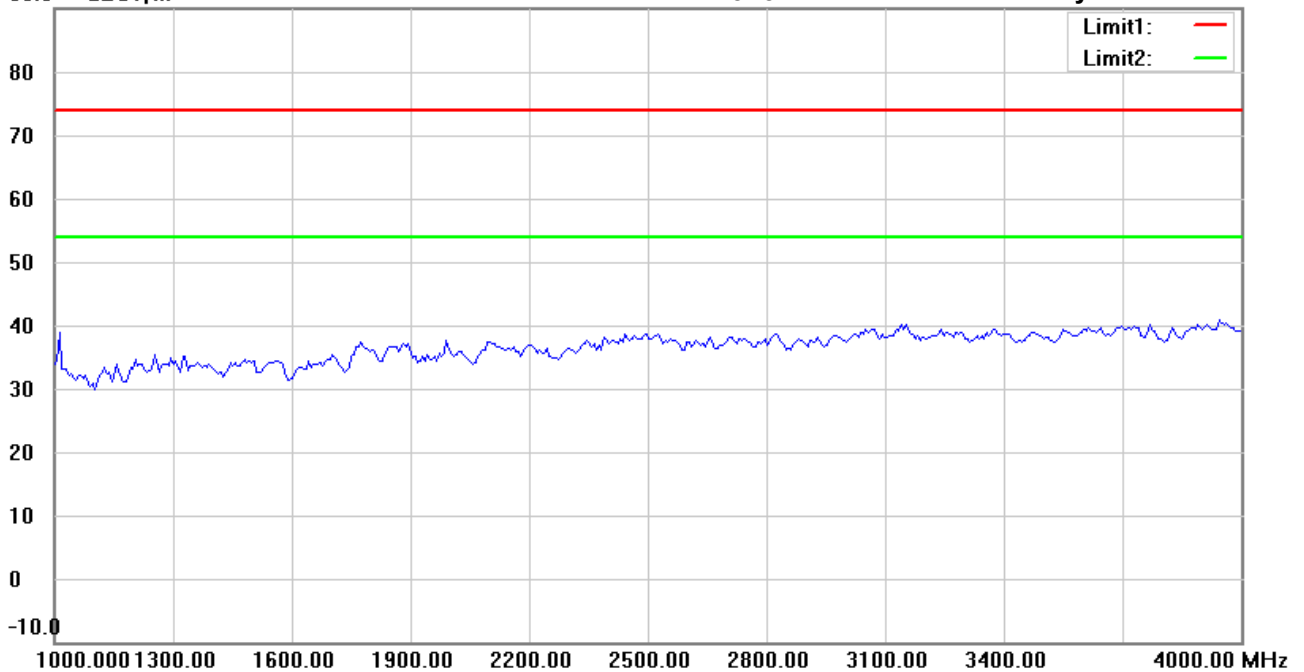
Site : Chamber

Condition : FCC\_part 15E RE\_Above 1GHz\_PK

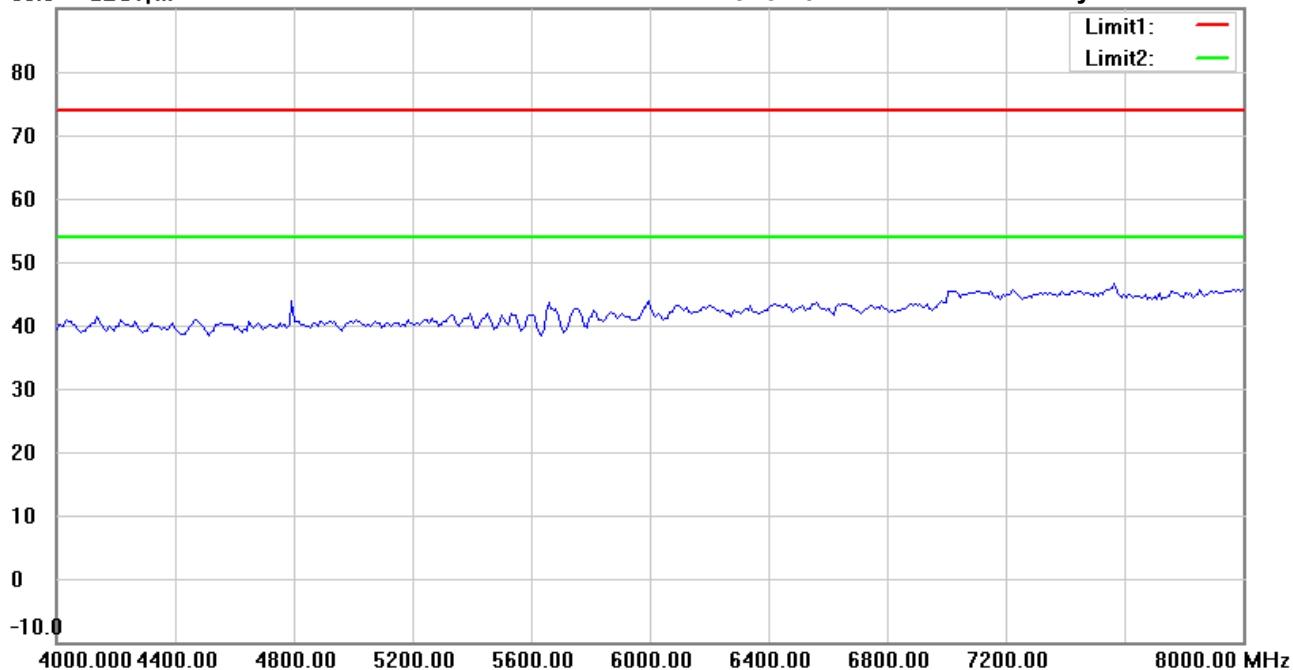
Site : Chamber

Condition : FCC\_part 15E RE\_Above 1GHz\_PK
